Tilden-Coil Safety Audit - V.2019

Gym & Wellness					Complete
Score	96.38%	Flagged items	0	Actions	0
Jobsite Name:					
Gym & Wellness					
Superintendent					
Joe Herzog					
Project Manager					
Tracy Ellis					
Project Executive					
Matt Breyer					
Conducted on					05.07.2022 18:08 PDT
Prepared by					Esteban Vazquez

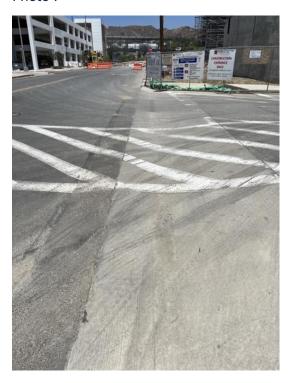
Photo 7

The rumble plates had to be removed because of excavation that recently took place. The jobsite is doing the best they can within reason to sweep daily to ensure the track out doesn't become an issue.
