RE: SWACC PROPERTY & LIABILITY INSPECTION

SWACC PROPERTY & LIABILITY INSPECTION

JUNE 2022

MT SAN ANTONIO COMMUNITY COLLEGE DISTRICT

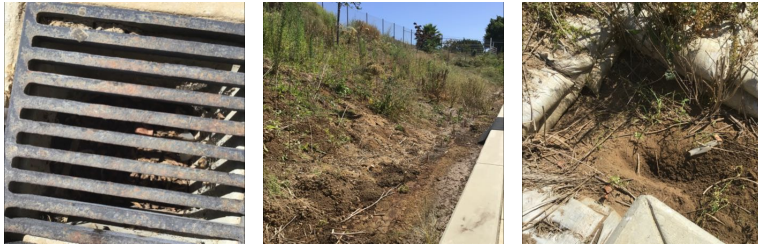
elevated risk of flooding and property damage. Water drainage measures should be placed on a preventative maintenance program to ensure they are intact, clear of debris and functioning properly.

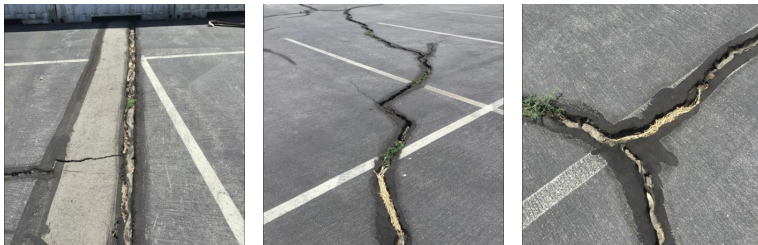
Description: Raised or cracked sections of asphalt/concrete present a trip hazard and should be repaired to reduce this hazard.

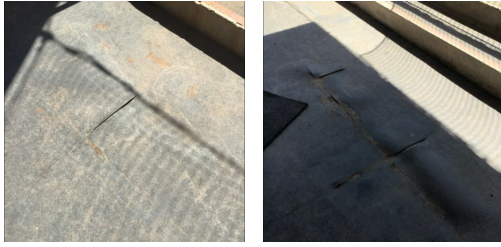
Description: Raised or voids in the dugout matting create a trip hazard and should be repaired or replaced.

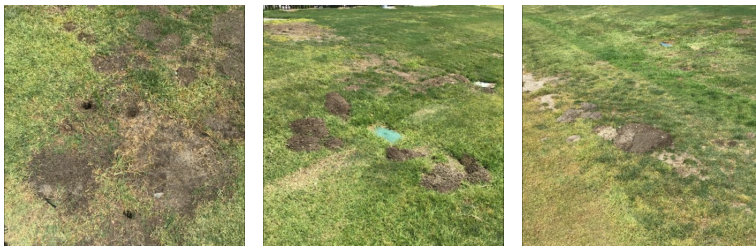
Description: Uneven field surfaces present a trip hazard and should be repaired.

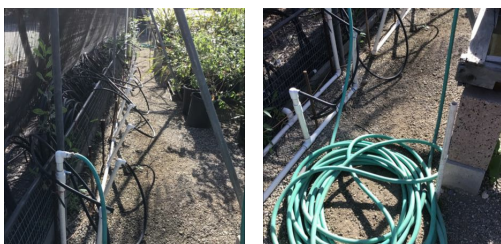
Description: Installation of suspended hose and cord reels should be installed to reduce clutter and trip hazards.

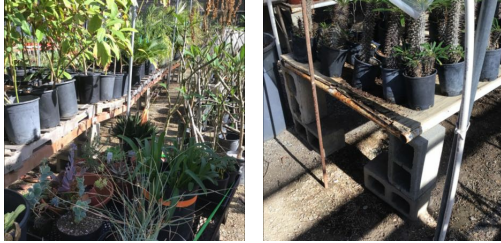
Description: The wood on some of the pallets appear to be in poor condition and should be repaired or replaced.

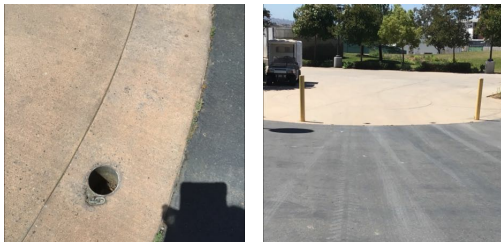
Description: The open holes where the bollards were create a trip/fall hazard. The bollards should be replaced or the holes covered to reduce this hazard.

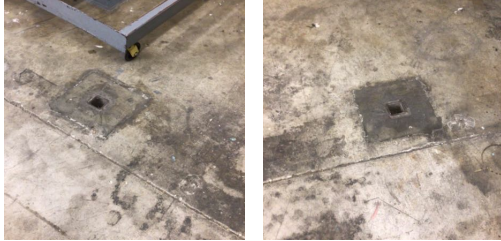
Description: The holes in the floor present a trip hazard and should be repaired to reduce this hazard.

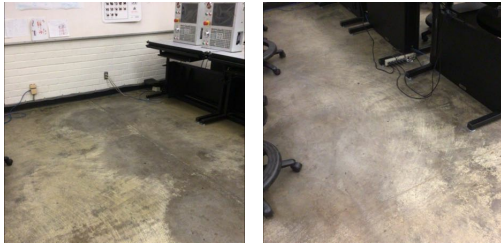
Description: Electrical cords on the floor creates a trip hazard in this area. The cords should be rerouted or covered with a cord cover/protector to reduce this hazard.

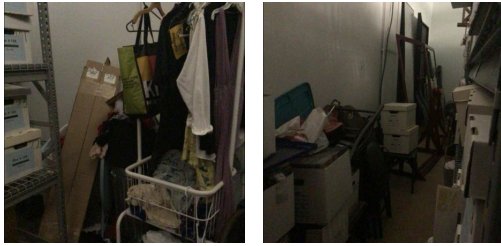
Description: Aisles and passageways were obstructed which could impede emergency egress. Aisles and passageways should be kept clear at all times and have a minimum width of 30 inches.

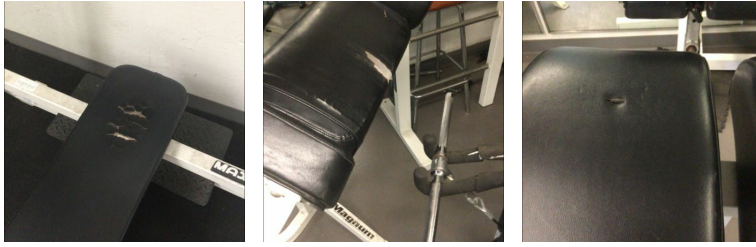
Description: Equipment pads were in various degrees of wear. Pads should not be torn or worn through to minimize the growth of bacteria.

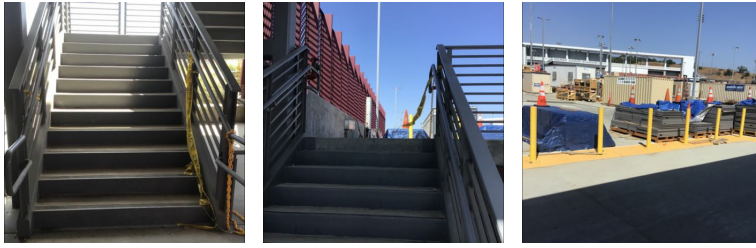
Description: The access to the second story of the parking structure should be restricted due to this area being utilized as storage.

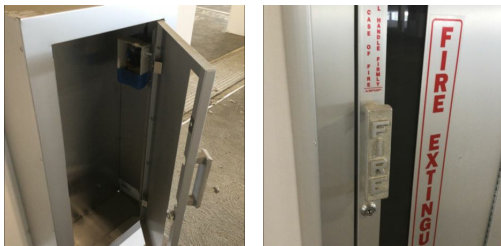
Description: Multiple fire extinguisher were missing and should be replaced.

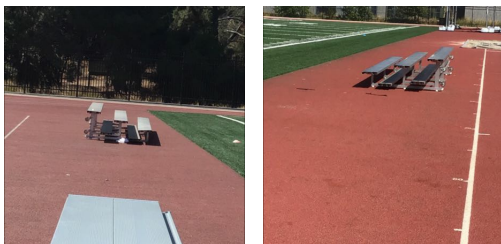
Description: Any missing end covers from metal bleacher seats should be replaced.

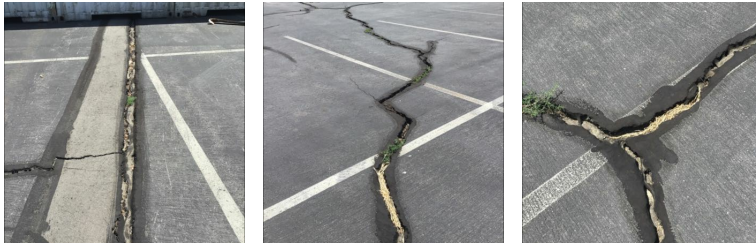
Description: Raised or cracked sections of asphalt/concrete present a trip hazard and should be repaired to reduce this hazard.

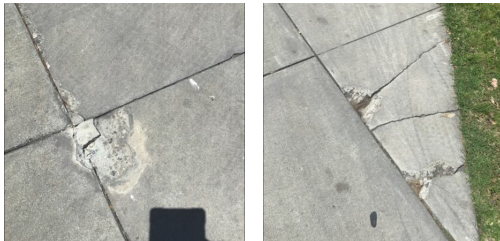
Description: Raised or cracked sections of asphalt/concrete present a trip hazard and should be repaired to reduce this hazard.
