Assessment of Distress At Mt. San Antonio Stadium

On Call Engineering Services

Subject: *Assessment of the Distress at Mt. San Antonio Stadium*
IDS Project Number: 29.157.03

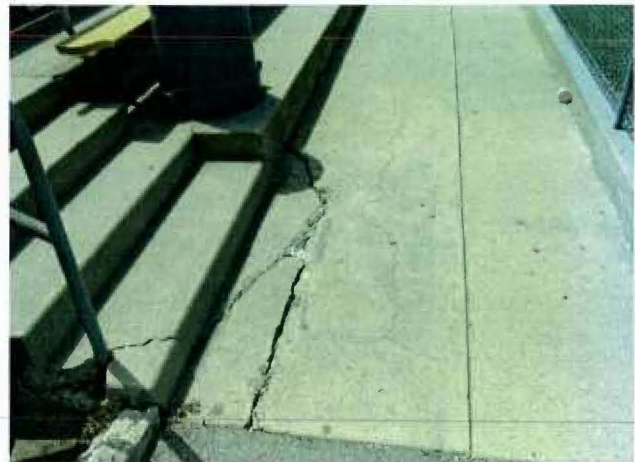
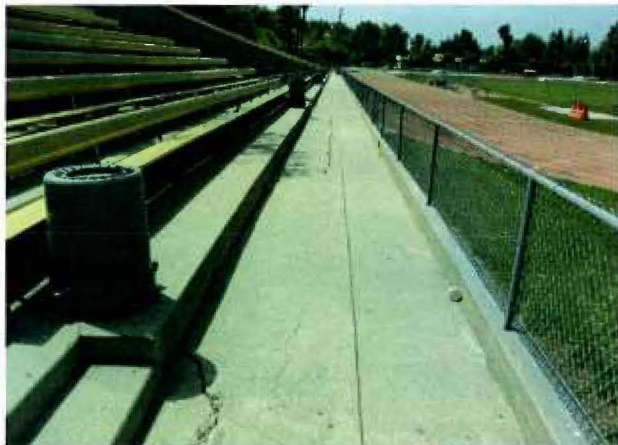
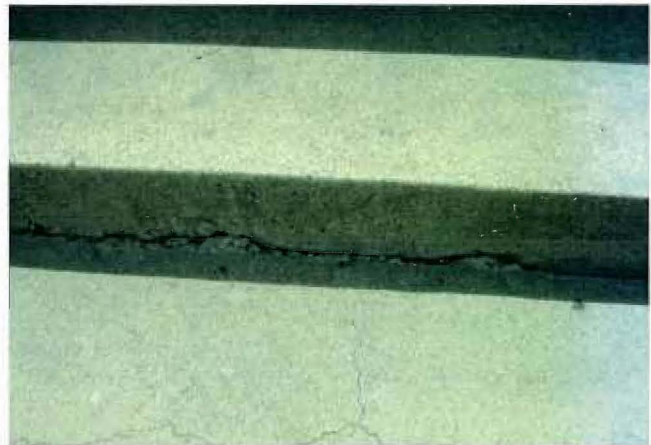
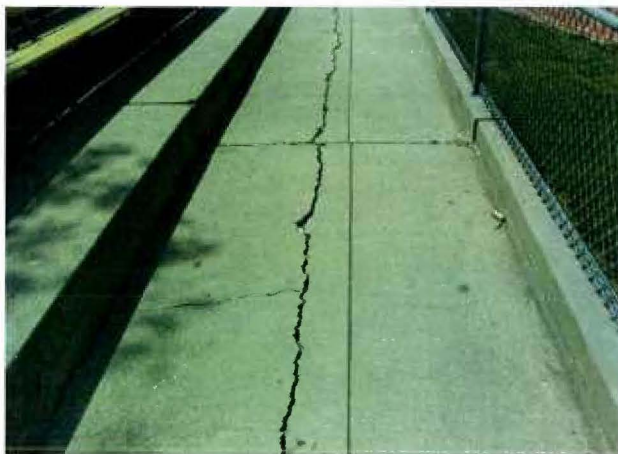
Item #	Description	Ref. Photo	Measurements	Recommended Action	Rough Constr. Cost
S1	Large cracking at slab on grade initiating from face of steps extending to the center of slab. Resulted in full-depth rupture of the slab with visible vertical offset.	S1a to S1d	75 ft	Damaged portion of the slab shall be demolished to pour new concrete and tied to existing slab using epoxy dowels.	\$13,400
S2	Top of concrete retaining wall is tilted. This is possibly caused by rotation of the foundation due to the soil and water pressure and has created slab rupture indicated in item 1.	S2a & S2b	4ft tall & 36 ft long	Retaining wall to be periodically monitored for further rotation and future reconstruction.	A/R
S3	Cracking at slab with width $\pm 1/8"$	S3	10 ft	Infill with epoxy injection.	\$1,000
S4	Separation of concrete at the bottom of the step	S4	16 ft	To be sealed with epoxy injection or other means.	\$1,200

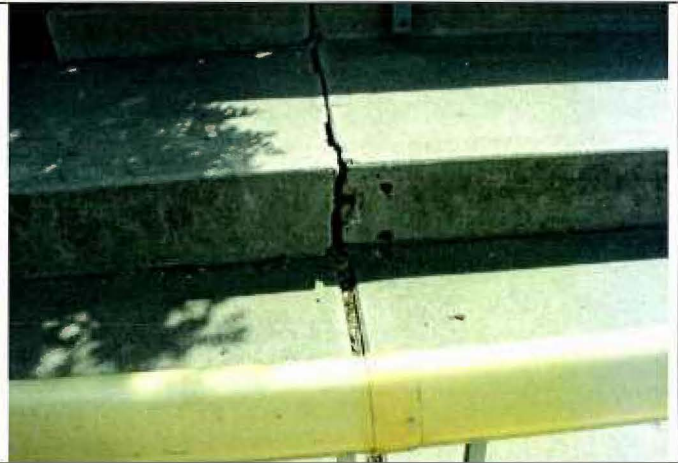
Photo S5:

S5	Exposed bar at joint	S5		Cover bar with epoxy coating.	\$150
S6	Concrete break down at railing support	S6a & S6b	4 plcs	Remove broken and cracked concrete around railing. Place new concrete repair mortar and connect to existing by epoxy dowels.	\$1,700
S7	Approximately 2/3 of the wood seats are rotten and damaged. Connection screws are loose and separated in many locations.	S7a to S7i	Approx. 5,000 linear ft	Replace all the seats.	\$205,000
S8	Slab reinforcing is exposed	S8a & S8b	8 plcs	Infill with epoxy to restore original shape and provide cover for exposed bar.	\$1,350
S9	Separation of concrete at the bottom of the step	S9	60ft	To be sealed with epoxy injection or other means.	\$4,500
S10	Concrete break down with tripping hazard. Possible nest for snakes	S10a & S10b	6ft	Remove broken and cracked concrete . Pour new concrete and connect to existing by epoxy dowels.	\$1,200
S11	Vertical offset of $\pm 2"$ between walkway and seat section. This is due to differential settlement between south and north portion of the stand. The south portion was added in 1957 and is supported by concrete columns, beams and footings while the north portion is older construction (probably) with slab on grade and shows more settlement.	S11a to S11d	6 plcs	Some portion of the concrete slab shall be demolished and new concrete to be poured for smooth leveling between two sides.	\$10,500

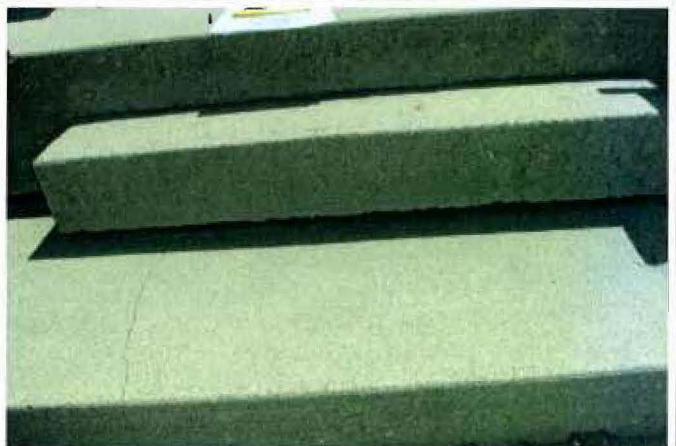
Photo S12:

S12	Separation of concrete at the bottom of the step $\pm 2"$	S12	6 ft	To be sealed with epoxy injection or other means.	\$225
S13	Vertical offset of $\pm 1"$ at separation joint with tripping hazard	S13	20 ft	Some portions of the concrete shall be demolished and new concrete to be poured for smooth leveling between two sides.	\$4,500

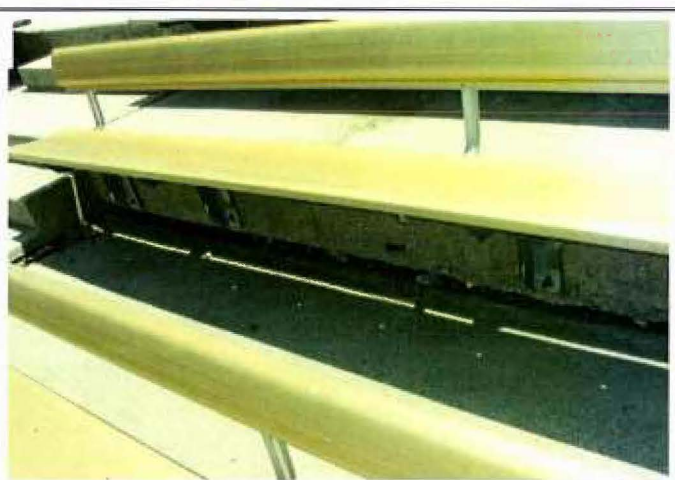
Photo S14:

S14	Large separation of concrete at the bottom of the step ±2"	S14	40ft	To be sealed with epoxy injection or other means.	\$1,500
S15	Vertical offset of ±1/2" at separation joint with tripping hazard	S15	10 plcs	Some portion of the concrete slab shall be demolished and new concrete to be poured for smooth leveling between two sides.	\$6,300
S16	Vertical offset of ±1/2" at separation joint with tripping hazard	S16	4 plcs	Some portion of the concrete slab shall be demolished and new concrete to be poured for smooth transition between two sides.	\$3,900
S17	Separation of concrete at the bottom of the step ±2"	S17	50ft	To be sealed with epoxy injection or other means.	\$3,000
S18	Separation of concrete at the bottom of the step ±1"	S18	40ft	To be sealed with epoxy injection or other means.	\$2,400
S19	Separation of concrete at the bottom of the step ±1"	S19	30 ft	To be sealed with epoxy injection or other means.	\$2,000

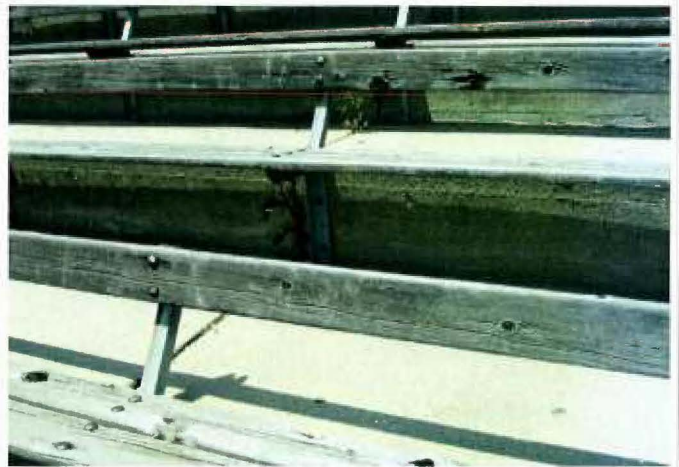
Photo S20:

S20	Vegetation inside construction joints	S20		Clean all the vegetation and trash.	\$2,600
S21	Approximately 2/3 of the Wood seats are rotten and damaged. Connection screws are loose and separated in many locations. Some of the seats are totally broken.	S21	Approx. 6,500 linear ft	Replace all the seats.	\$265,000
S22	Separation of concrete at the bottom of the step ±1"	S22	60 ft	To be sealed with epoxy injection or other means.	\$3,600
S23	Vertical offset of ±1/2" at separation joint with tripping hazard	S23	6 plcs	Some portion of the concrete slab shall be demolished and new concrete to be poured for smooth leveling between two sides.	\$4,000
S24	Cracking at slab with width ±1/8"	S24a & S24b	60 ft	Infill with epoxy injection. Concrete around seat support shall be demolished and new concrete to be poured with epoxy dowel connection.	\$6,800
S25	Damaged concrete with exposed bar and slab cracking	S25	6 ft	Remove damaged portions of concrete and infill with epoxy injection.	\$400

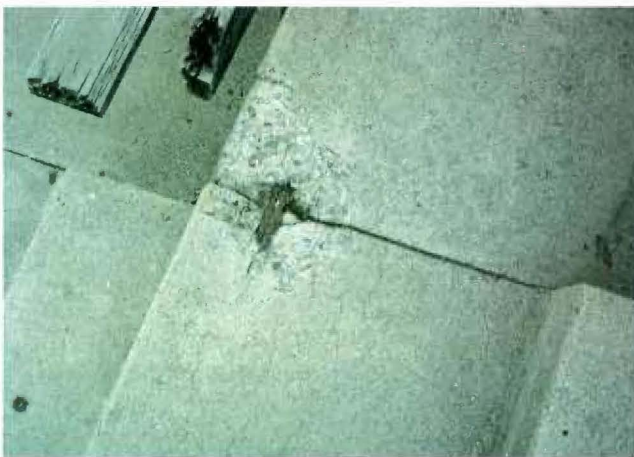
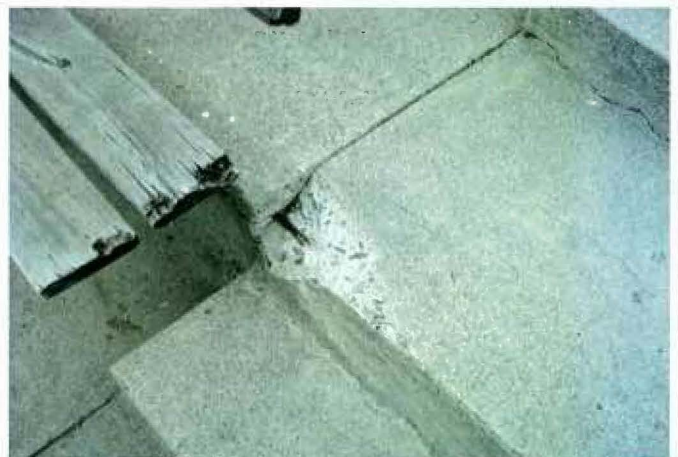
S25	Exposed bar at joint	S26a & S26b	8plcs	Cover bar with epoxy coating.	\$2,000
S26	Cracking at slab with width less tahn 1/8"		1,000 linear ft (assumed)	Cover bar Sealant.	\$12,000

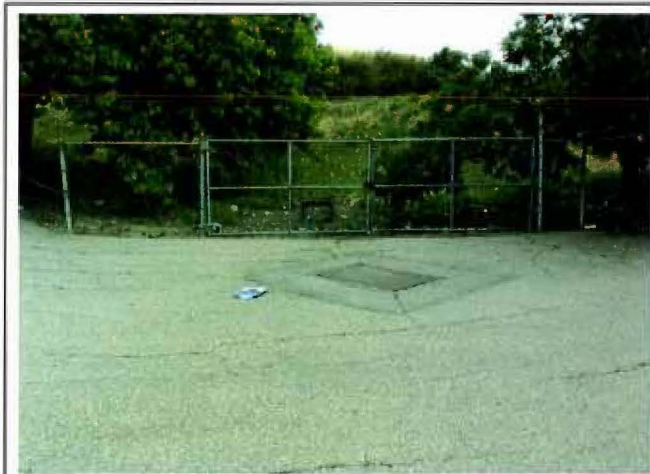
Photo C1:

Item #	Description	Ref. Photo	Measurements	Recommended Action	Estimated Constr. Costs
C1	At the proposed, 9-3-1957 Headwall location, a hole was cut at the top of the 30" CMP and a protective chain link screen box constructed over top of the hole. This new drainage point for the surface water coming from the East Stand area was observed to be silted over reducing the effect of the drain.	C1		Remove siltation, remove solid plate cover. Repair chain link fence guard. Install perforated cover over existing hole and secure to CMP	\$1,800
C2	The north East Stand entry point at the lower left corner of the entry steps; water is draining over the constructed concrete "V" ditch and flowing onto the asphalt drive area. This is due to excessive siltation build at the "V" ditch turning point.	C2		Remove siltation	\$250
C3	At the upper most elevation, the water from the high side of the sidewalk was being redirected to a lower point of the sidewalk, causing water flow over the concrete sidewalk to the earthen area. this new water direction created an undercutting of the sidewalk and exposing the underside of the walk by 1'-0" to 2'-0". This redirection is due to ground settlement, of 1 to 2 inches of the upper "V" ditch section.			At settlement area re-grade the area for positive drainage into the "V" ditch. Slurry mix the area of side walk that has been under cut and re-grade the landscape area for positive water flow.	\$7,700

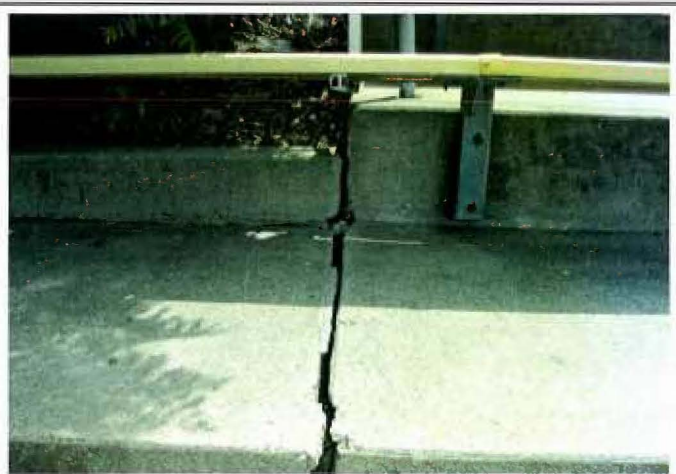
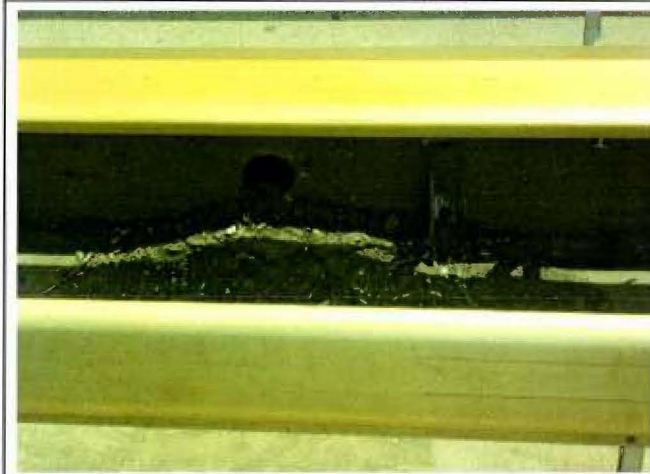
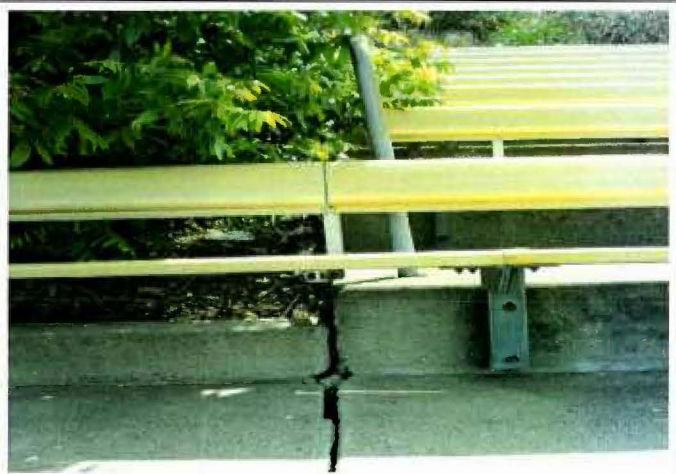
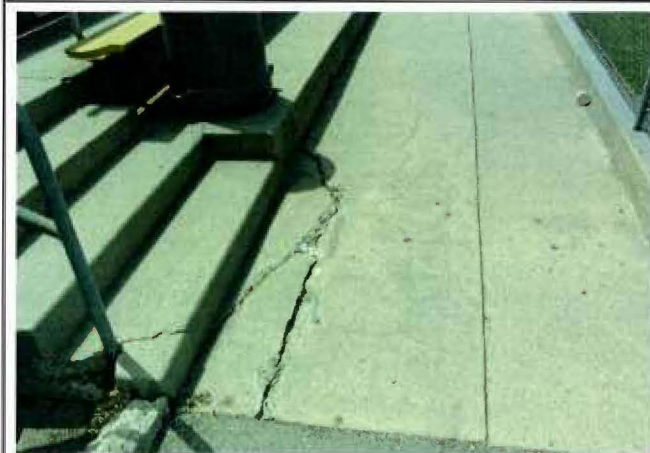
C4	This excessive water flow breached and silted over the upper concrete "V" ditch for the lower Stands, causing water to flow over the stands into existing cracks and butt joints. Several weep holes have visible siltation coming from them.	C4a to C4e		Remove siltation. At all points at both East and West Stands where the concrete "V" ditches make a 90 degree down turn, a concrete based material should be constructed at the upper most corner to direct the water away from going into the stand.	\$1,700
C5	At the top of the East Stand behind the light towers, the first "V" ditch, on the east side of the chain link fence, was non-existent. No exploratory measures were taken at this time			Remove siltation	\$7,500
C6	At the South side of the East Stand area; several under sidewalk drains were clogged with siltation making the drains inoperable.			Remove siltation	\$400
C7	The south side of the East Stand "V" ditches were also silted to the point they were inoperable.	C7		Remove siltation	\$700
