**UNITED WALNUT TAXPAYERS PRELIMINARY REVIEW OF NEGATIVE GEOTECHNICAL AND GEOLOGICAL ASPECTS OF CONSTRUCTING EARTHFILL PAD FOR A SOLAR FARM ON THE WEST PARCEL - DRAFT**

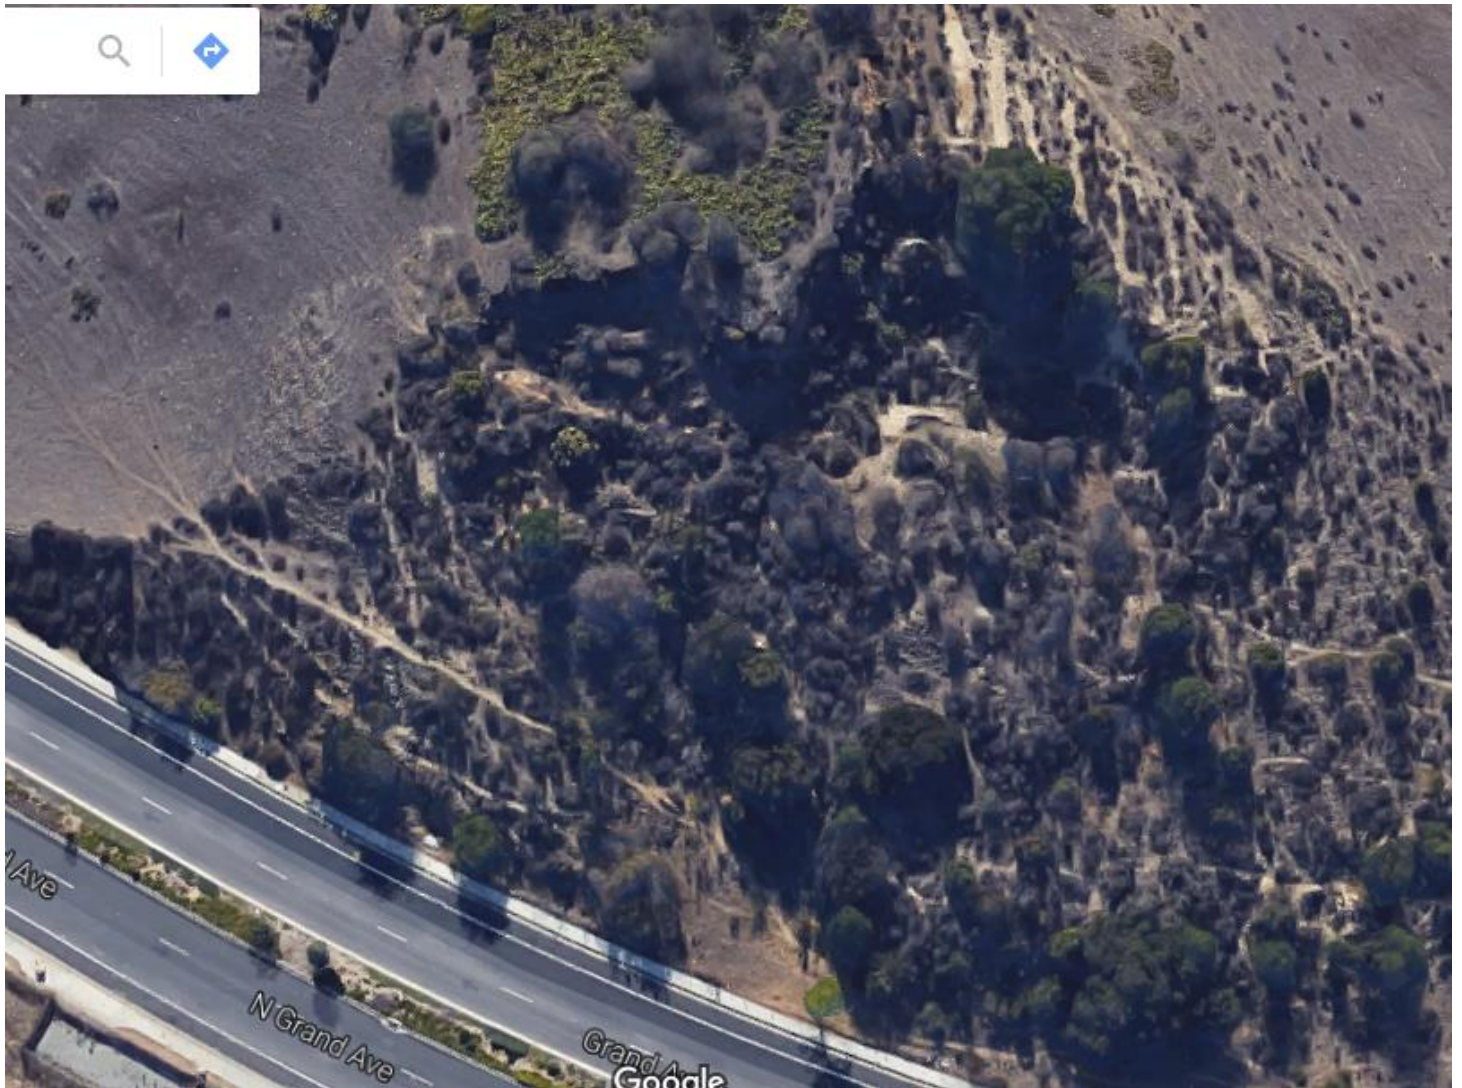
**Attachment**  
**Google Earth Image of Existing Landslide at West Parcel Site**

- vii. The Converse report did not recognize a significant landslide in the central hill of the project site present for more than thirty years (see Google Earth attachment), which is vulnerable to further sliding.

iv. Aerial imagery from Google Earth clearly indicates landslide(s) exists on the eastern side of the central knob descending down to Grand Avenue (see attachment). The landslide area on the central hill is present in aerial imagery dating from after 1980 until the present.

v. The above referenced landslide is further validated through field visits to the site by our Engineering Geologist and former City officials with first-hand knowledge of at least two landslides that occurred at the subject site after Grand Avenue was expanded to four lanes.

vi. At least one of the above landslides at the central hill of the site closed the road (Grand Ave.) and covered all the lanes. In addition, siltstone and shale bedrock with eastward dipping bedding subject to landsliding was observed in this area.

i. The landslide at the central hill along Grand Avenue likely took place along easterly out of slope bedding orientations.

ii. The central portion of the Grand Avenue site is underlain by the landslide.

i. The landslide at Grand Avenue occurred about 1980 shortly after Grand Avenue was widened to four lanes in the late 1970's, likely from the undercutting of the central hill near the roadway.
