United Walnut Taxpayers (UWT)  
P.O. Box 1665  
Walnut, CA. 91788  
Contact Person, Layla Abou-Taleb, President

September 8, 2017

**UWT Response to the July 2017 NOC of Tiered Draft EIR for the Mt. SAC West Parcel Solar Project**

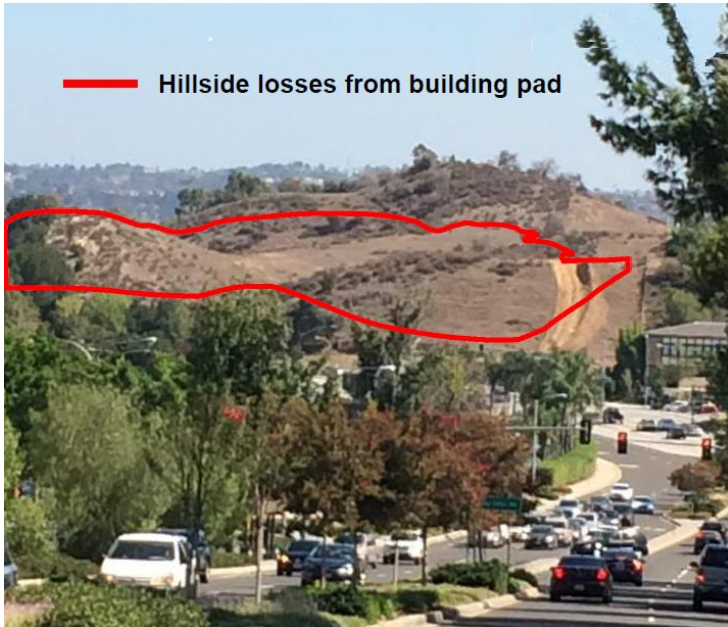
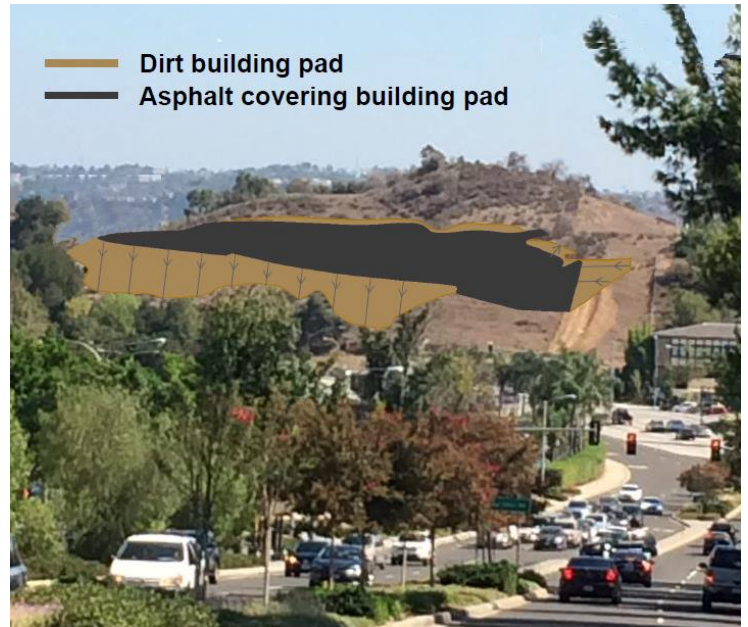
**Hillside Losses from Dirt Building Pad with Asphalt Cover Visible for Grand Avenue Entering**

3. Viewsheds along Grand Avenue are Significantly Changed. Massive alterations to the natural viewshed of motorists on Grand Avenue entering from the north are shown below. Viewsheds show significant losses of natural hillsides some 70 feet above Grand Avenue and land areas that will be destroyed and replaced with a sterile building pad with long linear earthfill side slopes, asphalt cover and solar installations. The Grand Avenue viewshed is experienced by 1000's of motorists a day. Similar views are seen from Mountaineer Road.

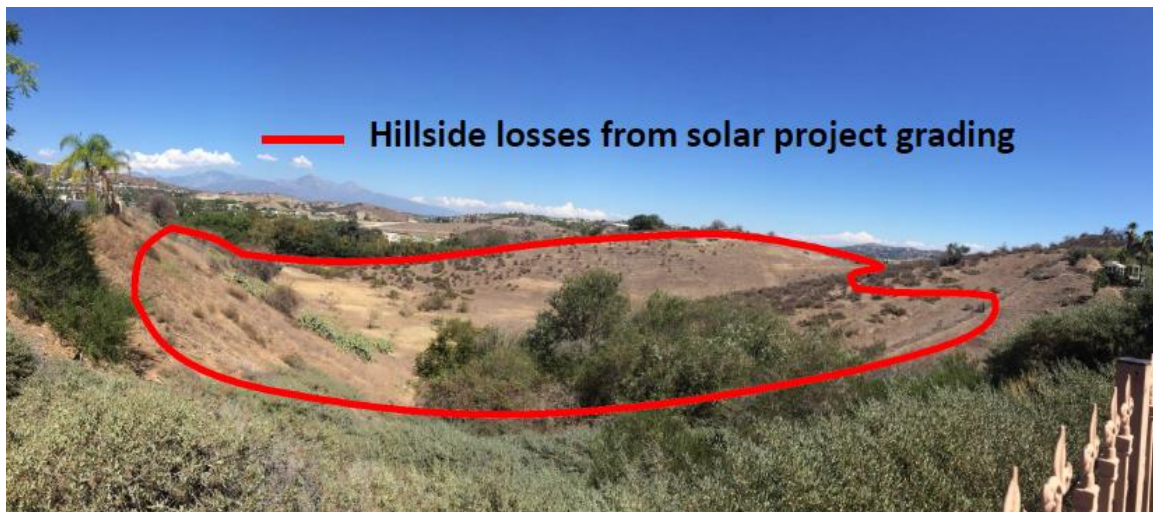
**Hillside Losses from Solar Project Building Pad at Regal Canyon Drive**

4. Regal Canyon Drive in the Willows Community. Residents traveling up Regal Canyon Drive will see the industrial looking solar facility immediately next to the roadway blocking views of the natural canyons that once existed. Hundreds of cars a day travel this route, which will change the character of the passive community into a rigid landscape at its entrance.

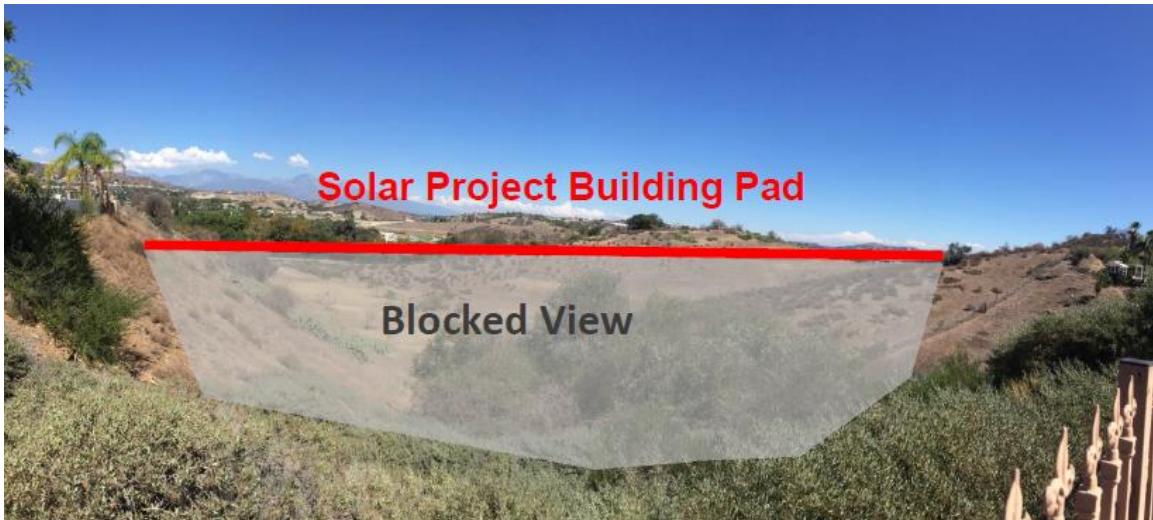
## Motorists Blocked View from Solar Project at Regal Canyon Drive

- c. Blocked View from Motorists at Street Level. Motorists accustomed to seeing unobstructed views from Regal Canyon Drive will be blocked from views of the natural hillsides and the scenic wildlife reserve. Views would be almost completely obstructed by the building pad of the solar project.

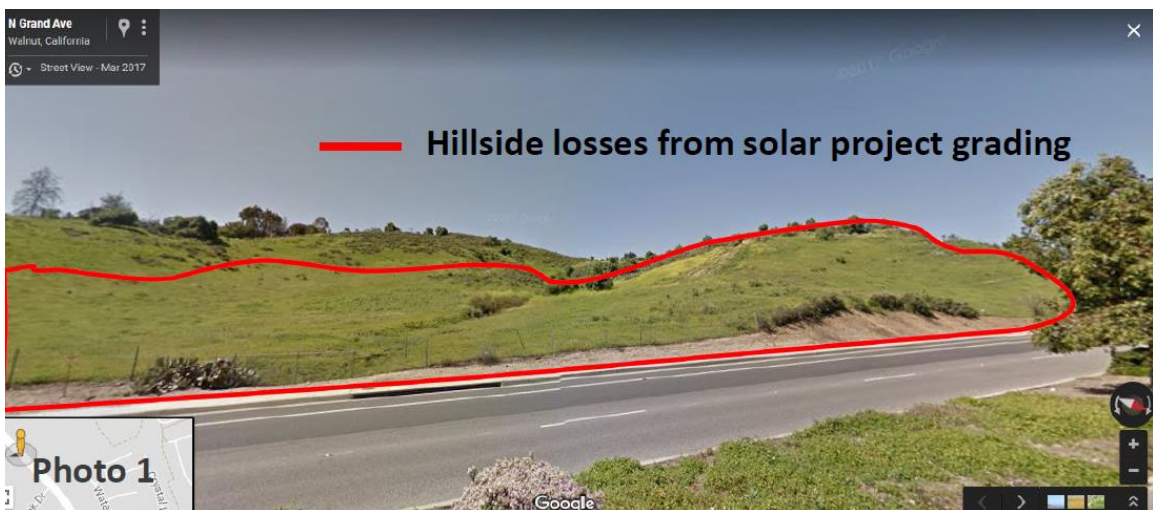
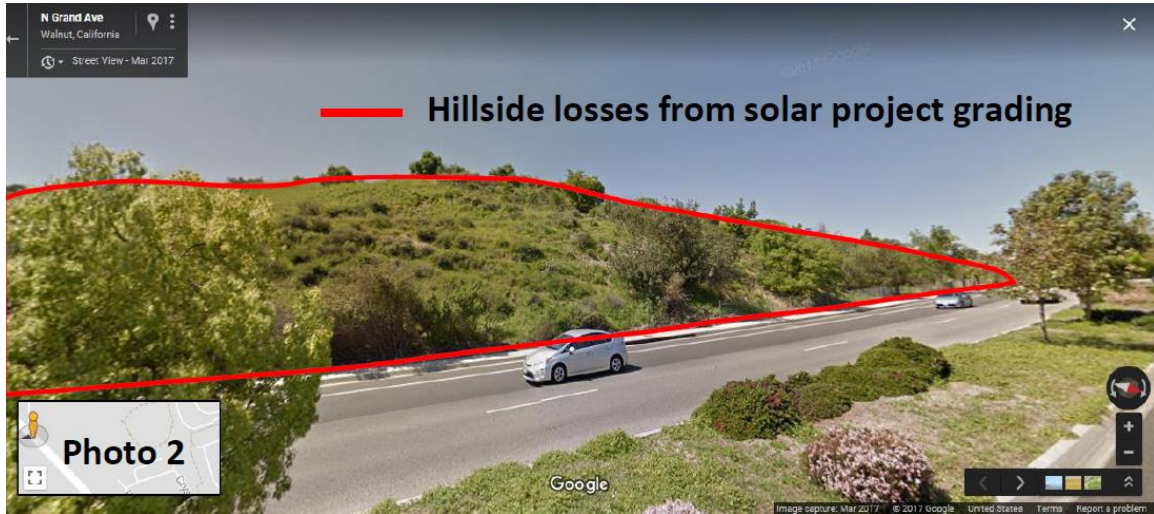
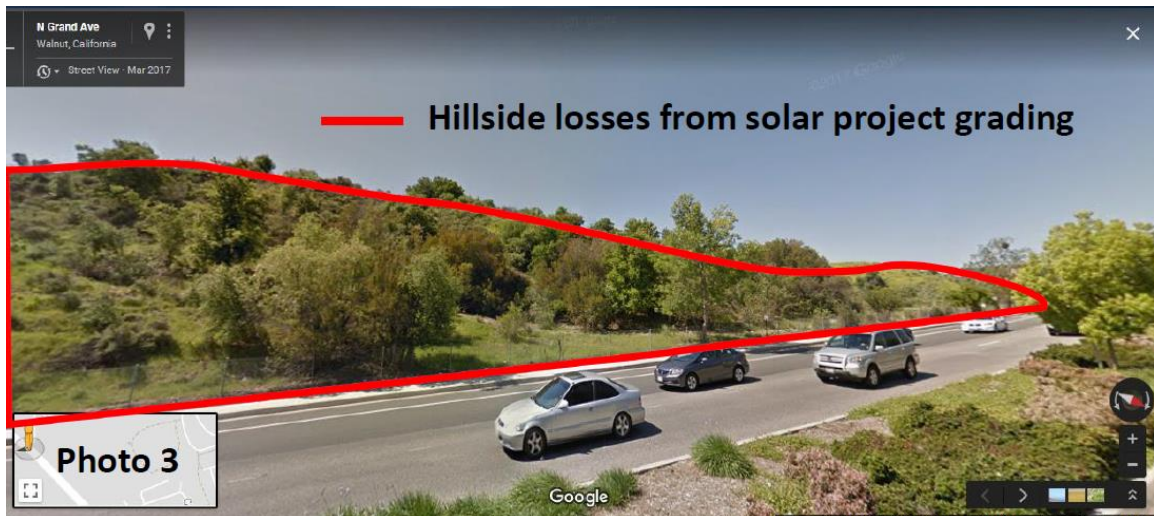
## Hillside Losses from Solar Project Traveling form Snow Creek Drive to Amar Road

5. Motorists traveling Grand Avenue would observe loss of hillsides, which is inconsistent with the General Plan Scenic Corridor designation of the roadway. The following views of Grand Avenue (photos 1 through 3, below) traveling from south to north from Snow Creek Drive to Amar Road displays the scenic values of Grand Avenue at street level and the significant destruction of native hillsides and vegetation caused by the west parcel project.

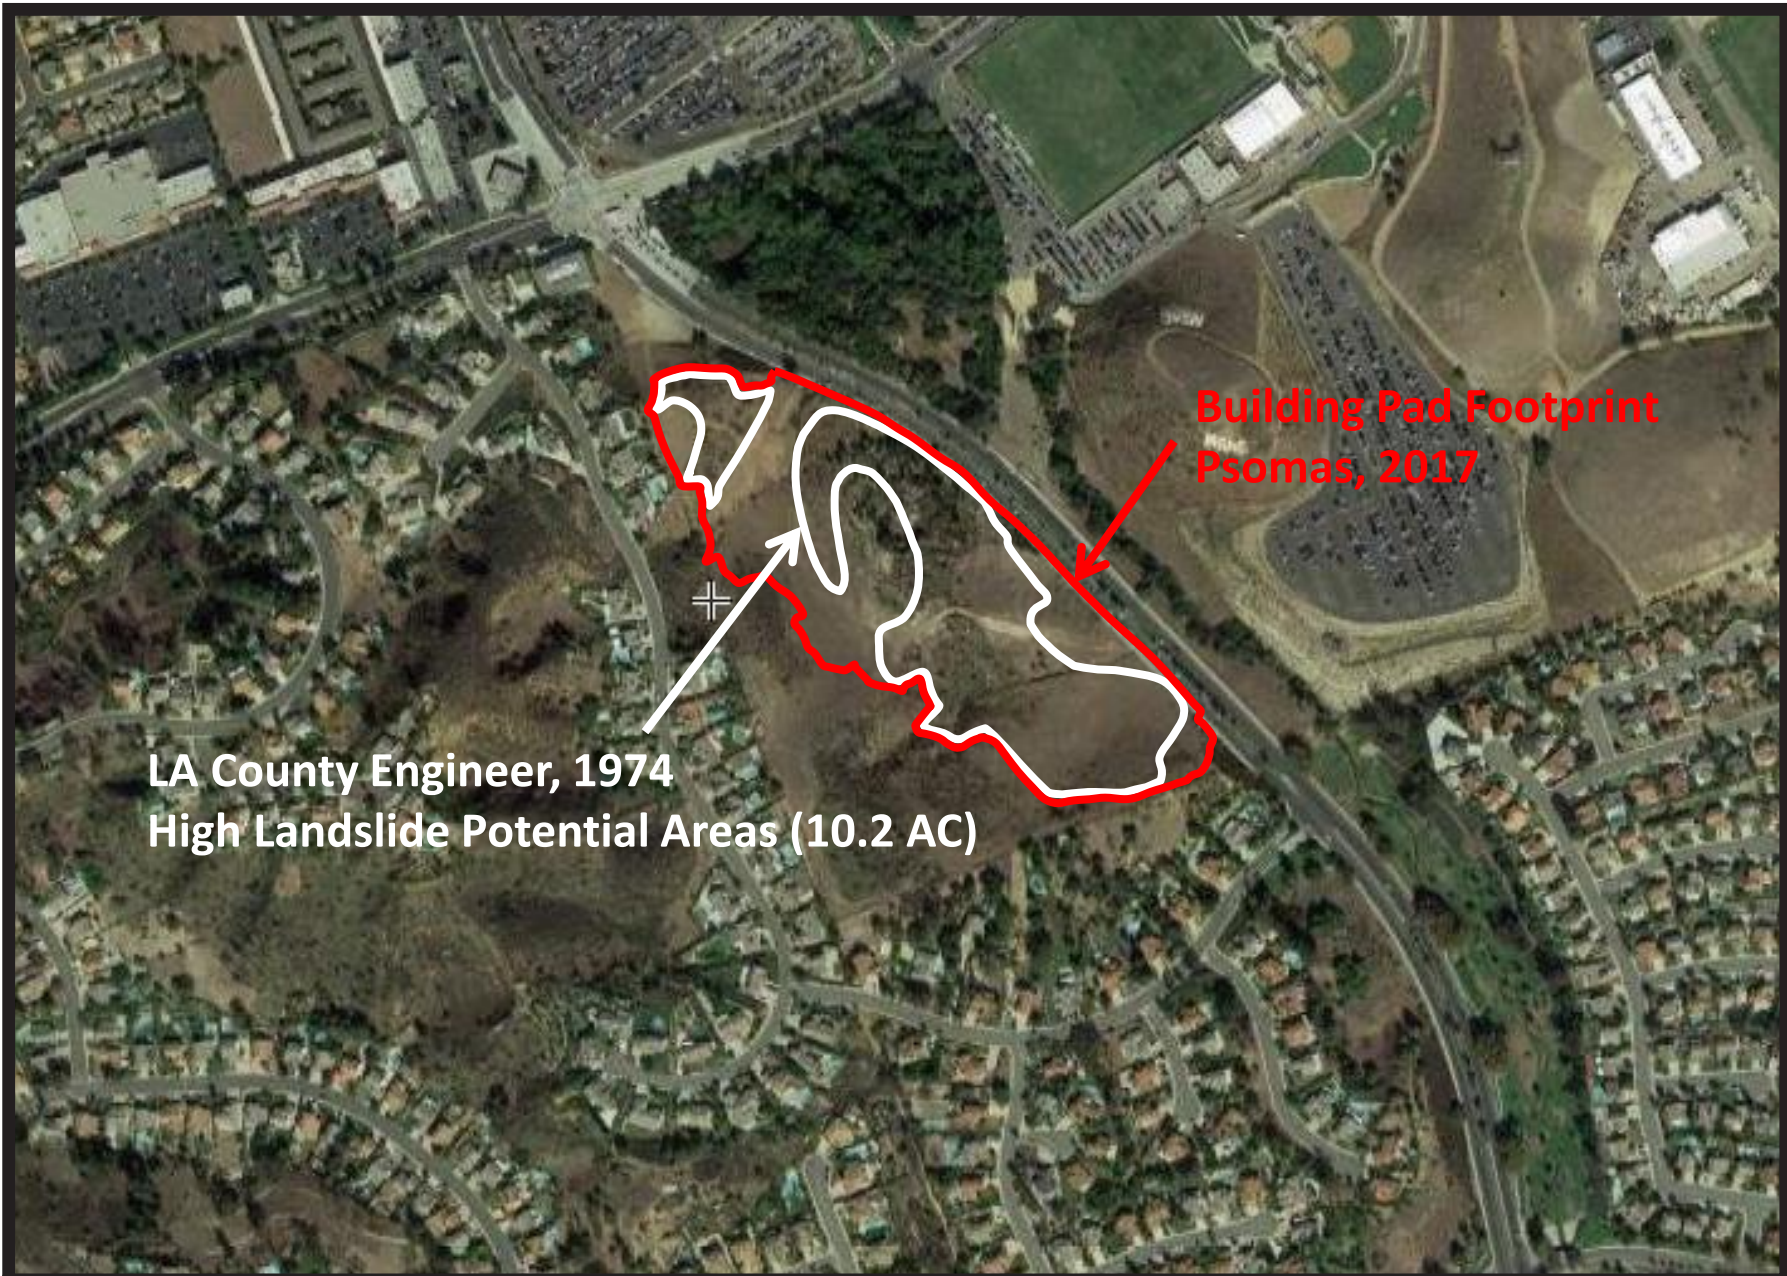
## Figure 2a

33. These costs also do not account for possible additional remediation of landslides associated with High Landslide Potential lands identified on the LA County Engineer mapping for the City of Walnut General Plan and on the California Geological Survey CGS 88-21 Map No. 12 for this region, designating most lands at the west parcel at “close to their stability limits”.

LA County Engineer, 1974  
High Landslide Potential Areas (10.2 AC)

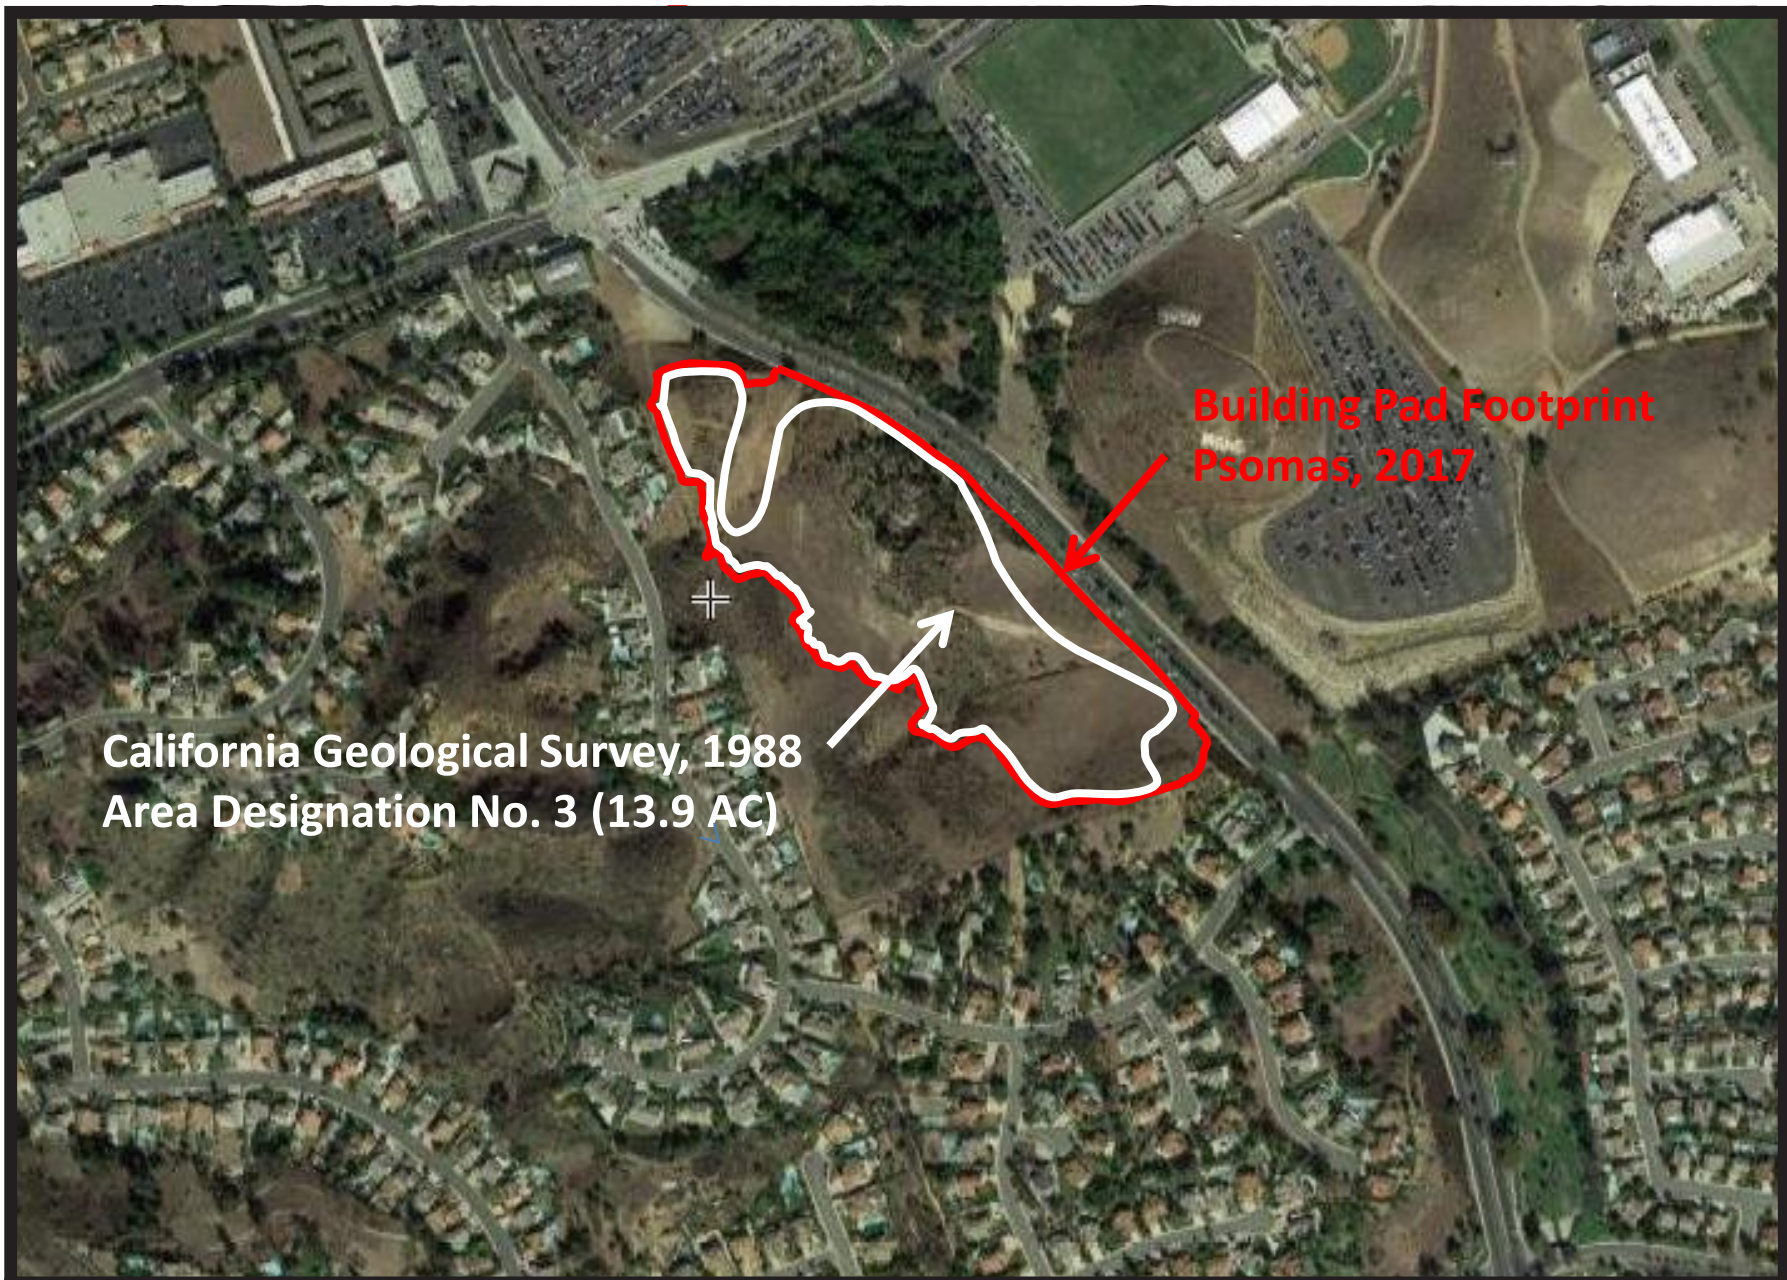
**Figure 3a**

*"Relative Landslide Susceptibility Areas; Area 3 - Generally Susceptible Area. Slopes within this area are at or near the stability limits due to a combination of weaker materials and steeper slopes. Although most of the slopes within Area 3 do not currently contain landslide deposits, the materials*

California Geological Survey, 1988  
Area Designation No. 3 (13.9 AC)

*that underlie them can be expected to fail, locally when modified by natural processes or the activities by man because they are close to their stability limits.”*

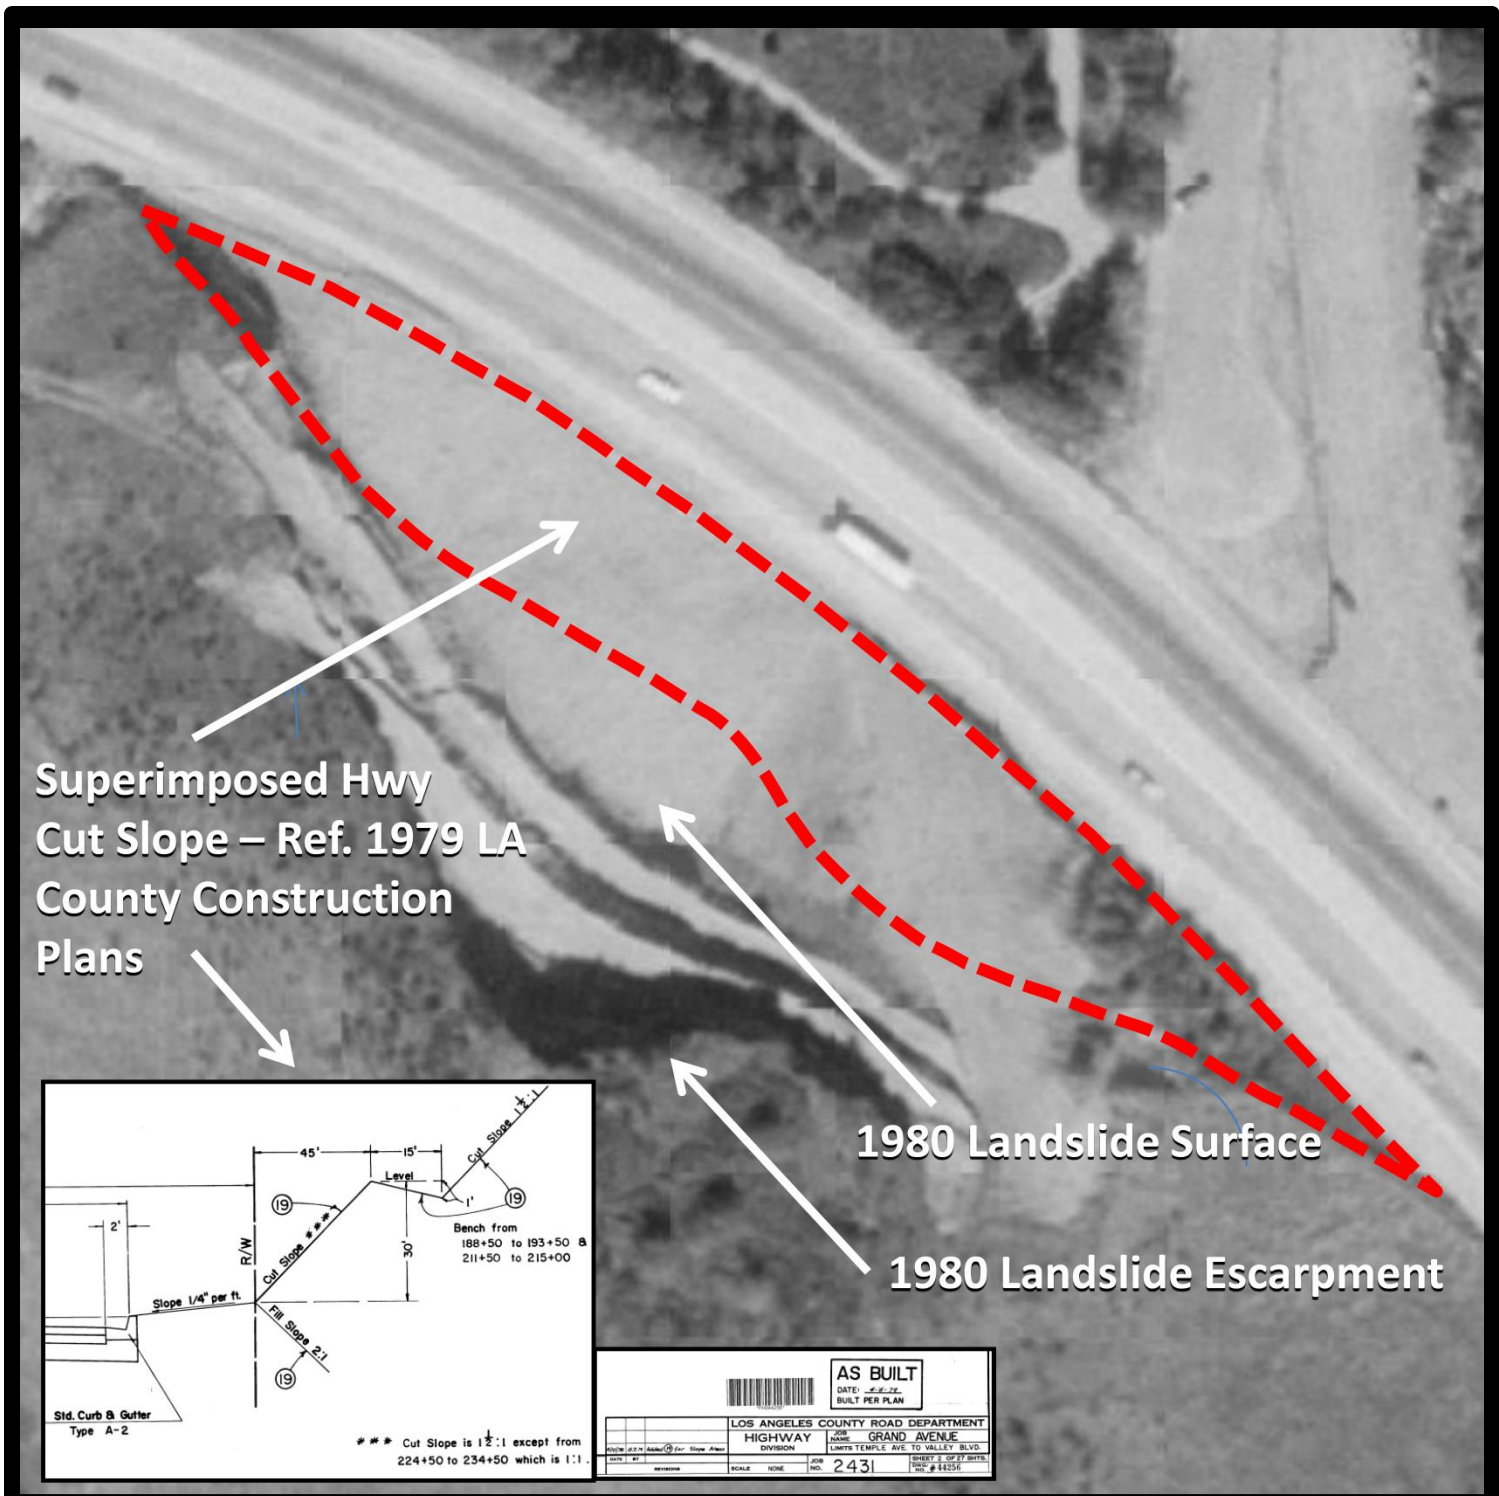
**Figure 5**

TSI conducted a brief review of the potential for landsliding at the site. A review of aerial imagery from Google Earth clearly indicates a landslide(s) exists on the eastern side of the central hillside area descending to Grand Avenue (Photo's 1 and 2). This landslide area is present in aerial imagery dating from after 1980 until the present. The presence of this landslide complex was further confirmed based on the brief field reconnaissance on March 30, 2017. In addition, siltstone and shale bedrock with eastward dipping (toward Grand Avenue) bedding was also observed in this area.

**Aerial Showing Location of Landslide on Grand Ave. and Footprint of Original Cut Slope**

The slope along Grand Avenue consists of variable cut, fill, and in some locations, fill over the existing slope. As discussed earlier, the central hill portion of the site along Grand Avenue is underlain by a landslide. The proposed cut slope in this area will most likely not remove all the landslide debris, and the underlying cause(s) of the landslide. The geologic conditions (including the presence of the landslide) have not been modeled by Converse for the differing conditions along the length of this proposed slope. No specific stability analysis was provided for any of this variable slope which is nearly 2000 feet in length and up to 80 feet in height. Grand Avenue is a major roadway within the City of Walnut and is located at the toe of this proposed slope. Therefore, understanding the stability of this slope is a critical aspect of this project.

Remediation of the landslide materials that exist within the central hillside area, and other areas of the site, will consist of total removal of the landslide debris to competent bedrock. In addition to normal remedial removals a thorough evaluation, including subsurface investigations, of the underlying weak bedrock conditions must be conducted to determine the width and depth of a shear key that will likely be necessary to stabilize the proposed development. The Converse report indicated that a “Fill Slope Stabilization Keyway” was necessary for portions of the site (Drawing No. 2). However, their key was not based on specific slope stability analysis and was not recommended for cut slopes and/or areas of landsliding or potential slope stability issues.

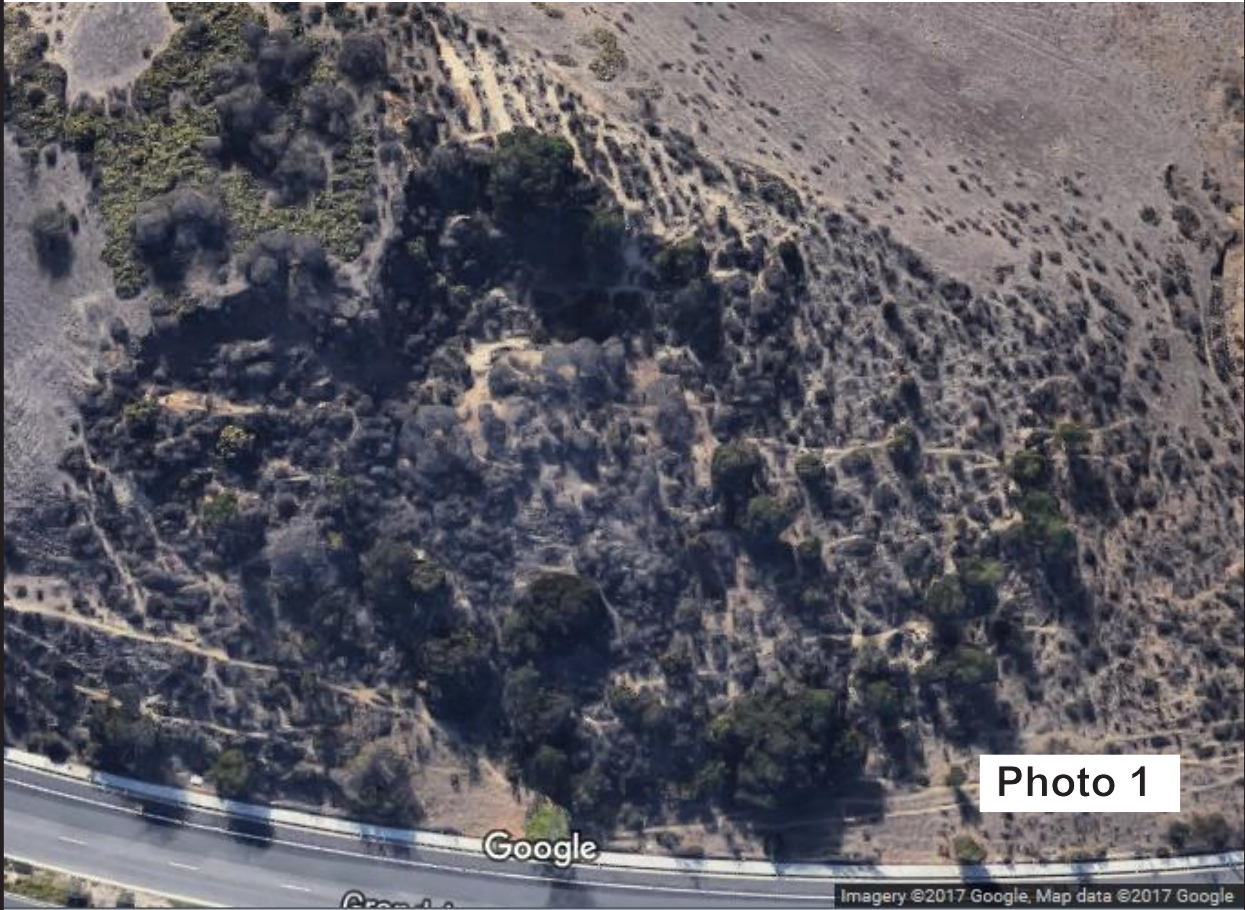
**Photo 1**

**Central Hill Landslide Area (close up and broader view)**

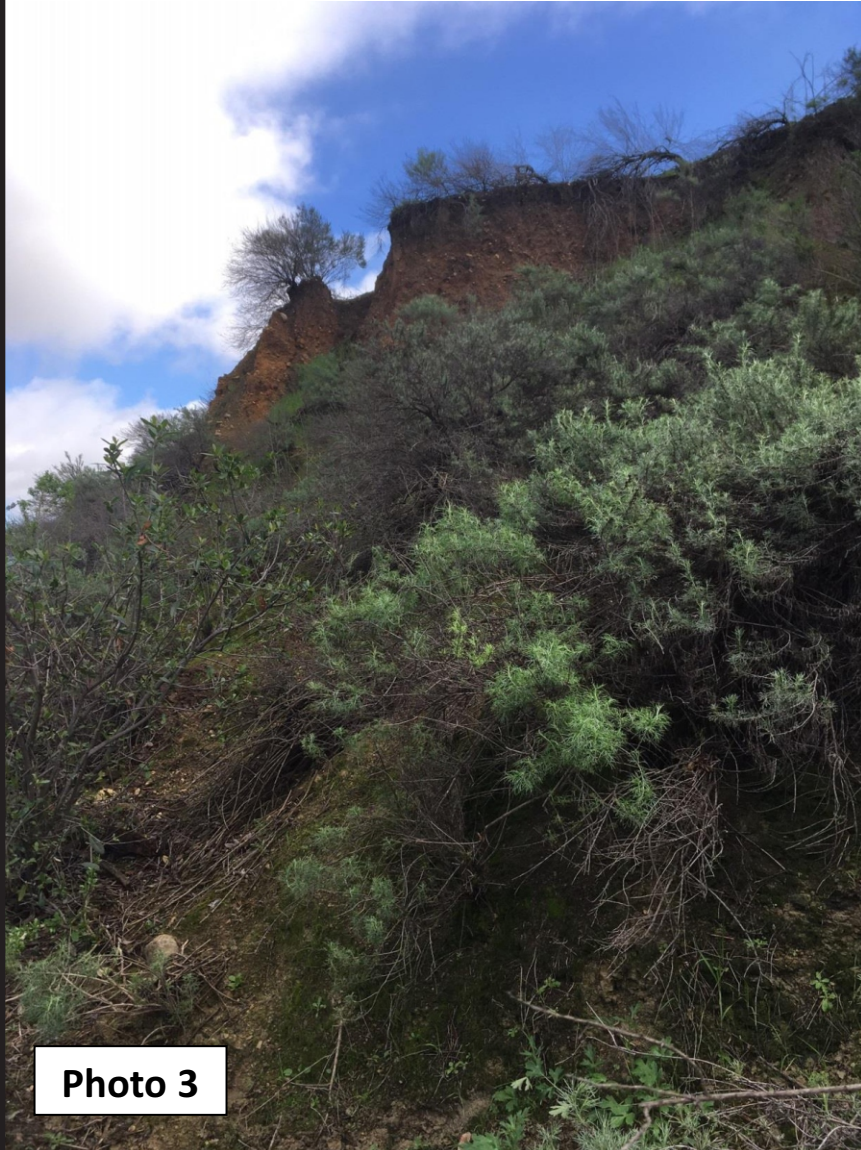
**Photo 3**

**East Side of Landslide  
Escarpment (February 11, 2017)**

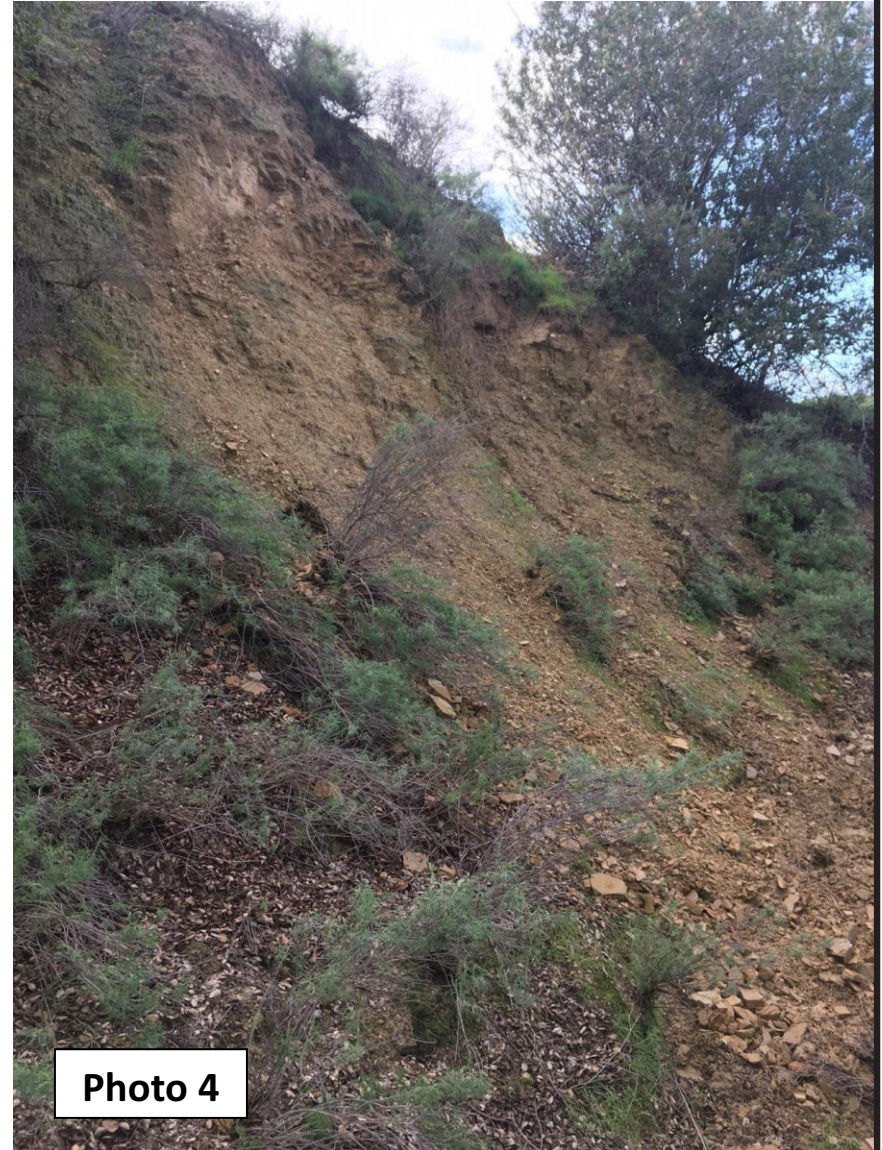
**Photo 4**

**West Side of Landslide  
Escarpment (February 11, 2017)**

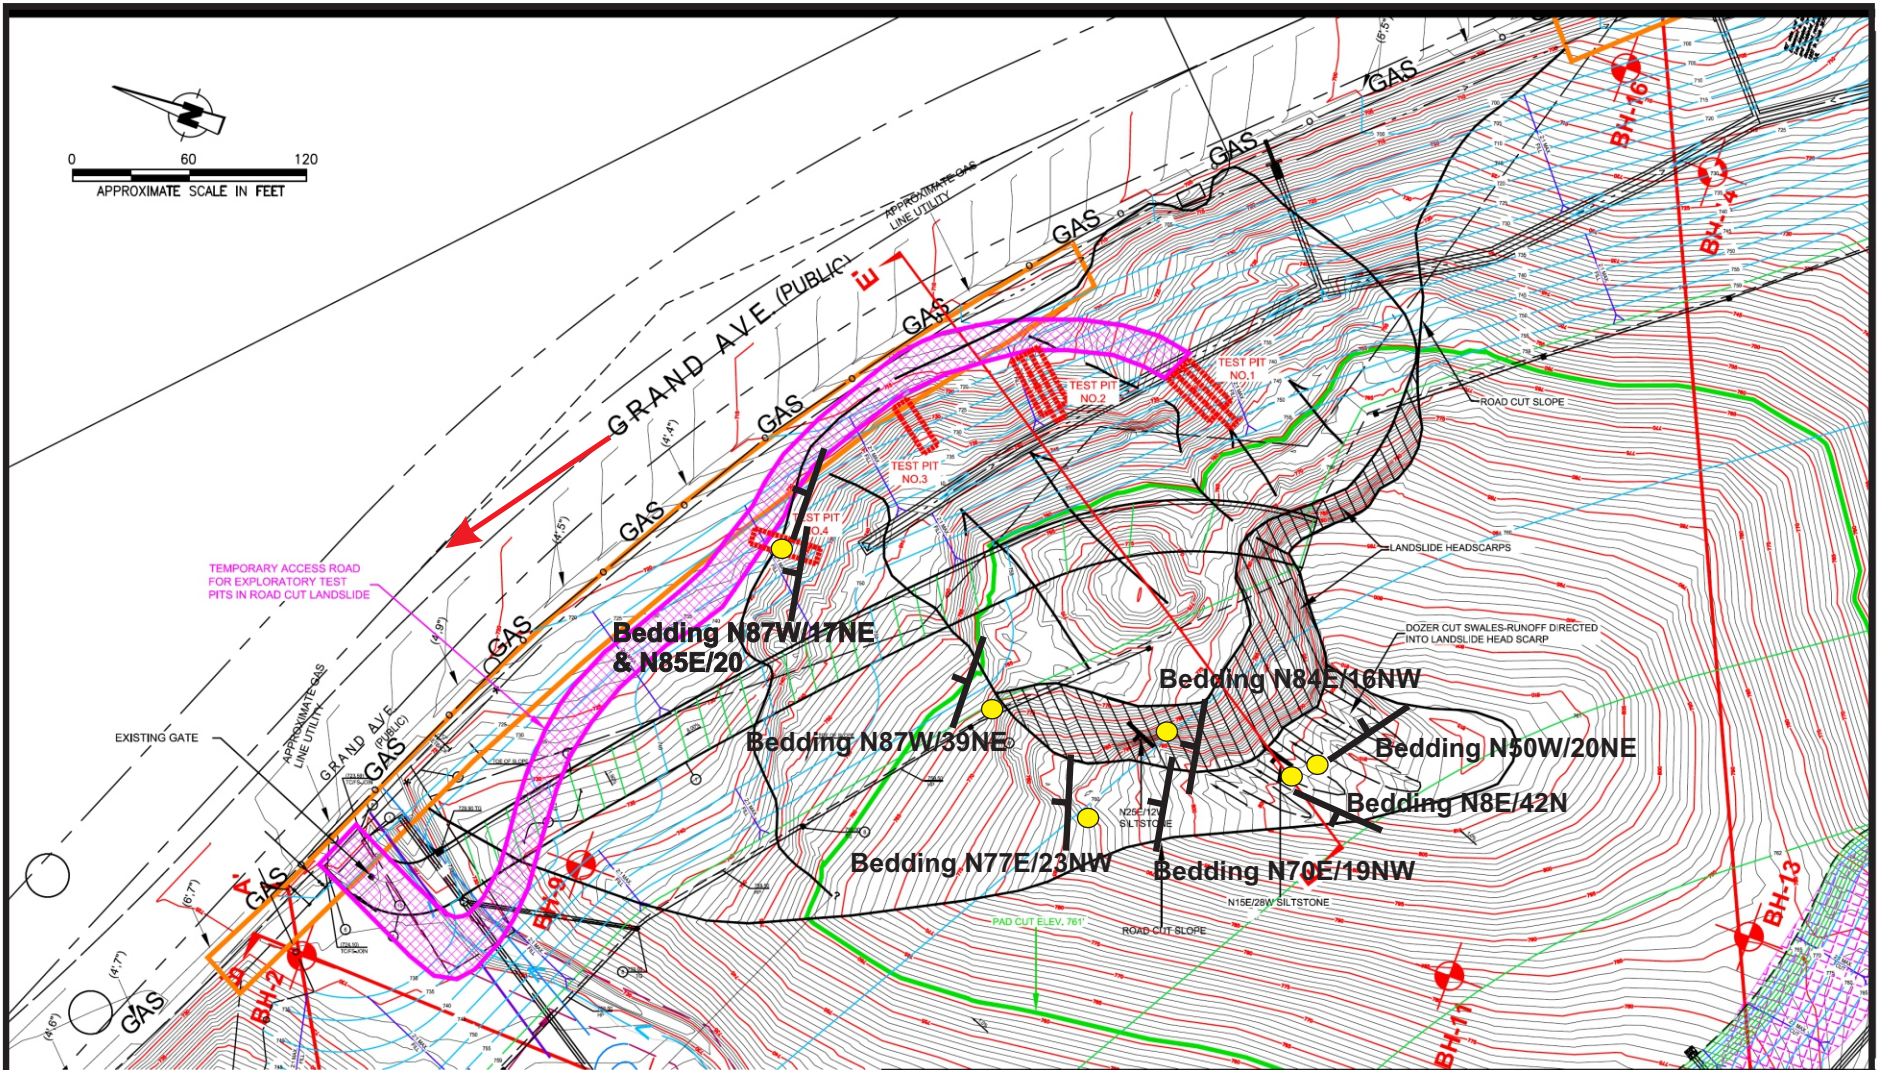
**ROAD CUT LANDSLIDE EVALUATION**

Converse excavated 4 test pits in the area immediately adjacent to Grand Avenue where TSI (2017) previously identified a landslide. Converse had not indicated this landslide in their 2014 report. The logs for these trenches are presented at the end of their report and the locations are indicated on their Drawing No. 1 (see Figure 1). They also added two bedding attitudes to Drawing No. 1 located outside the limits of the landslide. A cross-section line is shown on this drawing but the cross-section was not presented in the report. It is our understanding that Converse did not have a permit to conduct destructive field activities (excavation of test pits) and therefore, the trenching program was halted by enforcement agencies. A test pit was still open at the time when a representative visited the site. It appears that the open test pit is in the Location of Test Pit No. 4 (Converse, 2017). The reviewed report is apparently supplemental to their previous report (Converse, 2014) although they do not specifically say that it is.

All four test pits indicate that a landslide slip plane was encountered and that the bottom portion of the test pit encountered bedrock. There were no slip plane attitudes indicated in the trench logs, or descriptions of the slip plane (except possibly Test Pit #3). Bedding attitudes were noted within the bedrock in all four of the trenches. The bedding attitudes were variable within the test pits. However, within Test Pits 2 through 4 most of the bedrock bedding attitudes had nearly east-west strikes with dips ranging from 12 to 21 degrees to the north. In Test Pit No. 1 the bedding attitudes had a strike ranging from north 52 to 65 degrees east and northwesterly dips ranging from 12 to 22 degrees. The two attitudes near the headscarp had strikes that ranged from north 15 to 25 degrees east with dips of 12 and 28 degrees.

Converse provided recommendations to be implemented during rough grading of the site in relation to the landslide. Their recommendations repeated throughout the report included total removal of the landslide material and construction of a key near the toe of the slope. They indicate that the size, width and depth of the key will be increased during grading to remove the disturbed landslide deposits as necessary. They also indicate that subdrains will be installed to prevent build-up of hydrostatic pressure behind the compacted fills. There is no mention of conducting slope stability analysis or that a specific factor of safety will be achieved.

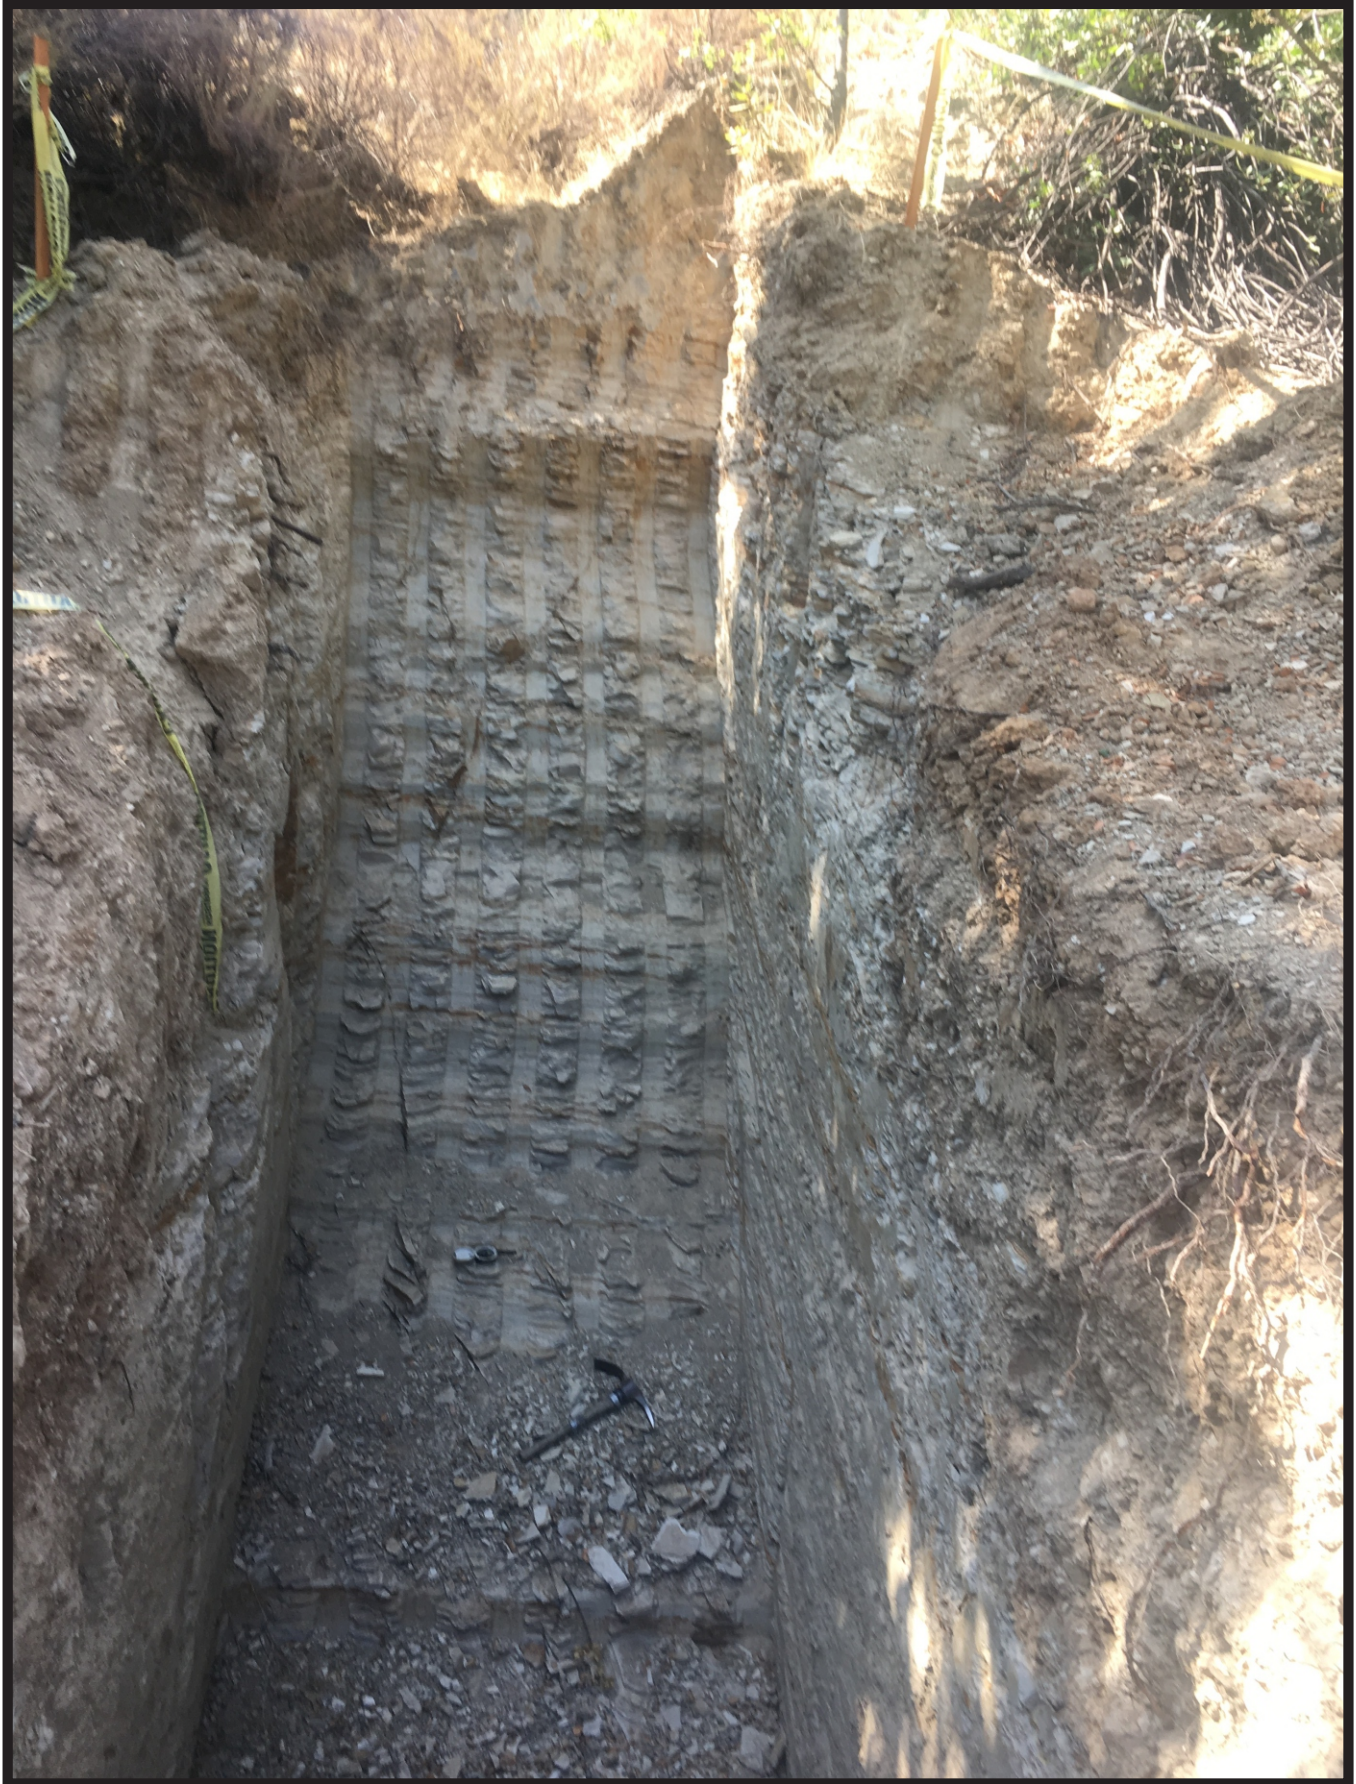
Photo 1A

Test Pit No. 4

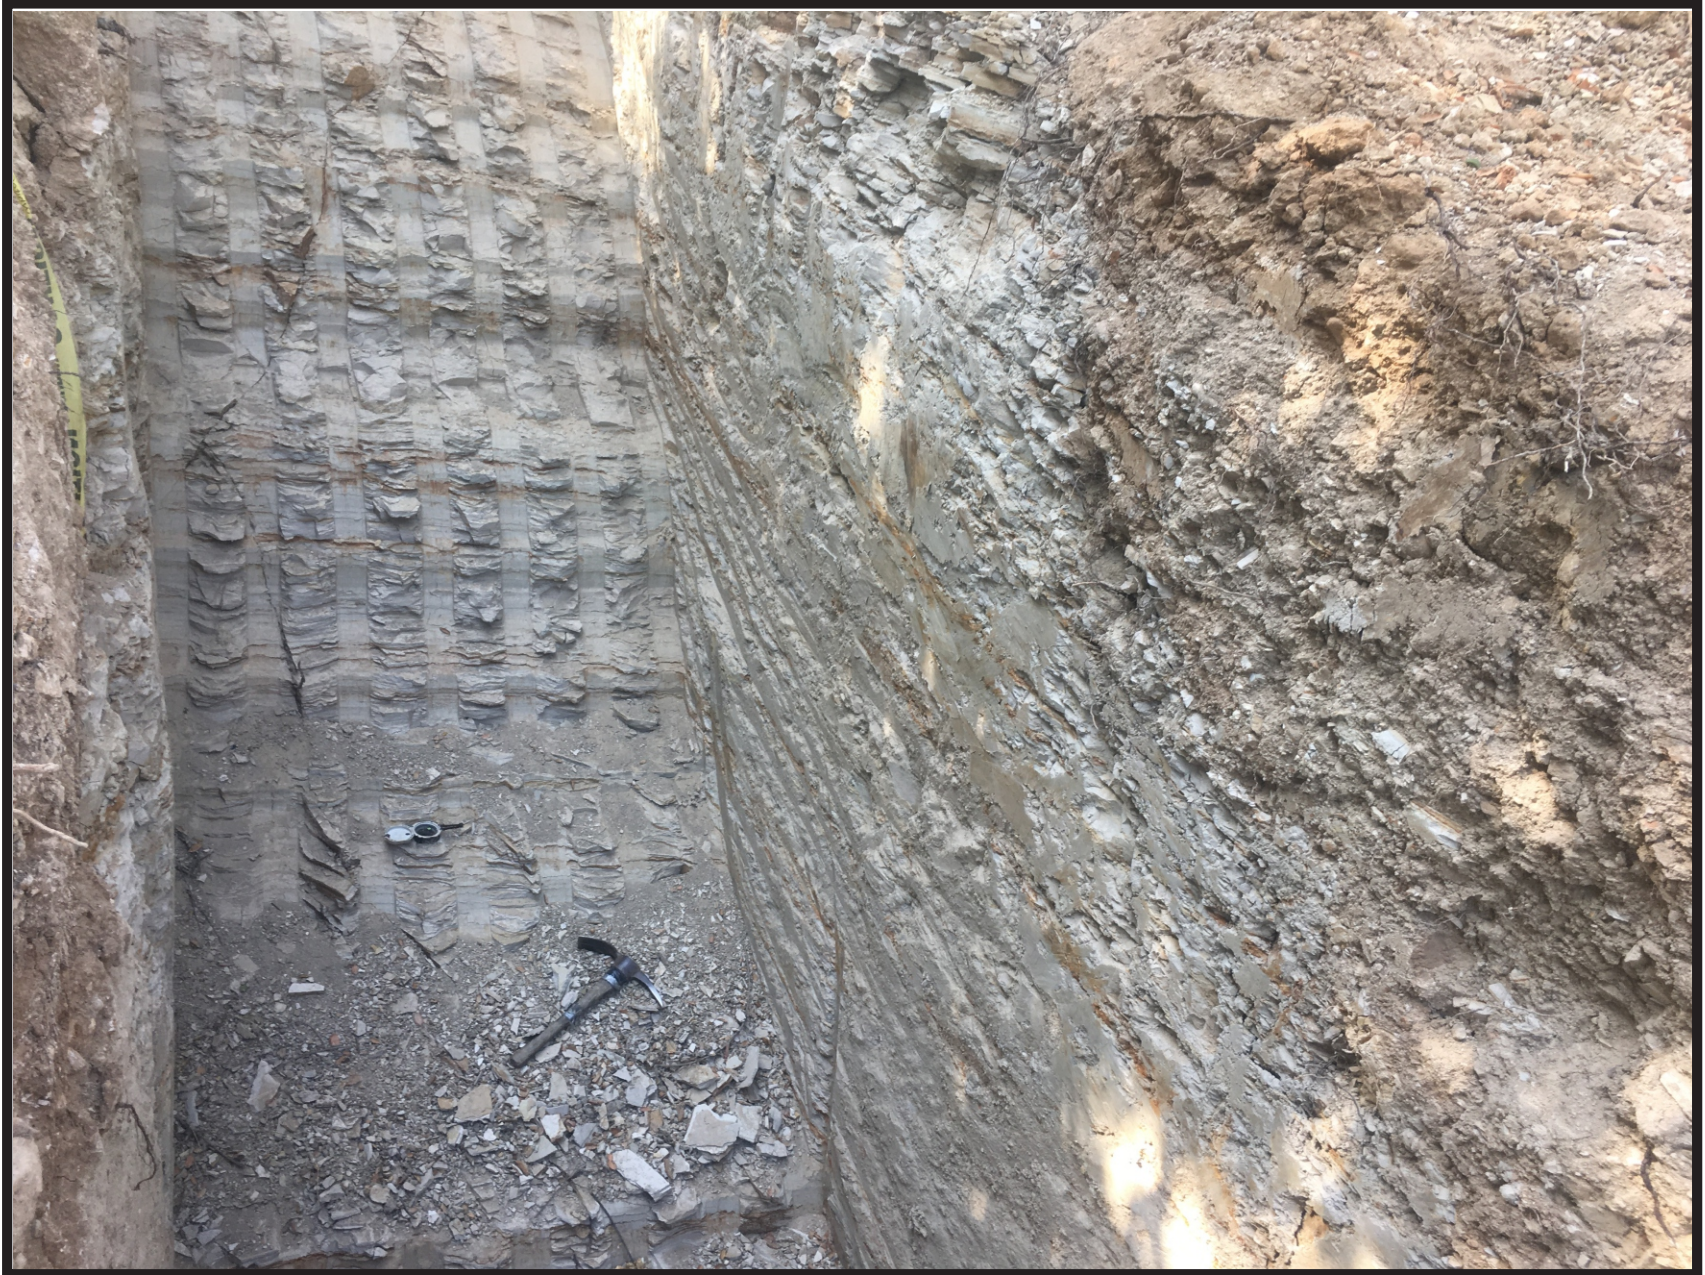
Photo 1B

Test Pit No. 4
