WRITTEN COMMENTS TO SCOPING MEETING FOR WEST PARCEL SOLAR PROJECT, JUNE 7, 2017

UNITED WALNUT TAXPAYERS PRELIMINARY REVIEW OF NEGATIVE GEOTECHNICAL AND GEOLOGICAL ASPECTS OF CONSTRUCTING EARTHFILL PAD FOR A SOLAR FARM ON THE WEST PARCEL - DRAFT

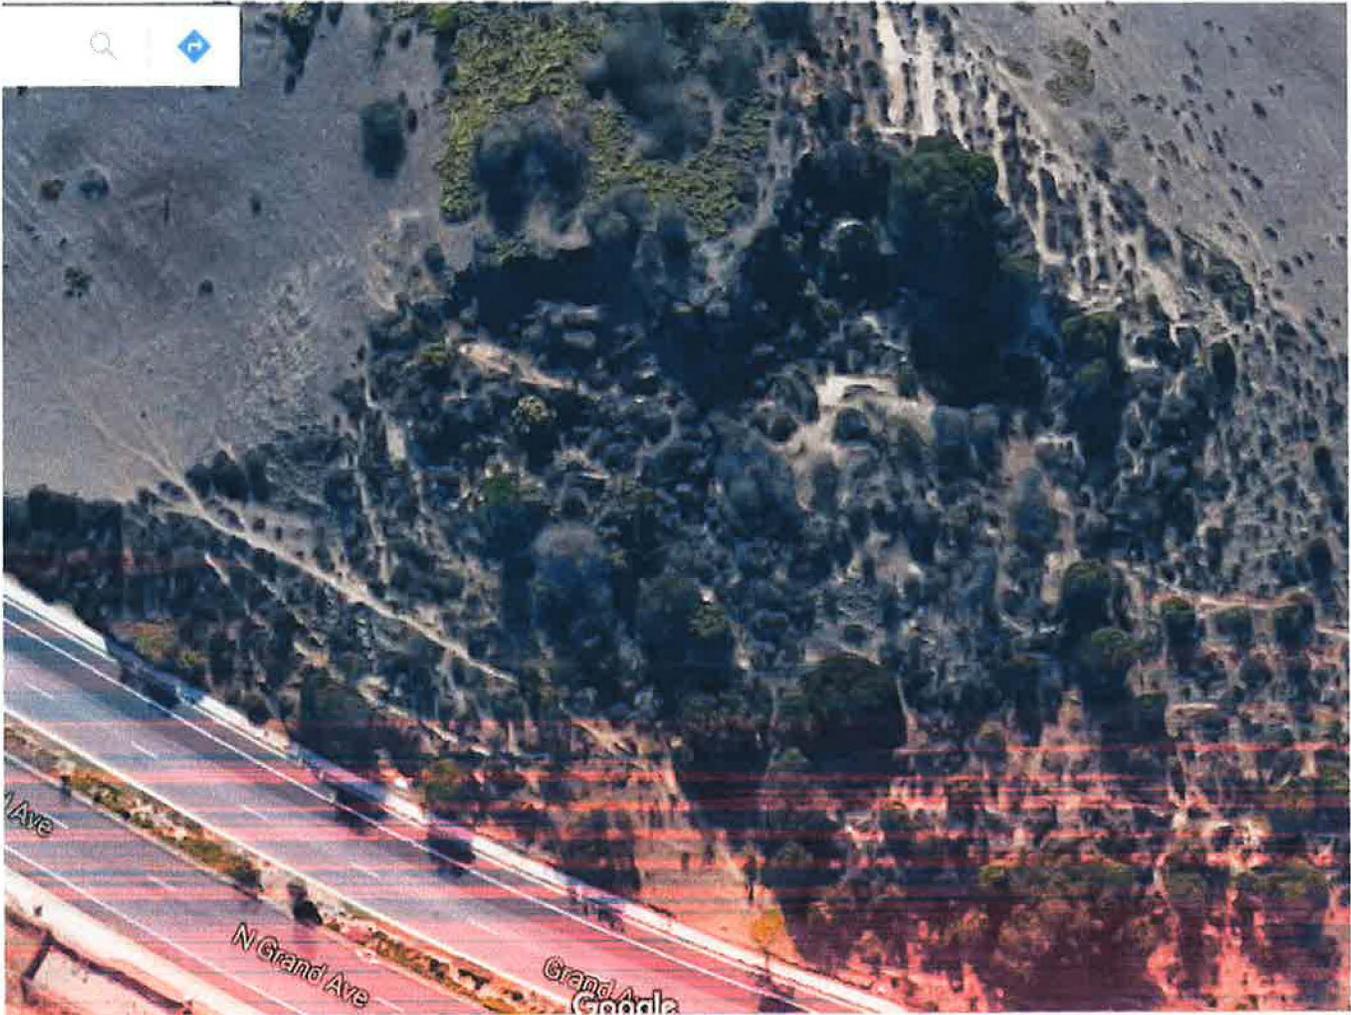
Attachment
Google Earth Image of Existing Landslide at West Parcel Site

- vii. The Converse report did not recognize a significant landslide in the central hill of the project site present for more than thirty years (see Google Earth attachment), which is vulnerable to further sliding.

iv. Aerial imagery from Google Earth clearly indicates landslide(s) exists on the eastern side of the central knob descending down to Grand Avenue (see attachment). The landslide area on the central hill is present in aerial imagery dating from after 1980 until the present.

v. The above referenced landslide is further validated through field visits to the site by our Engineering Geologist and former City officials with first-hand knowledge of at least two landslides that occurred at the subject site after Grand Avenue was expanded to four lanes.

vi. At least one of the above landslides at the central hill of the site closed the road (Grand Ave.) and covered all the lanes. In addition, siltstone and shale bedrock with eastward dipping bedding subject to landsliding was observed in this area.

i. The landslide at Grand Avenue occurred about 1980 shortly after Grand Avenue was widened to four lanes in the late 1970's, likely from the undercutting of the central hill near the roadway.
