**UWT Response to the July 2017 NOC of Tiered Draft EIR for the Mt. SAC West Parcel Solar Project**

**Geotechnical Review of Proposed Grading of the West Parcel Site for  
Mt. San Antonio College, June 2017** PDF Page 19

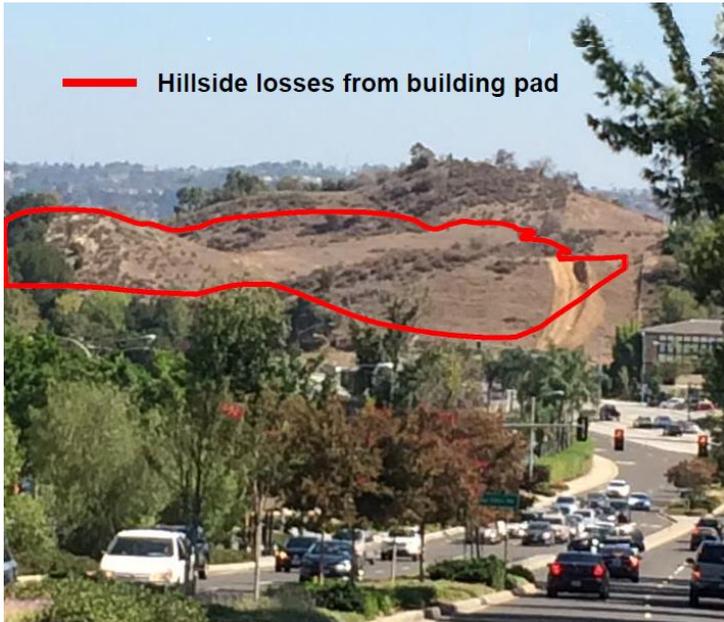
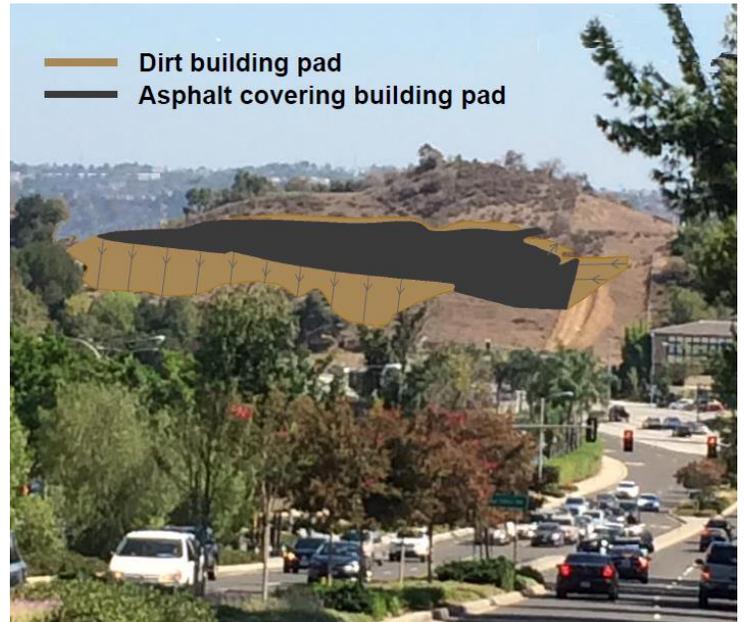
3. Viewsheds along Grand Avenue are Significantly Changed. Massive alterations to the natural viewshed of motorists on Grand Avenue entering from the north are shown below. Viewsheds show significant losses of natural hillsides some 70 feet above Grand Avenue and land areas that will be destroyed and replaced with a sterile building pad with long linear earthfill side slopes, asphalt cover and solar installations. The Grand Avenue viewshed is experienced by 1000's of motorists a day. Similar views are seen from Mountaineer Road.

### Hillside Losses from Dirt Building Pad with Asphalt Cover Visible for Grand Avenue Entering

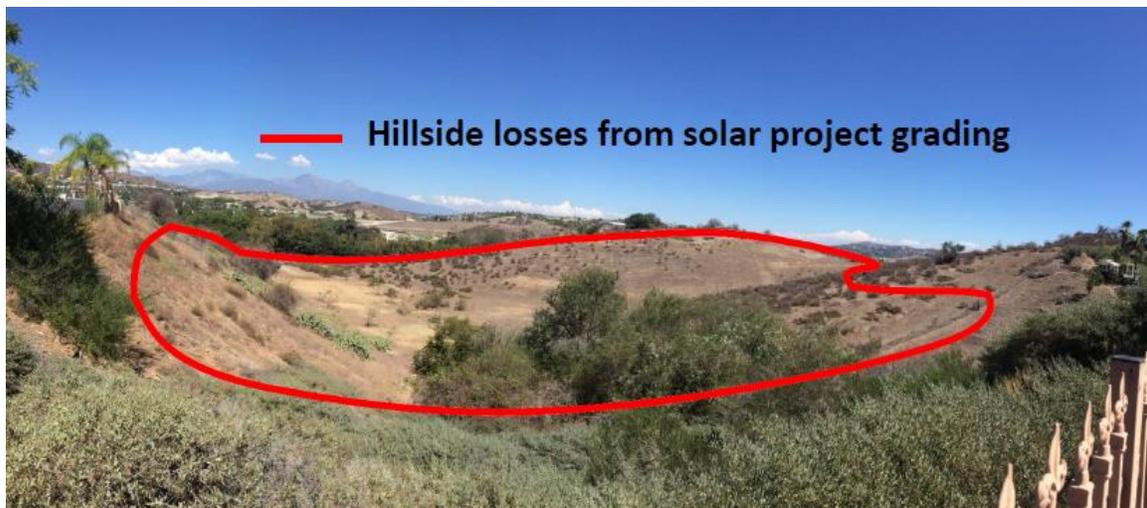
4. Regal Canyon Drive in the Willows Community. Residents traveling up Regal Canyon Drive will see the industrial looking solar facility immediately next to the roadway blocking views of the natural canyons that once existed. Hundreds of cars a day travel this route, which will change the character of the passive community into a rigid landscape at its entrance.

### Hillside Losses from Solar Project Building Pad at Regal Canyon Drive

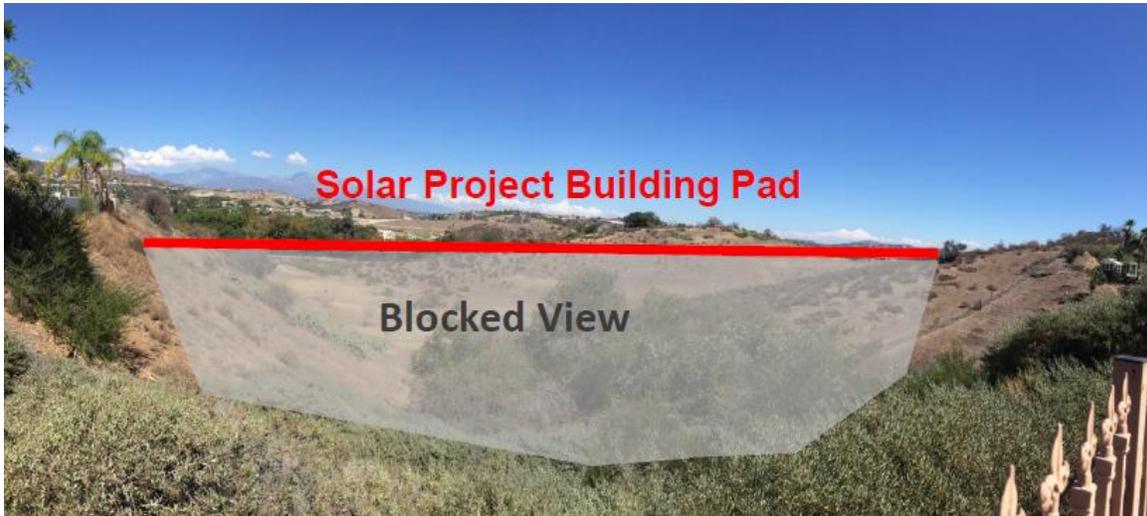
- c. Blocked View from Motorists at Street Level. Motorists accustomed to seeing unobstructed views from Regal Canyon Drive will be blocked from views of the natural hillsides and the scenic wildlife reserve. Views would be almost completely obstructed by the building pad of the solar project.

## Motorists Blocked View from Solar Project at Regal Canyon Drive

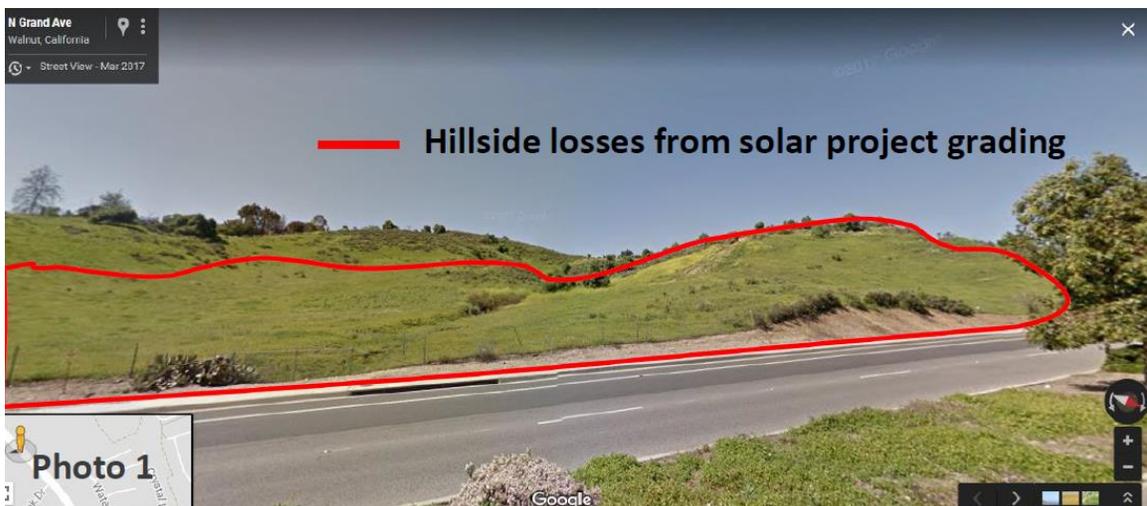
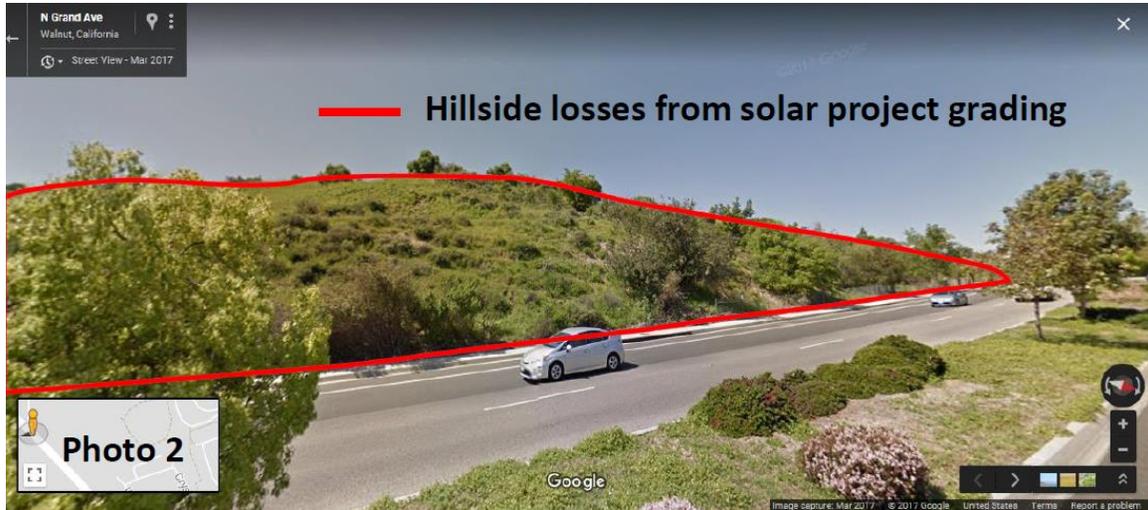
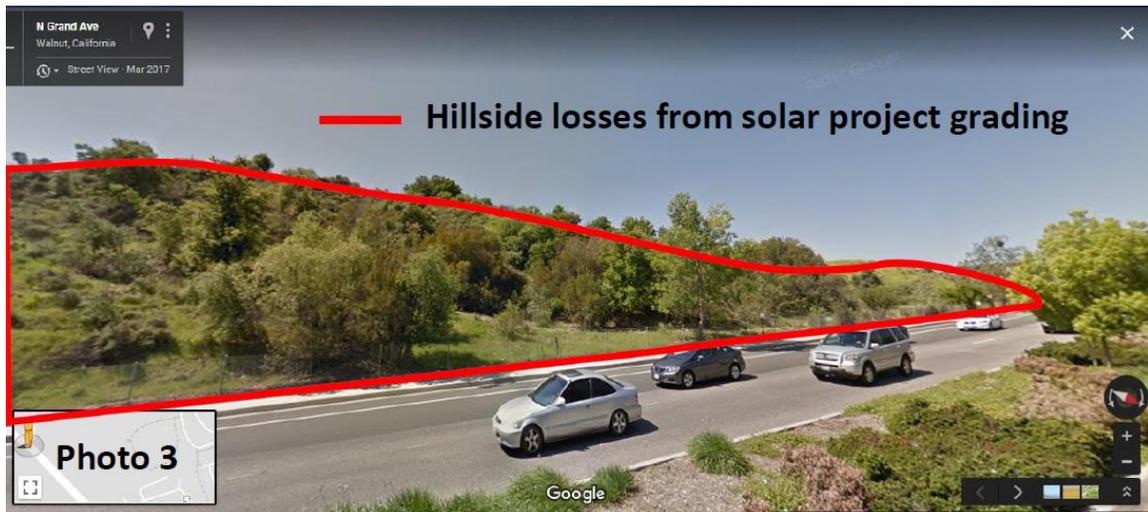
5. Motorists traveling Grand Avenue would observe loss of hillsides, which is inconsistent with the General Plan Scenic Corridor designation of the roadway. The following views of Grand Avenue (photos 1 through 3, below) traveling from south to north from Snow Creek Drive to Amar Road displays the scenic values of Grand Avenue at street level and the significant destruction of native hillsides and vegetation caused by the west parcel project.

## Hillside Losses from Solar Project Traveling form Snow Creek Drive to Amar Road

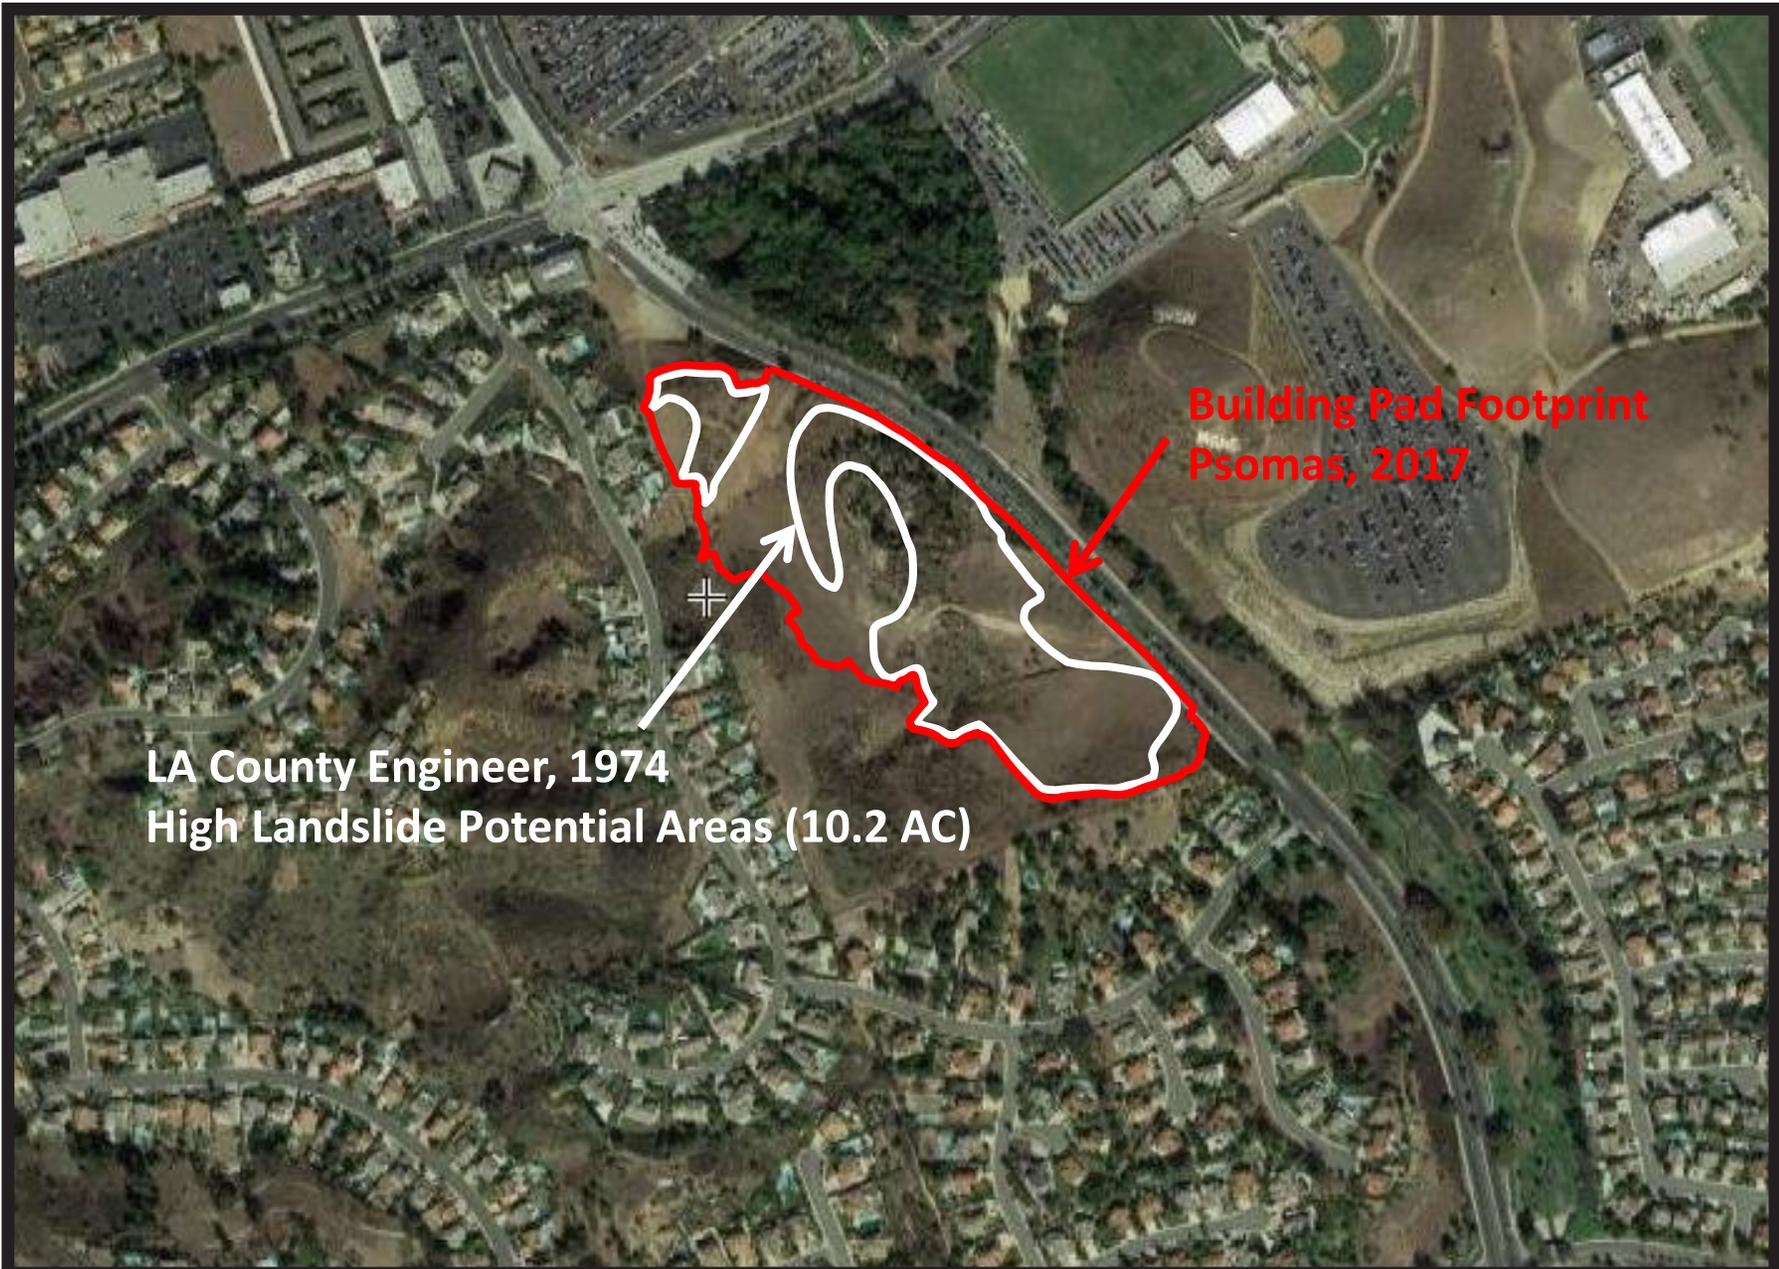
**Figure 2a**  
*Terrestrial Solutions Inc.*

LA County Engineer, 1974  
High Landslide Potential Areas (10.2 AC)

*"Relative Landslide Susceptibility Areas; Area 3 - Generally Susceptible Area. Slopes within this area are at or near the stability limits due to a combination of weaker materials and steeper slopes. Although most of the slopes within Area 3 do not currently contain landslide deposits, the materials*

*that underlie them can be expected to fail, locally when modified by natural processes or the activities by man because they are close to their stability limits.”*

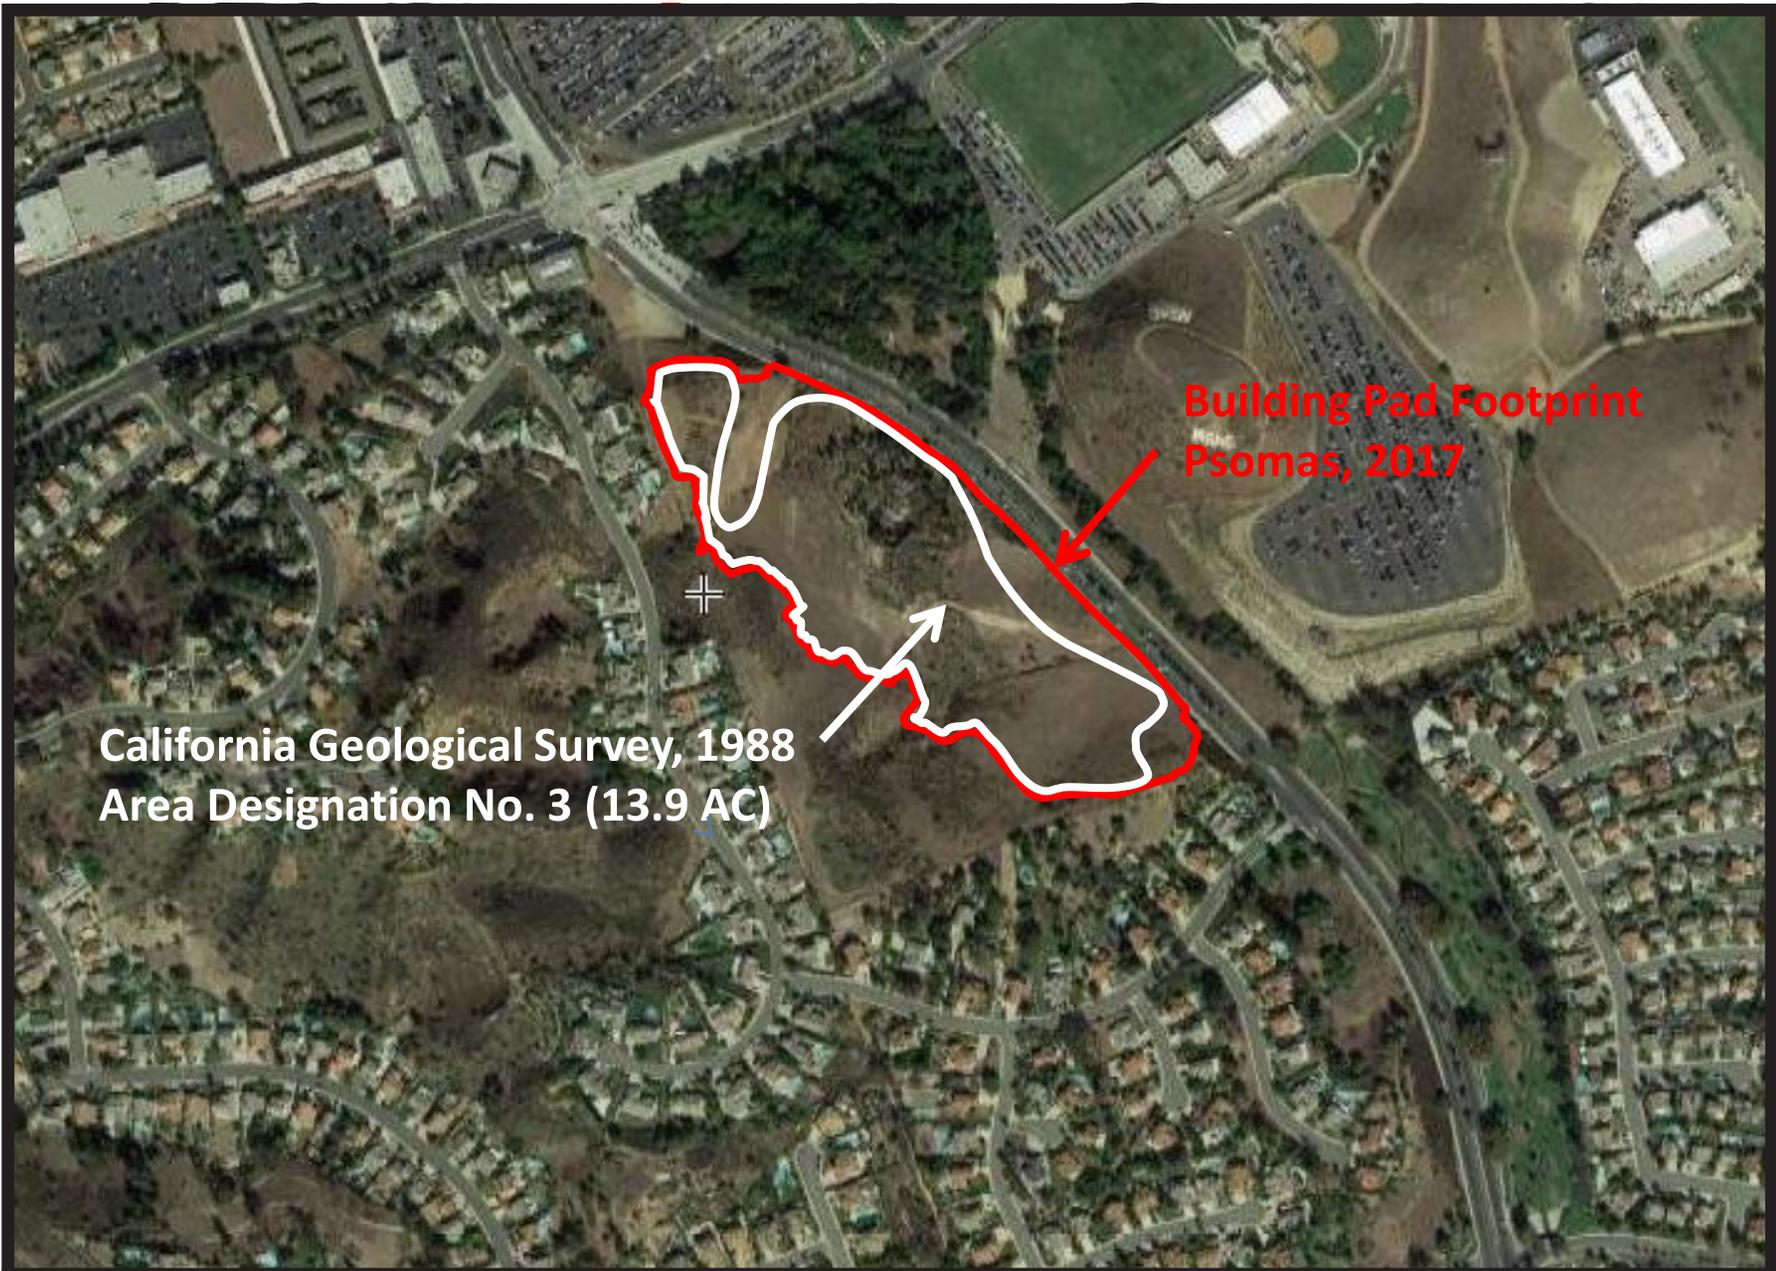
**Modified from CGS 88-21 Map No. 12.  
Landslide Hazards in the Puente and San Jose Hills  
1988**

California Geological Survey, 1988  
Area Designation No. 3 (13.9 AC)

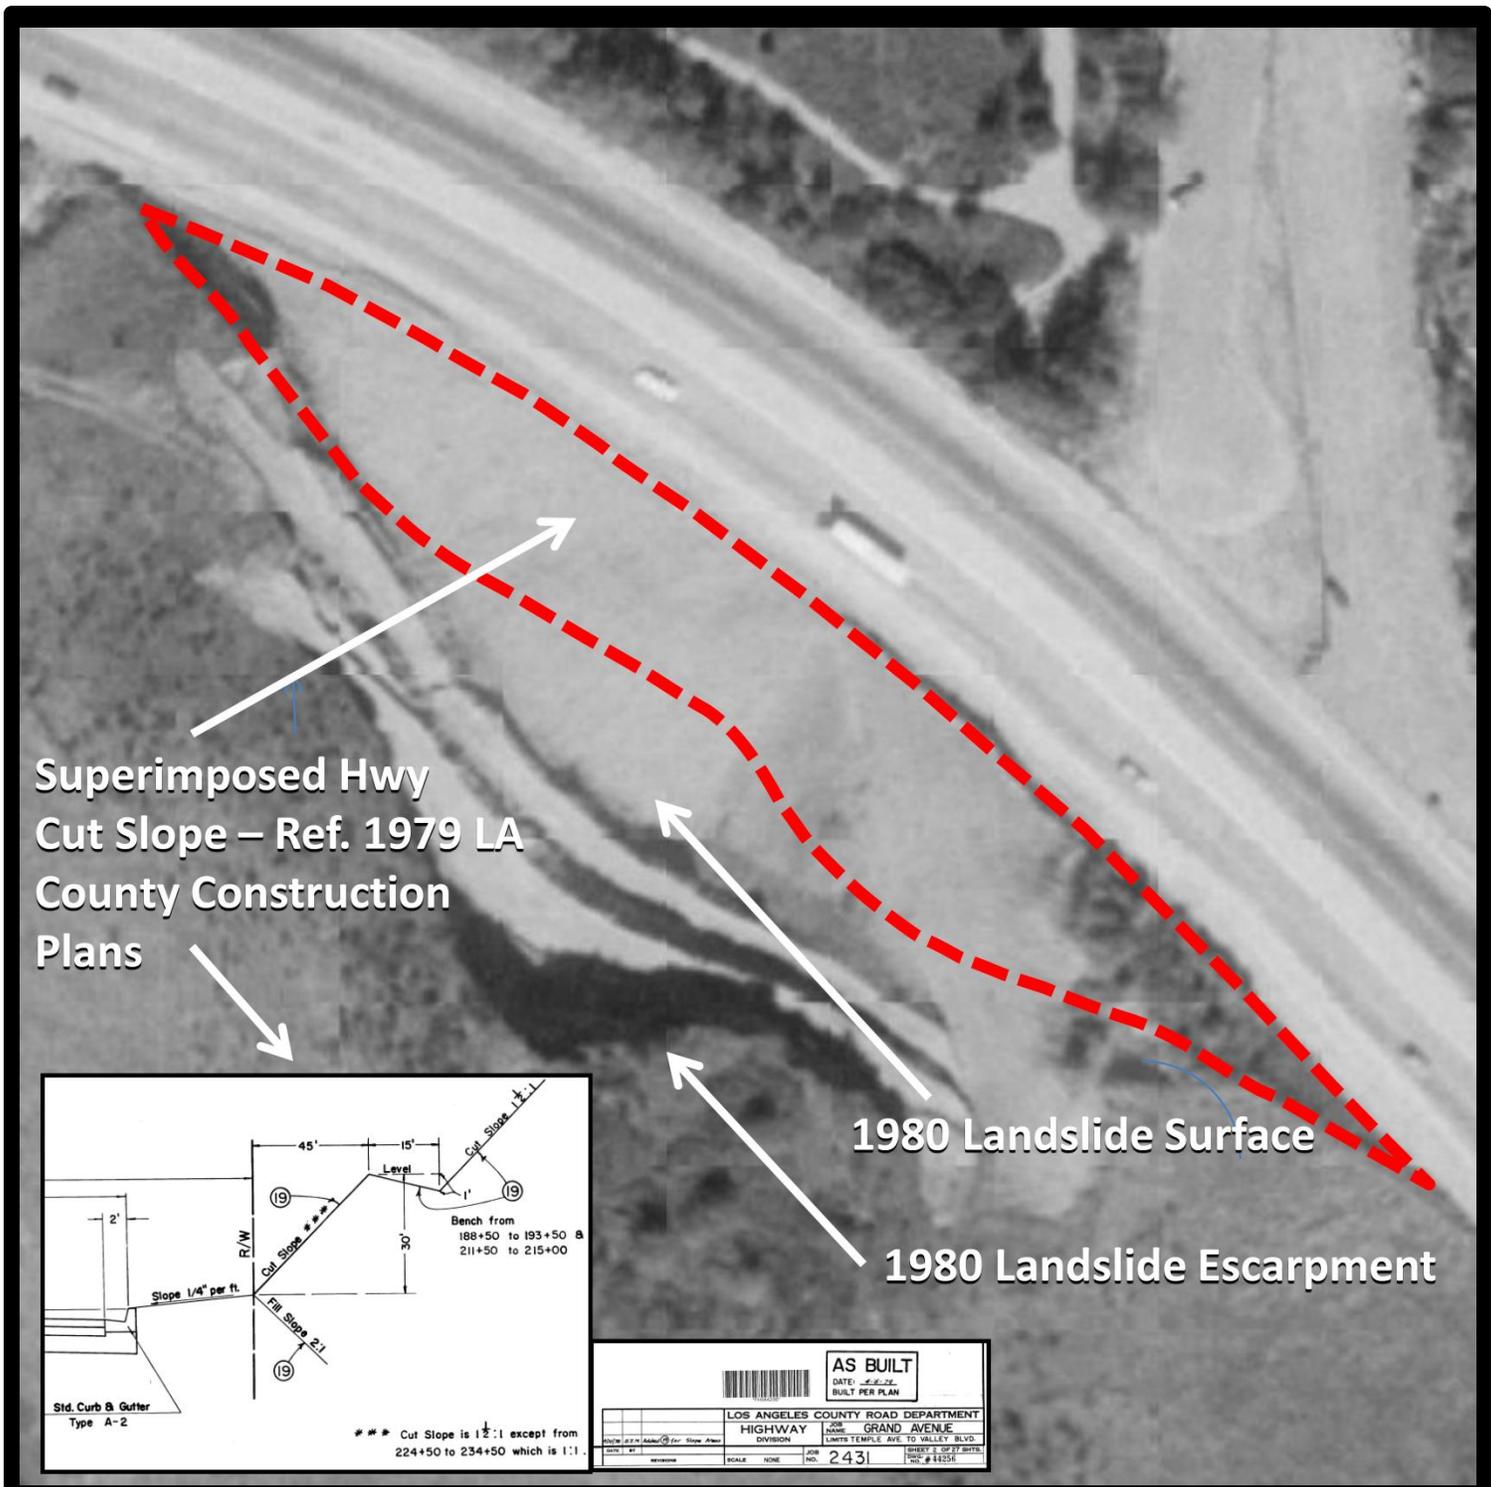
**Figure 5**

**Aerial Showing Location of Landslide on Grand Ave. and Footprint of Original Cut Slope**

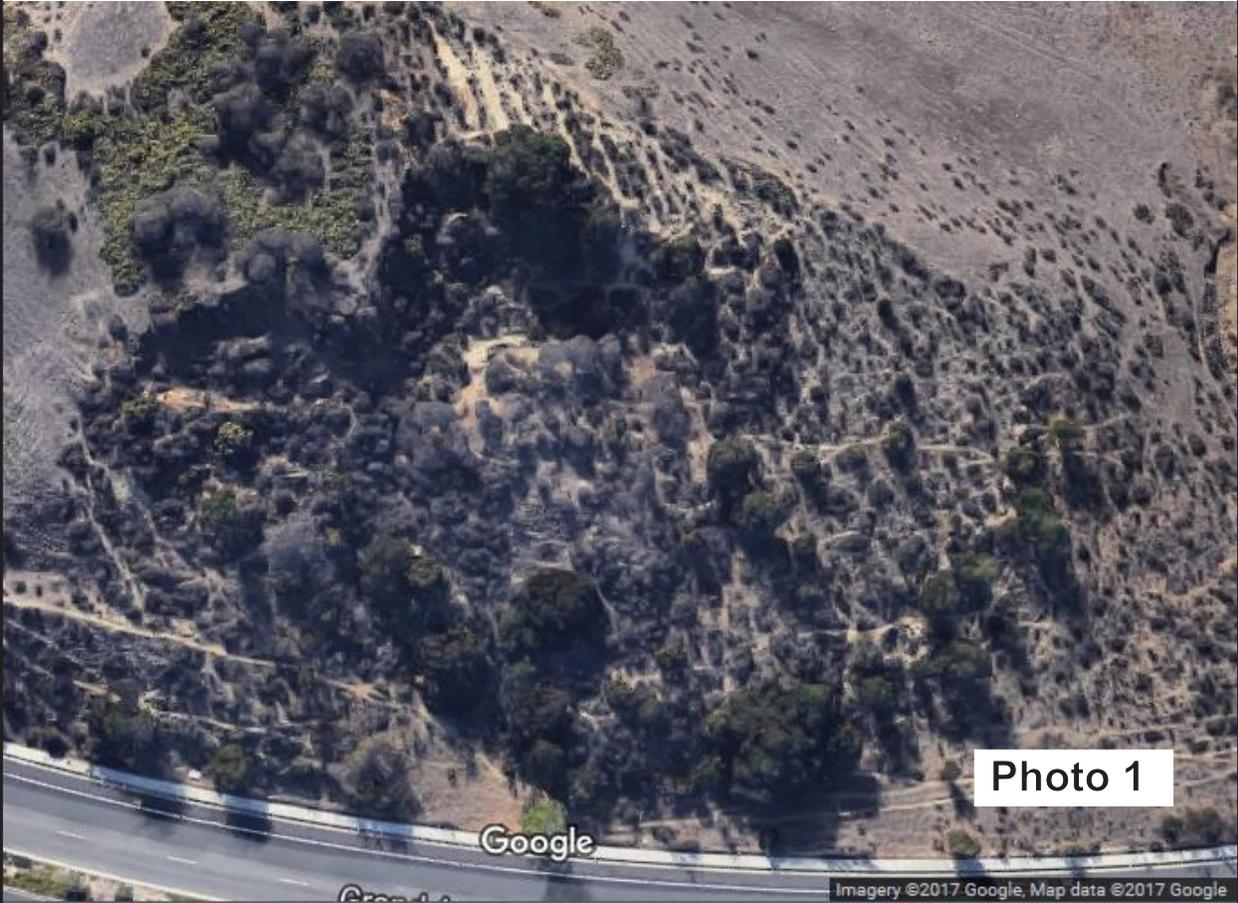
**Photo 1**

TSI conducted a brief review of the potential for landsliding at the site. A review of aerial imagery from Google Earth clearly indicates a landslide(s) exists on the eastern side of the central hillside area descending to Grand Avenue (Photo's 1 and 2). This landslide area is present in aerial imagery dating from after 1980 until the present. The presence of this landslide complex was further confirmed based on the brief field reconnaissance on March 30, 2017. In addition, siltstone and shale bedrock with eastward dipping (toward Grand Avenue) bedding was also observed in this area.

**Central Hill Landslide Area (close up and broader view)**

Remediation of the landslide materials that exist within the central hillside area, and other areas of the site, will consist of total removal of the landslide debris to competent bedrock. In addition to normal remedial removals a thorough evaluation, including subsurface investigations, of the underlying weak bedrock conditions must be conducted to determine the width and depth of a shear key that will likely be necessary to stabilize the proposed development. The Converse report indicated that a “Fill Slope Stabilization Keyway” was necessary for portions of the site (Drawing No. 2). However, their key was not based on specific slope stability analysis and was not recommended for cut slopes and/or areas of landsliding or potential slope stability issues.

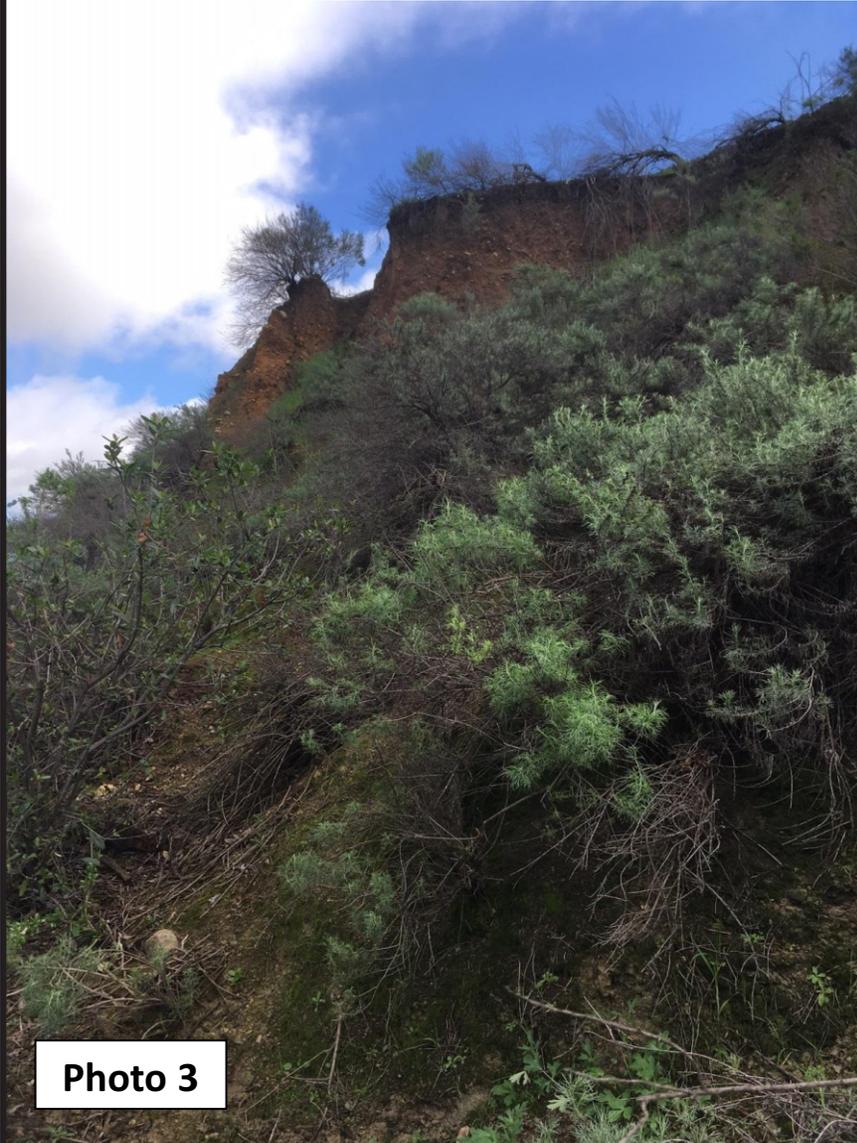
**Photo 3**

**East Side of Landslide  
Escarpment (February 11, 2017)**

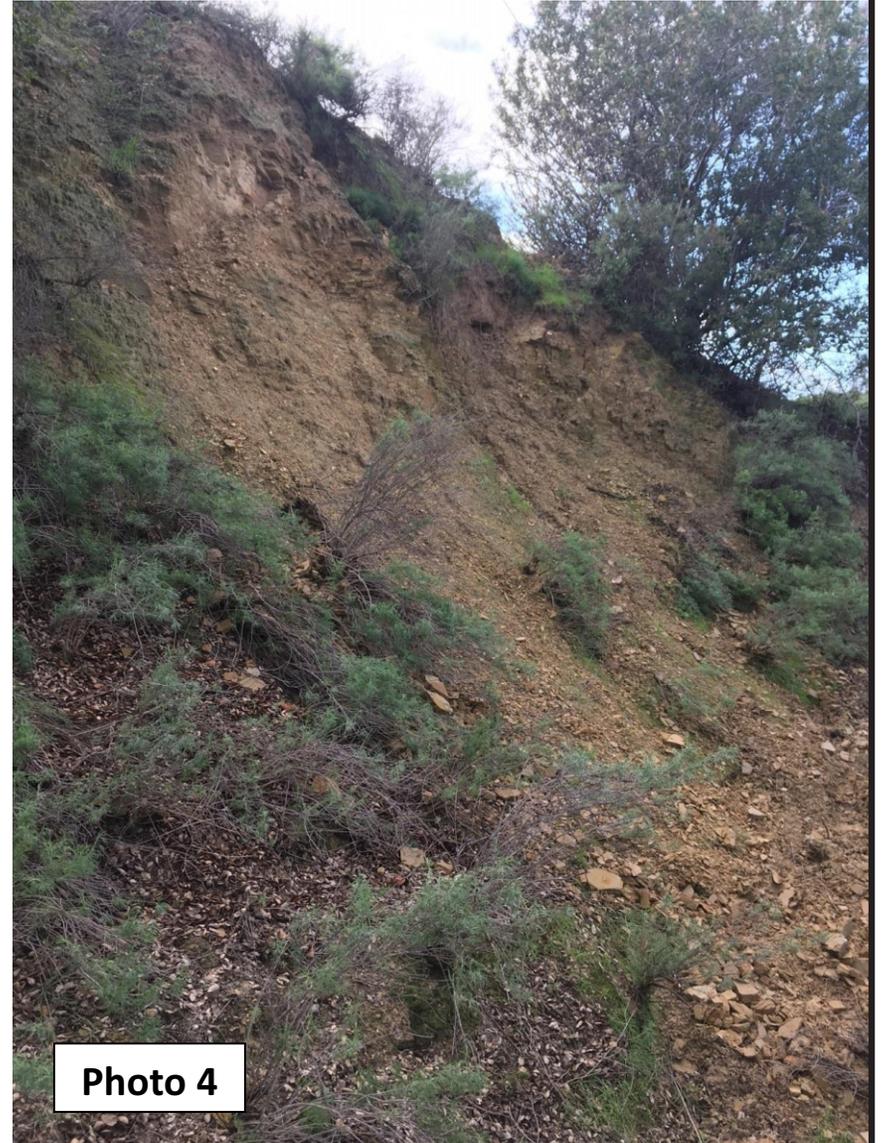
**Photo 4**

**West Side of Landslide  
Escarpment (February 11, 2017)**

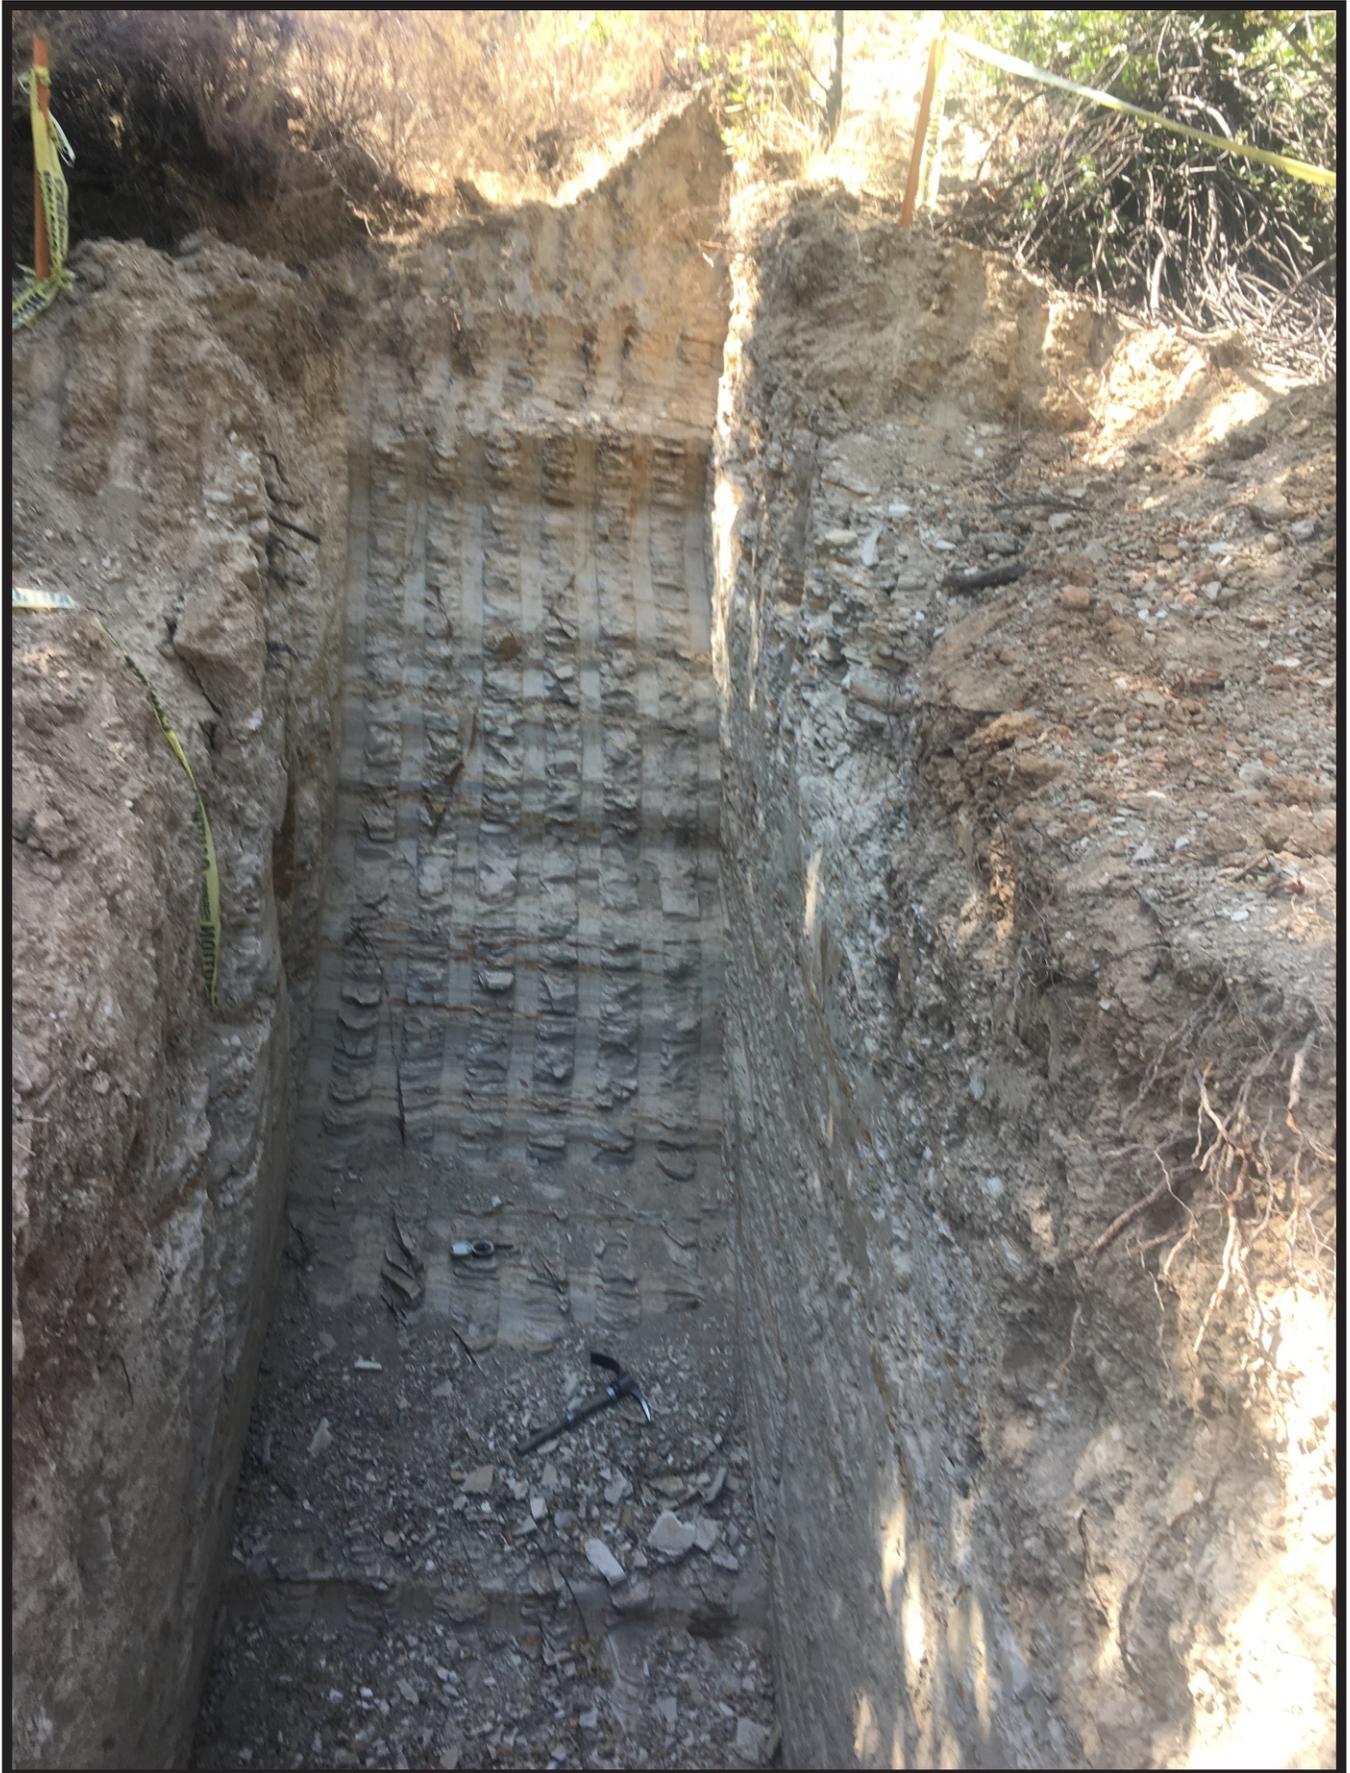
Photo 1A

All four test pits indicate that a landslide slip plane was encountered and that the bottom portion of the test pit encountered bedrock. There were no slip plane attitudes indicated in the trench logs, or descriptions of the slip plane (except possibly Test Pit #3). Bedding attitudes were noted within the bedrock in all four of the trenches. The bedding attitudes were variable within the test pits. However, within Test Pits 2 through 4 most of the bedrock bedding attitudes had nearly east-west strikes with dips ranging from 12 to 21 degrees to the north. In Test Pit No. 1 the bedding attitudes had a strike ranging from north 52 to 65 degrees east and northwesterly dips ranging from 12 to 22 degrees. The two attitudes near the headscarp had strikes that ranged from north 15 to 25 degrees east with dips of 12 and 28 degrees.

Test Pit No. 4

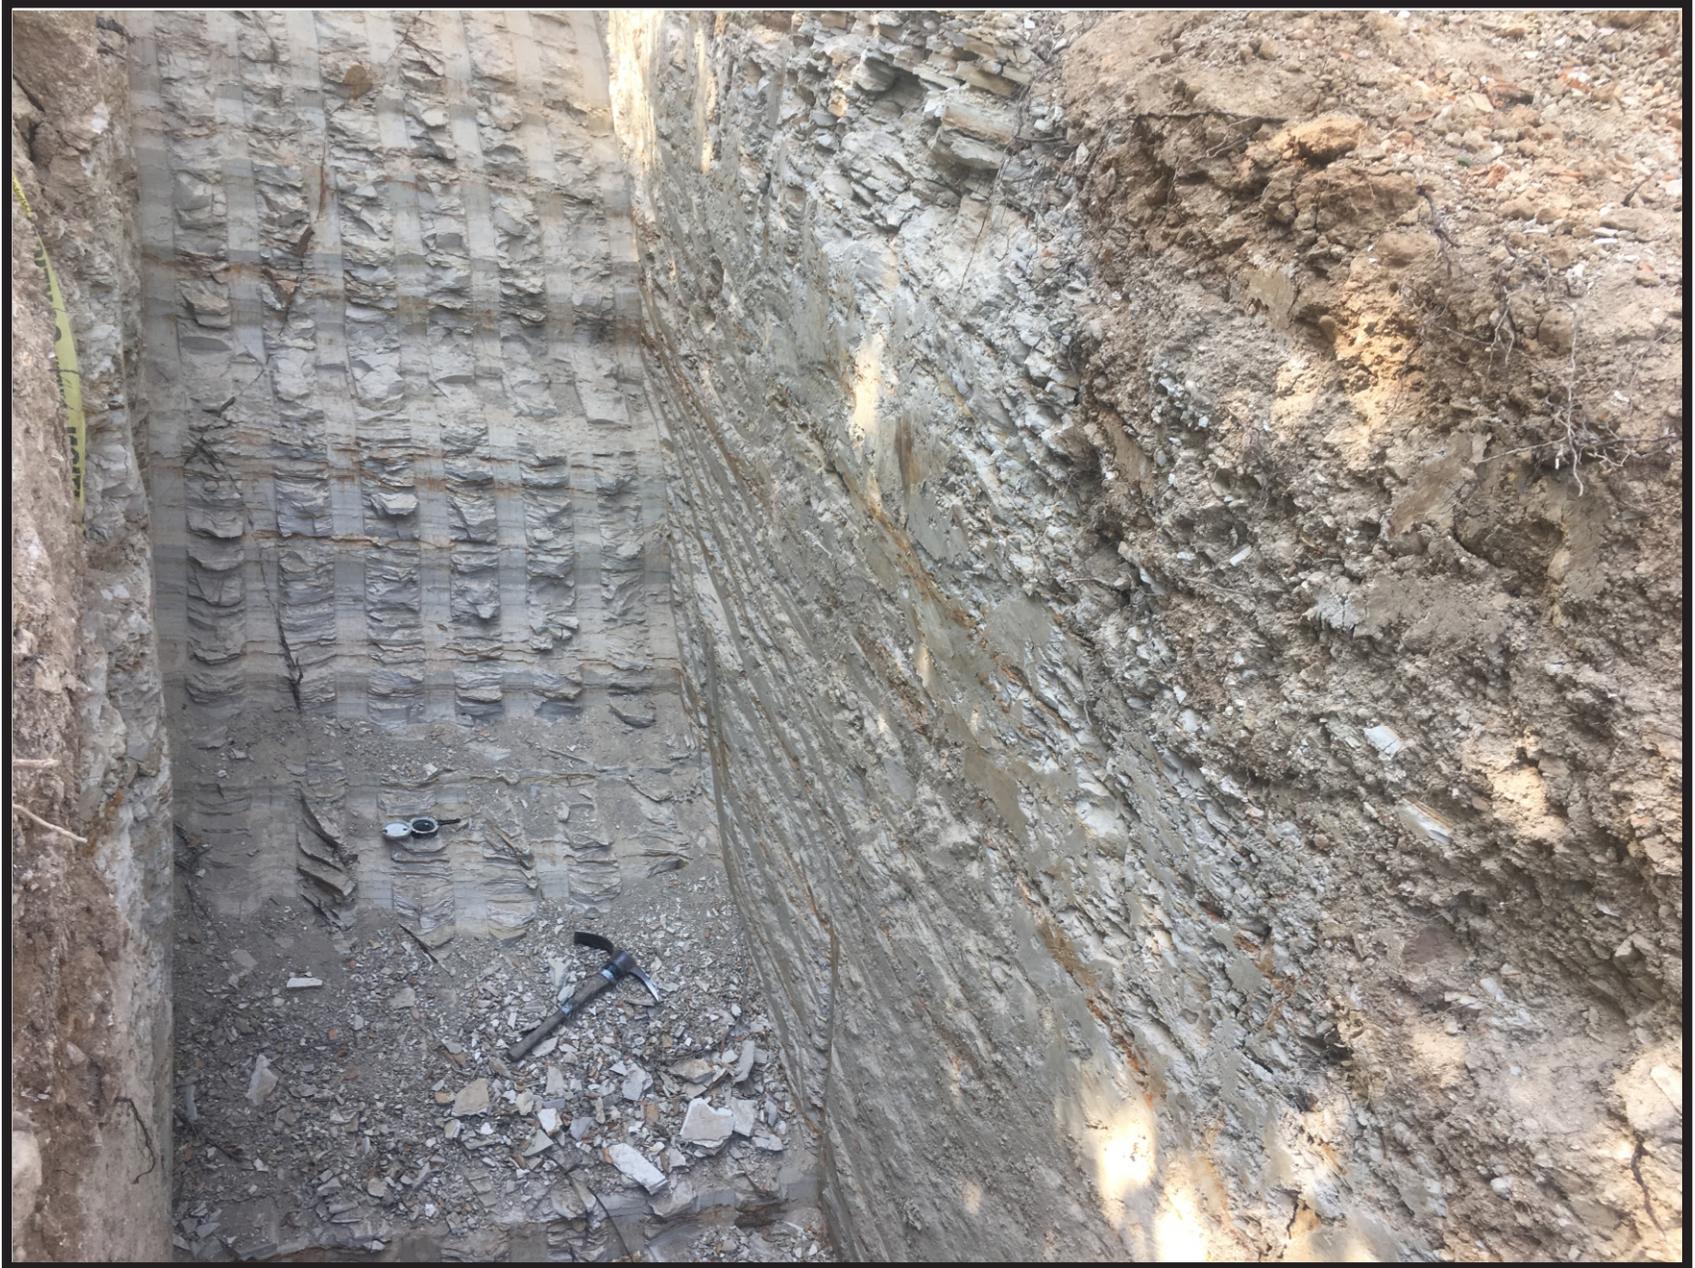
Photo 1B

Test Pit No. 4
