Leighton Consulting, Inc.
A LEIGHTON GROUP COMPANY

Project No. 11672.001

**Subject: Geotechnical Review
Mount San Antonio College South Campus-West Parcel
West of Grand Avenue and Approximately 500 Feet Southeast of
Temple Avenue/Amar Road
City of Walnut, California**

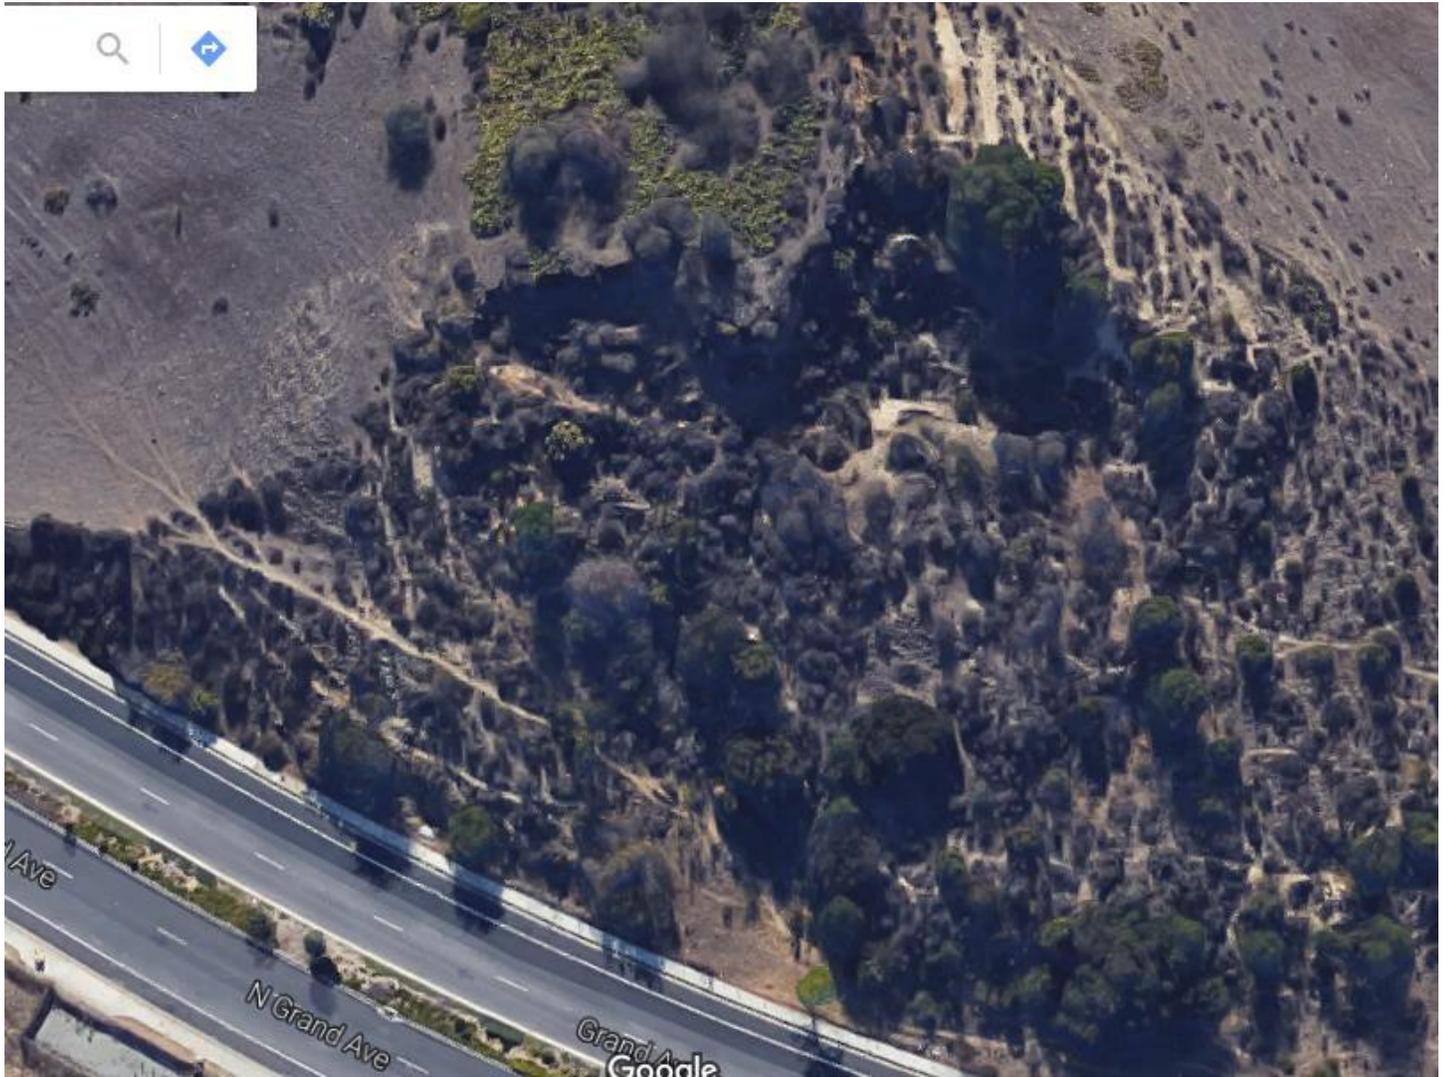
Attachment
Google Earth Image of Existing Landslide at West Parcel Site

vi. At least one of the above landslides at the central hill of the site closed the road (Grand Ave.) and covered all the lanes. In addition, siltstone and shale bedrock with eastward dipping bedding subject to landsliding was observed in this area.

The consequence of not identifying the landslide was that significant earthfill would have been placed over landslide rupture surfaces without any remedial measures, making it subject to future landsliding. The public safety consequences of a potential landslide on the highly traveled Grand Avenue are apparent.
