Cultural Resource Evaluation Report for Mt. SAC SEIR for 2015 Facilities Master Plan Update and Physical Education Projects, Walnut, Los Angeles County, California

1. Introduction

4. Identification of Historic Resources

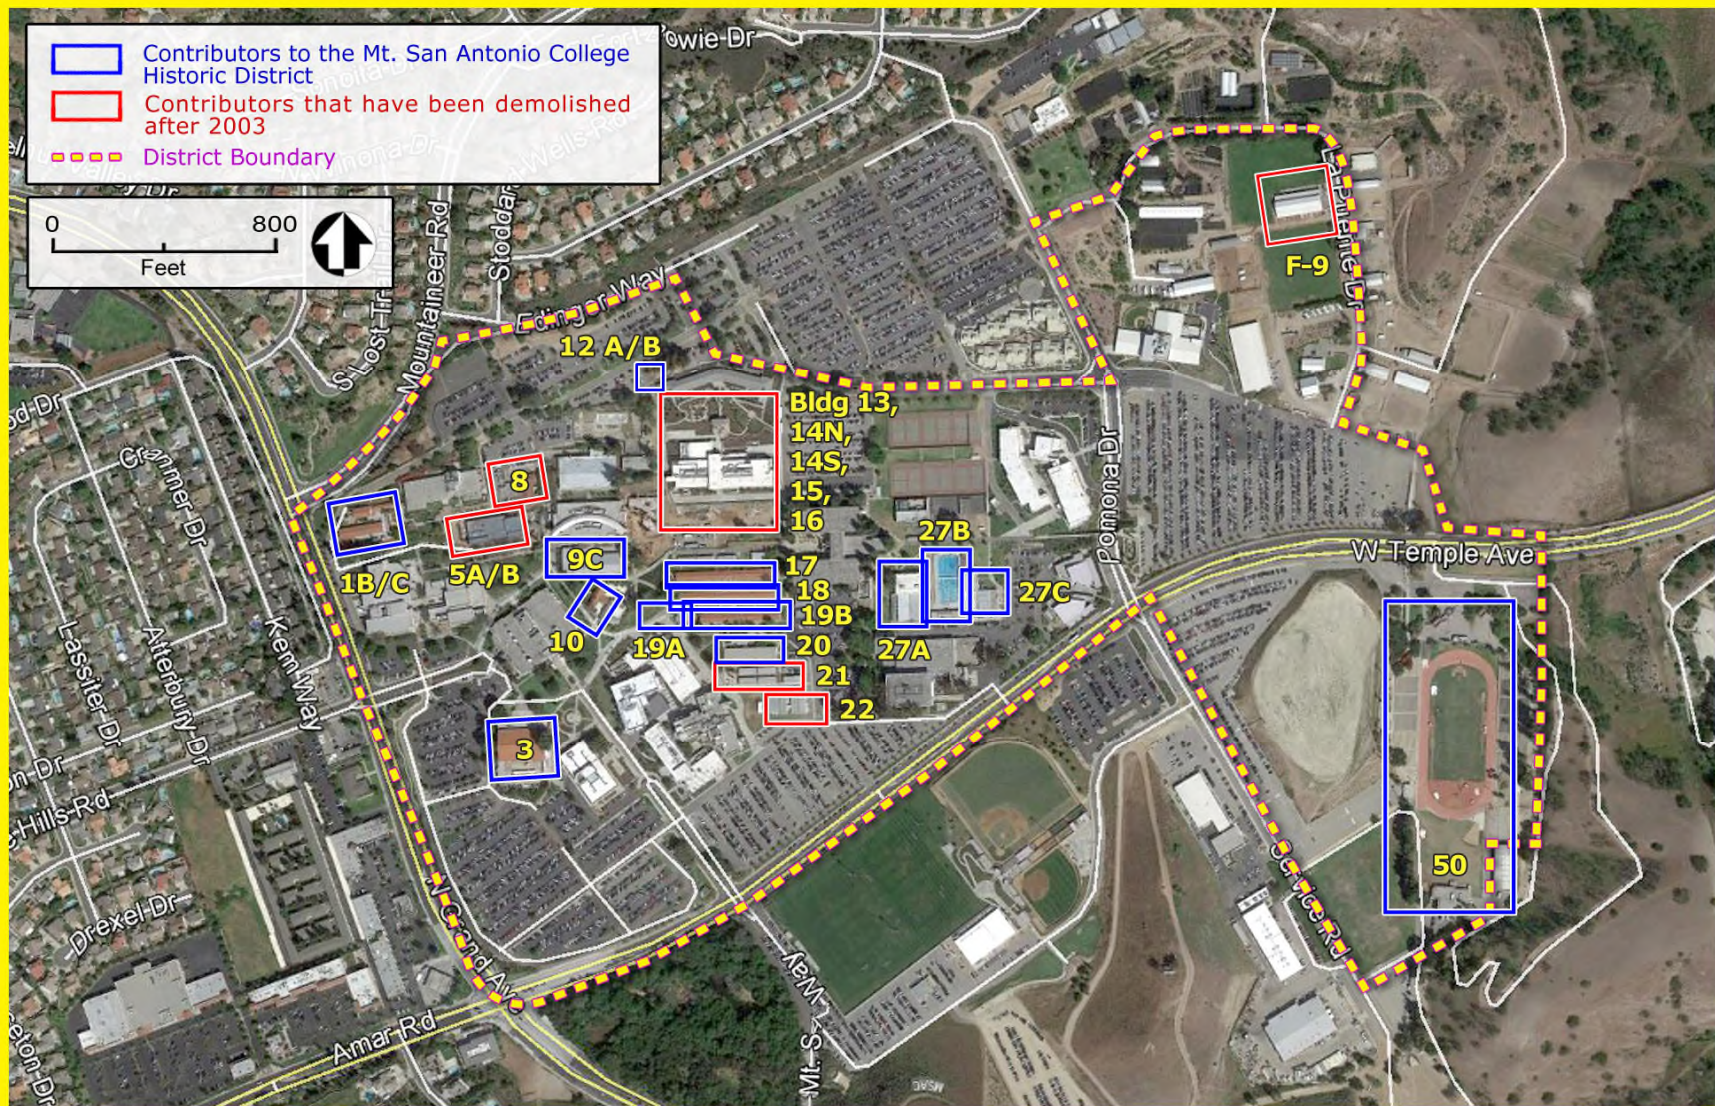
Figure 4. Mt. SAC Historic District identifying contributing resources and demolished contributors, as of November 2015.

The district was previously recommended as eligible for the CRHR under Criterion 1 at the local level, under the theme of Education, for its association with the development of Walnut, California, and its surrounding communities. The college served 10 different communities and thousands of residents and is today the largest community college in the San Gabriel Valley and one of the largest in California. Mt. SAC was one of the first junior colleges in California and the San Gabriel Valley to be established as independent from a high school campus. The period of significance for the district is 1946-1972, reflecting the date the present site of the college became its permanent residence, its early years of development and growth, and ending with the construction of the last major campus facility (the Marie T. Mills Aquatic Facility) to be built until the 1990s, before the growth of the college plateaued (only two buildings being constructed between 1972 and 1990). The college was built to accommodate the increased need for an independent community college (not located on a high school campus) in the area after World War II, and became one of the largest and most significant junior colleges in the San Gabriel Valley. Mt. SAC is the largest of six junior colleges in the San Gabriel Valley, with more than 35,000 students enrolled. The Student Life Center, Aquatic Facility, Women's Locker Facilities, and the Exercise Science/Wellness Center each reflect the college's long-standing efforts to foster student participation in extracurricular and recreational activities during the first 25 years of its establishment. Each building/structure contributes to the educational theme of the historic district and was built during the period of significance. Additionally, the resources maintain good integrity in all seven aspects.

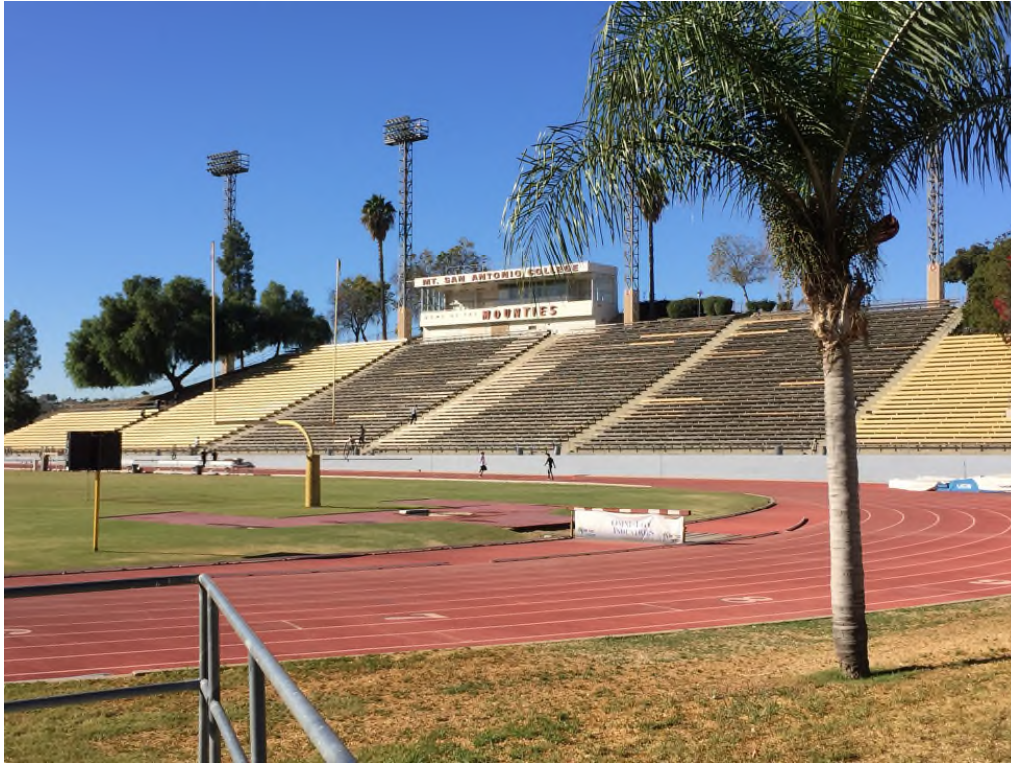
Figure 5. View looking southwest at Hilmer Lodge Stadium, including the track, western bleachers, and press box (50D).

At the peak of the west bleachers sits the stadium press box, Building 50F. This building is rectangular in form and faces east toward the track and field. It consists of a concrete foundation, vertical wood boards, and a flat roof. The building is single story with a bottom level that is accessed on the west façade; the bottom level is enclosed with doors that lead to the mezzanine level. The mezzanine consists of an unenclosed recessed deck that has seating and a metal and glass-enclosed press box. There are rectangular fluorescent light fixtures on the ceiling and an open metal grid-pattern wall on either end of the building within this level. On top of the mezzanine is an open upper deck with a metal railing. The east façade of the building reads “Mt. San Antonio College” on the fascia between the upper deck and the mezzanine level, and “Home of the Mounties” on the fascia between the mezzanine level and lower level.

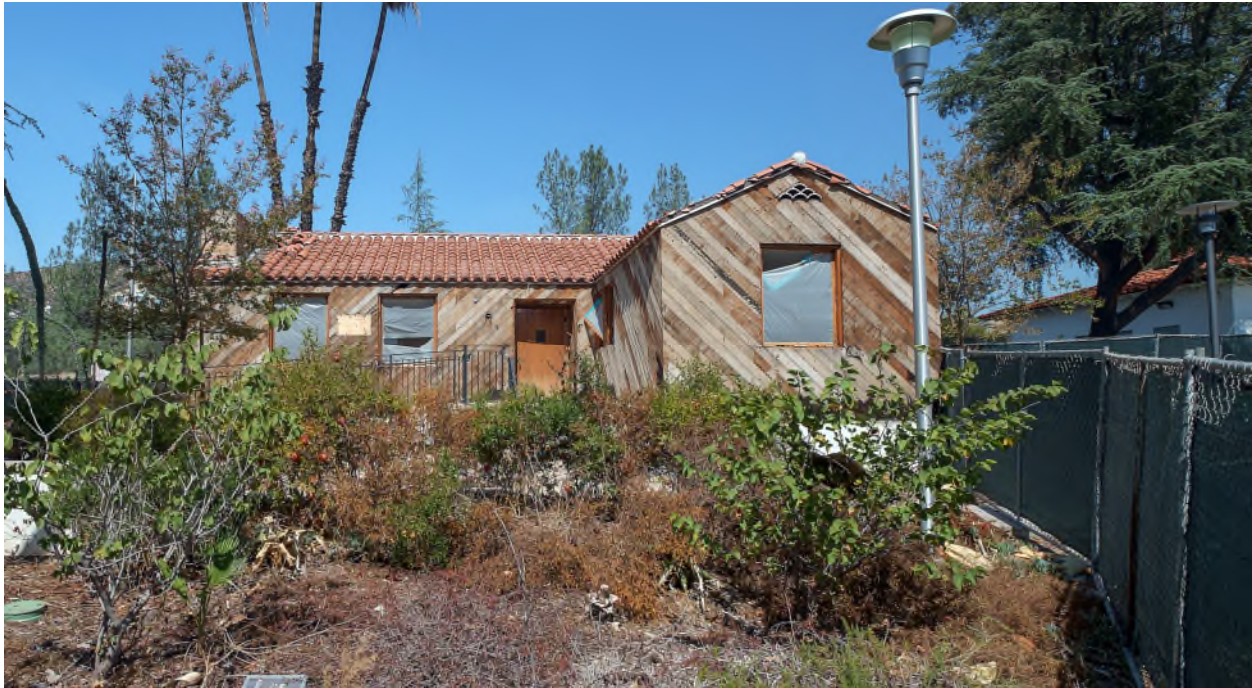
Figure 11. Oden House (12A) and garage (12B) to the right, view looking north at south façade.

Buildings 12A/B were constructed in 1947 as a single-family residence in the Spanish Colonial Revival style (Figure 11). They served as the residence for the college's first campus maintenance supervisor. According to the 2003 Gregory DPR form, the building is referred to as the "Oden House," presumably named after the first college maintenance supervisor; however, no other documentation or mention of this name is given in the report or DPR (Gregory 2003). Building 12A is the residence. Building 12B is believed to have served as a garage for the residence, but unusually contains a vented cupola at the top of the hipped roof that housed a siren.

Oden House is located in the northwest part of the campus, south of Edinger Way and Walnut Drive. At the time of the survey, the building was vacant and in a partial state of demolition. The single-story building has a concrete foundation and a T-shaped footprint. It was covered in stucco prior to partial demolition. The exterior siding at the time of the survey consisted of diagonal wood boards that were originally used as lathing for the stucco exterior. The roof is cross-gable with shallow eaves and is clad in red clay tiles. Concrete steps with an iron railing lead to the primary entrance which is located within the northeast corner of the south façade and consists of a recessed entrance with a wood door. Since demolition began, the windows have been removed. Originally they consisted of wood casements. Other features of the building include bird's nest vents made of red clay tiles located under the apex of the gable end projections. The building has a chimney on the west gable end lateral interior. The interior of the building consists of wood floors, plaster walls, arched entryways, pocket doors, and exposed beams on the ceiling. The building plan consists of eight rooms (Oden House 1999).

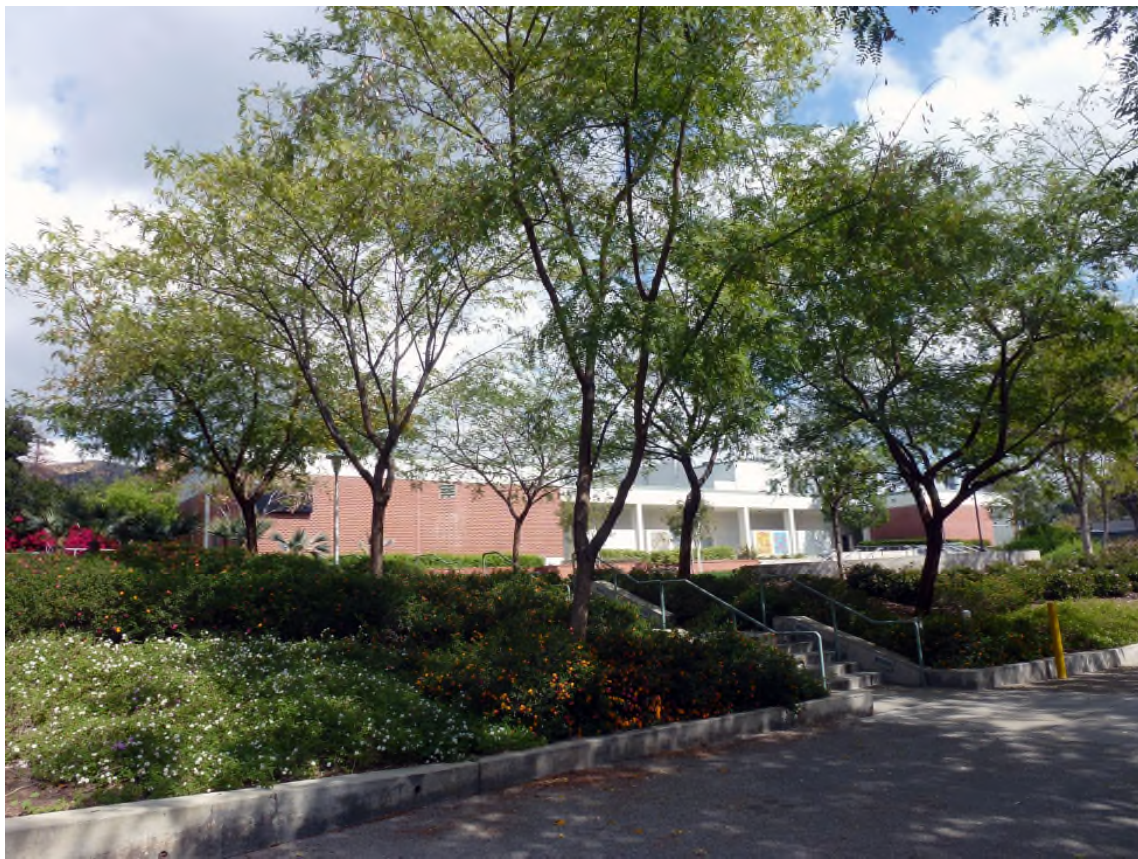
Figure 12. View of the south façade of Building 1A.

Building 1A, the Art Center, was constructed in 1972 (Figure 12). The Modern single-story building has a rectangular floor plan and concrete foundation. The educational building has brick and poured concrete siding and a flat roof. The windows are primarily fixed steel and are located on the north façade. Concrete steps with metal railings lead to the primary entrance on the south façade that consists of a partial-width arcade with rectangular concrete columns. At the center of the walkway within the arcade is a large glass display case flanked by walls of built-in lockers. In between the columns of the arcade are large concrete bulkheads adorned with geometric mosaics facing south; the north sides of the bulkheads have built-in lockers. Within the arcade are five entrances consisting of flush metal doors, some with partial glazing.

On the north, the façade consists of a poured concrete exterior with squared pilasters. In between the pilasters are boarded-over window openings with small partitions in between. Above the row of boarded-over windows are rows of steel-framed windows. Some classroom entrances are located on this façade, as well as a recessed porch entrance with mechanical equipment within. There is a kiln for the ceramics department located on the east façade within a walled partition. Secondary entrances are located on the east and west façades.

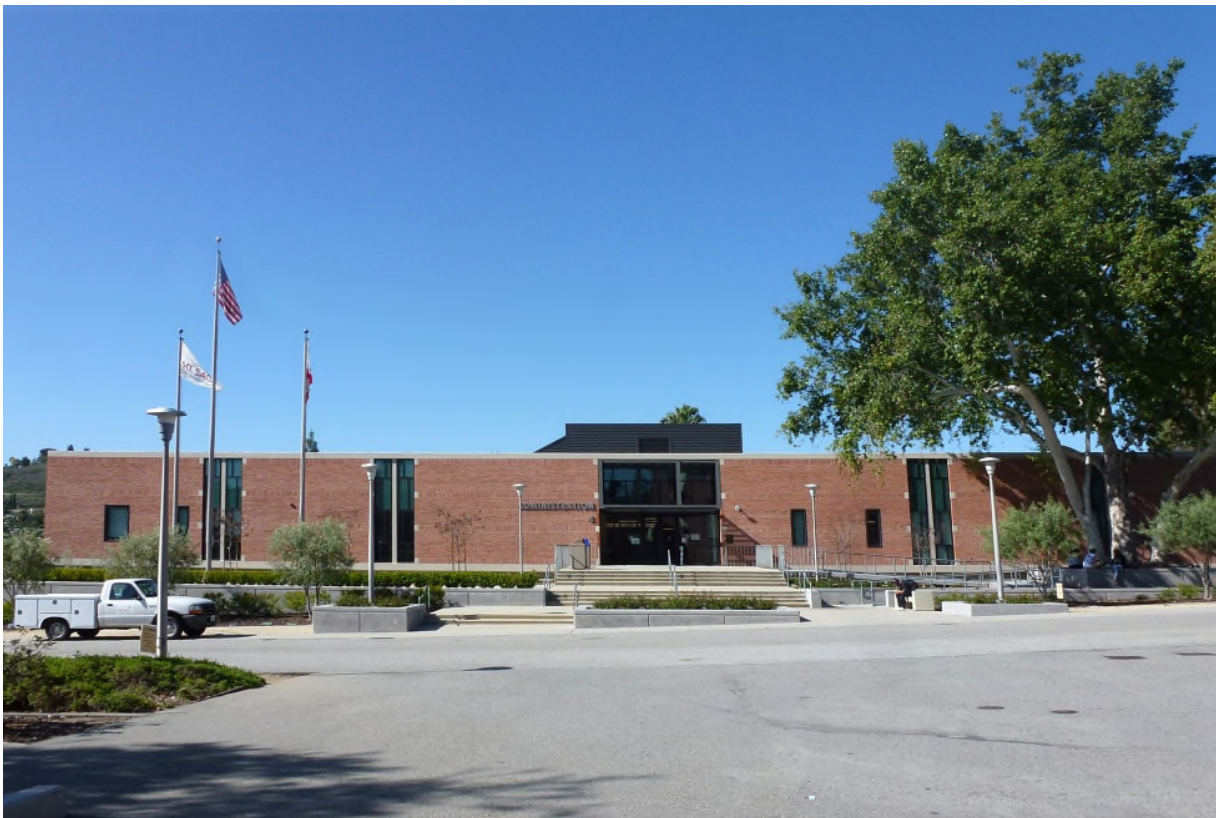
Figure 13. View of the primary (west) façade of Building 4.

Building 4, the Administration building, was constructed in 1965 in the Modern style (Figure 13). It is a two-story building located on the northeast of Temple and Grand avenues on the southwest side of the Mt. SAC campus. The administration building has a rectangular footprint with a concrete foundation. The upper portion of the building's exterior is clad in brick with scored concrete siding on the lower portion of the building. The brick is laid in three sections of running bond with a single sailor course in between each section. The concrete on the lower portion of the building is scored in a grid pattern. The roof is flat and has a poured concrete parapet cap. There is a penthouse on the roof that houses mechanical equipment. The primary entrance is located on the east façade and consists of a centrally-located recessed aluminum and glass entryway with a steel canopy over the double doors that have steel beams and screens to shade the entrance. The recessed entrance has been framed-in with steel posts and beams and accommodates lighting fixtures at the ceiling of the entryway. A secondary entrance is located on the north façade where a non-original steel canopy has also been installed. The south and west façades also have secondary entrances located within the lower portion of the building that has scored concrete siding. These entrances, like the east and north, consist of aluminum-framed glass entryways.

Modifications to the building include two additional fixed windows on the north façade, four additional fixed windows on the east façade, the steel post and beam framing and canopy on the east entrance, the canopy on the north façade's entrance, and the addition of five windows on south façade. According to original building plans, the narrow paired windows on the north and south façades were originally filled in with colored glass block windows, and have since been replaced with fixed metal windows. The interior of the building consists of carpet and tile floors, squared columns and a designed angular, cut-out ceiling. The building retains high integrity of material, location, setting, and association. The building has lost some integrity of design and workmanship with the installation of a number of additional windows that change the fenestration of the building. The building retains sufficient overall integrity.

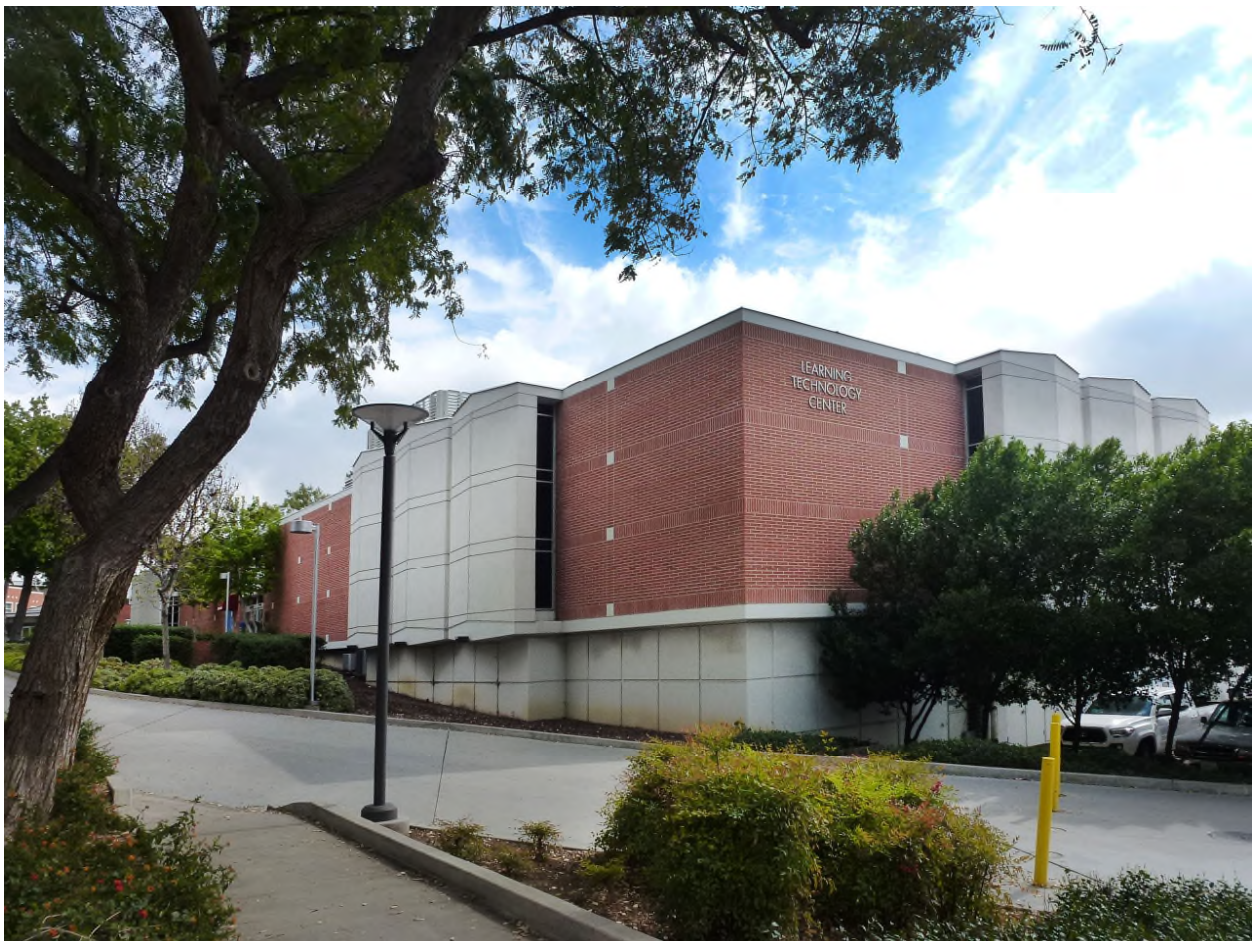
Figure 14. Oblique view of the north and west façades of Building 6.

Building 6, the Library, was constructed in 1963 in the Modern style (Figure 14, above). It is a three-story building located on the northeast side of Temple and Grand avenues on the west side of the Mt. SAC campus. The educational building has a rectangular footprint with a concrete foundation. The exterior is clad in brick and scored concrete siding. The brick is laid in three sections of running bond with a single

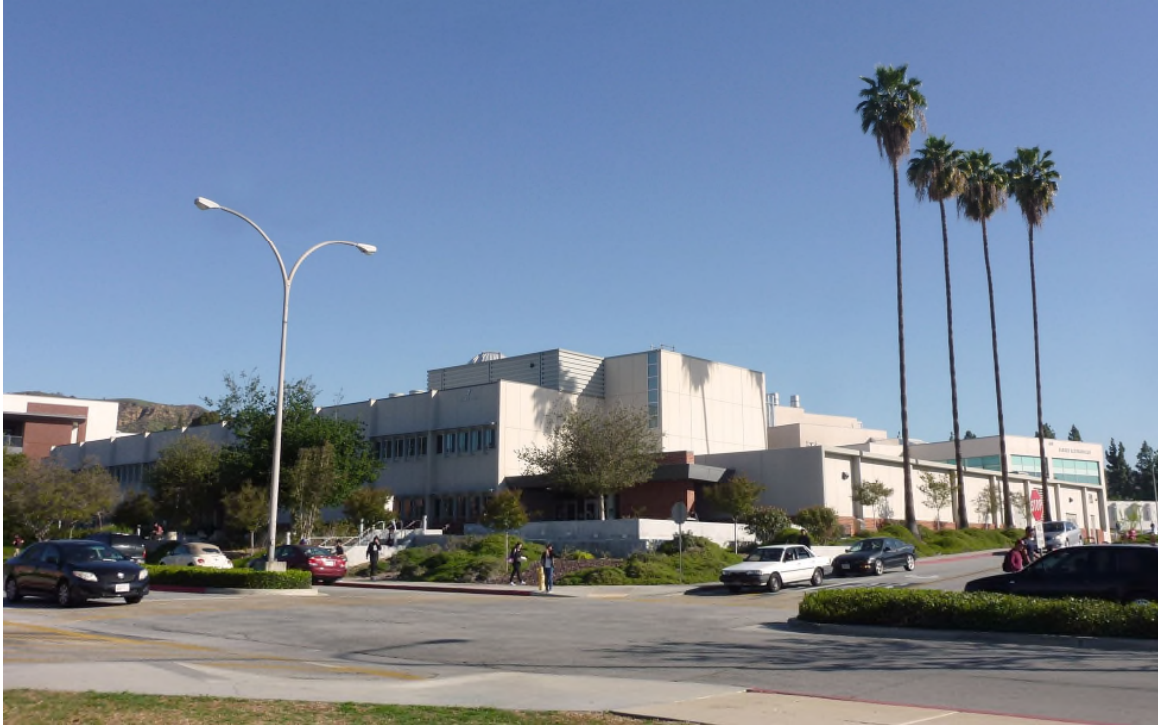
Figure 15. Oblique view of the west and south façades of Building 7.

The building was designed as the Student Union and Activity Facility by the architectural firm Austin, Field, & Fry.

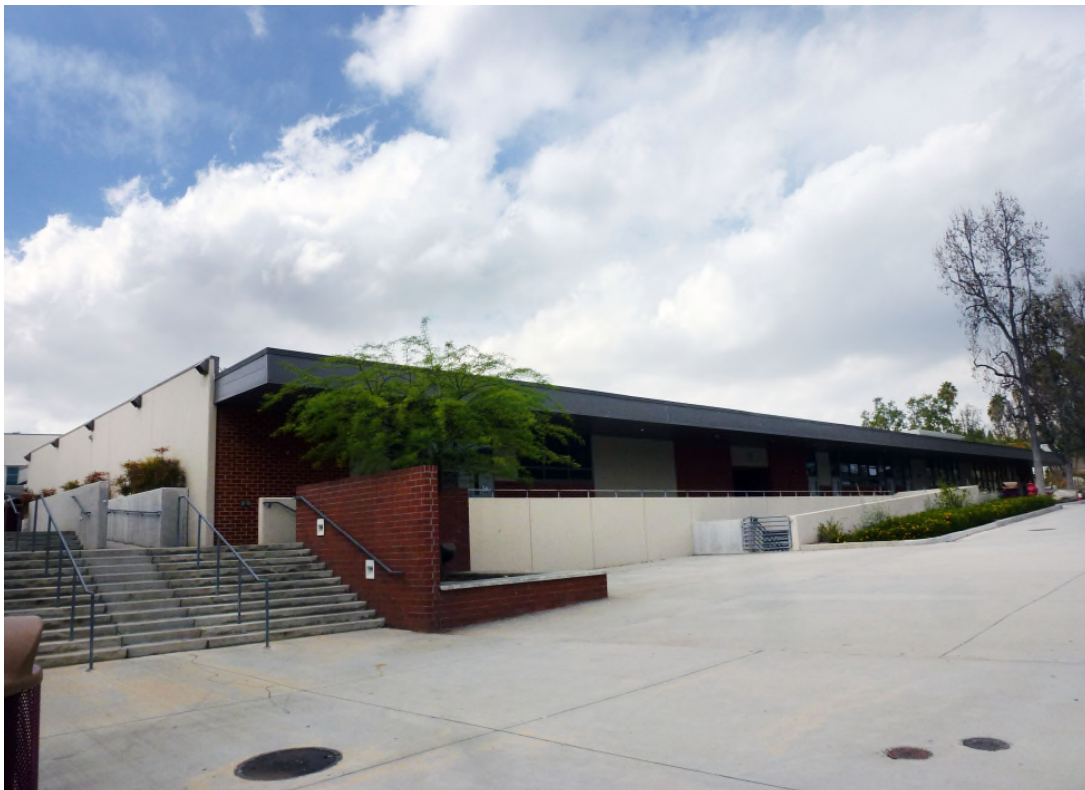
Figure 17. Oblique view of the east and south façades of Building 11.

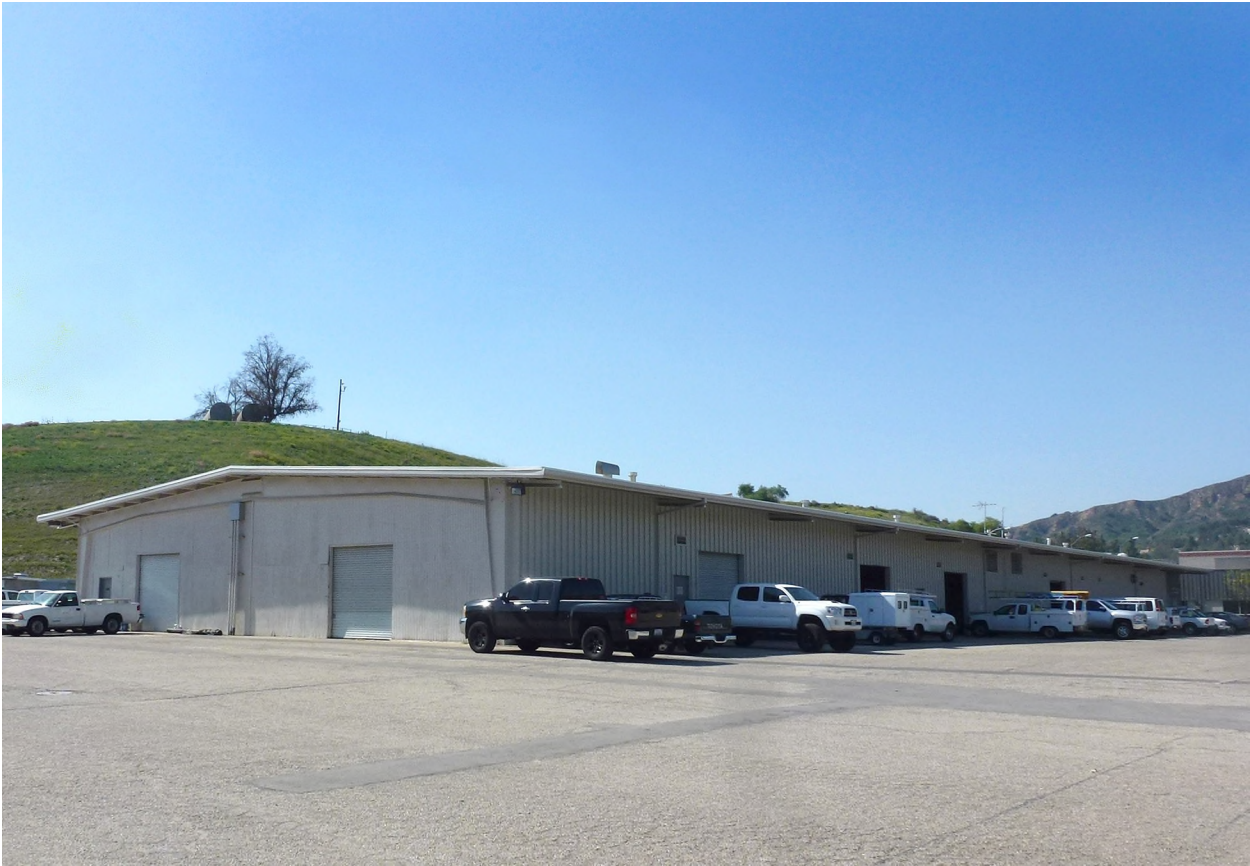
Figure 24. Oblique view toward the west of the northeast and southeast façades of Building 47.

Constructed as the Maintenance and Operations building, it was designed to house five offices and shops for carpenters, electricians, plumbers, general maintenance, painters, and gardeners. It was part of a larger complex which included Building 48 to consolidate facilities, maintenance, operations, receiving-distribution, and transportation departments in a single modern complex called the College Service Center. The cost was \$1.1 million, including outdoor storage areas and the construction of Bonita Drive. The complex was designed by Mt. SAC campus architects Austin, Field & Fry as an element of the college master plan, with Hartman Construction Company of San Bernardino as contractor. The modern concrete block-and-steel buildings are Type V-N construction. Groundbreaking for the center was August 1967, with completion on August 2, 1968 (Mt. SAC c. 1948).

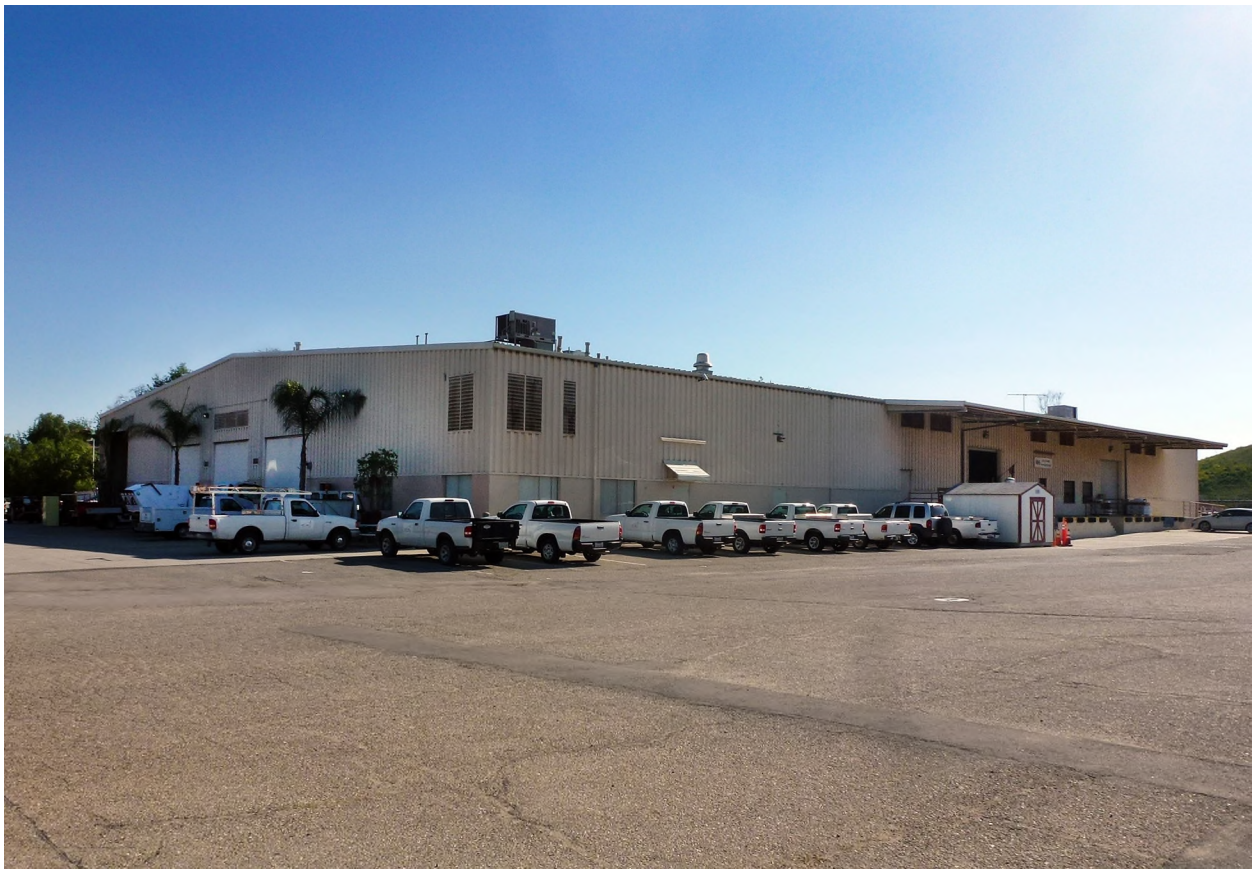
Figure 25. Oblique view toward the south of the northwest and northeast façades of Building 48.

Building 48, the Warehouse and Transportation building, was constructed in 1968 in no particular architectural style (Figure 25). It is a single-story maintenance building located on the southwest side of Temple Avenue and Service Road on the east side of the Mt. SAC campus. The building has a rectangular floor plan with a concrete foundation. The exterior is clad in vertically-oriented steel siding with a concrete block bulkhead. The roof is a low-pitched side gable roof with overhanging eaves and clad in metal. The primary entrance is located on the north façade. The windows are primarily multi-light steel security windows. The building also has metal louvered vents under the roofline and over the roll-top metal garage doors. There is no ornamentation on the building. The interior of the building includes bays for equipment and vehicles as well as a large warehouse space with a concrete floor, a tall exposed metal frame ceiling, and metal shelving for storage.

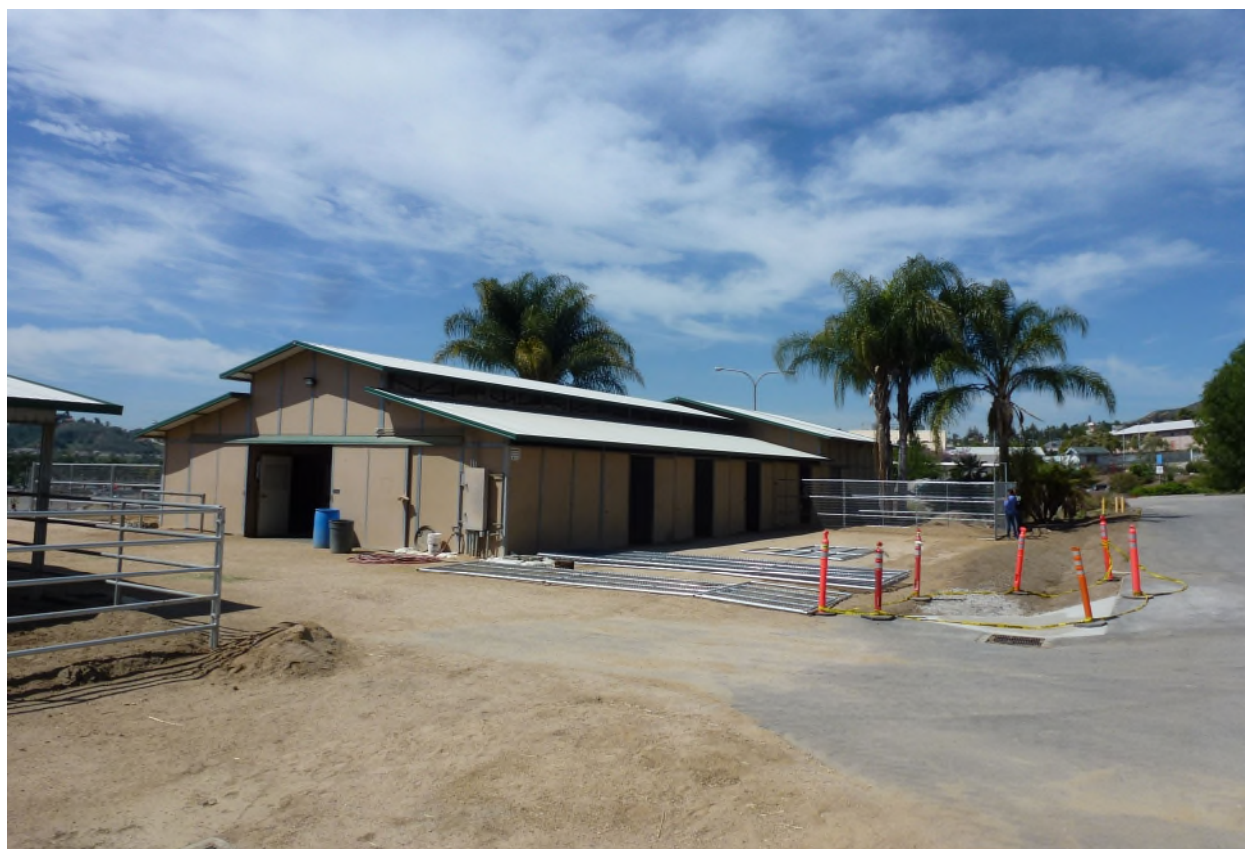
Figure 32. Oblique view of the east and north façades of Building F6A.

Building F6A, the Breeding Barn, was constructed c. 2000 in no specific architectural style (Figure 32). It is a single-story agricultural building located on the southeast side of Farm Road and Bonita Drive on the east side of the Mt. SAC campus. The building has a rectangular floor plan with a concrete foundation. The exterior is clad in metal shed siding. The roof is a front gable roof with shed roof extensions that are clad in standing seam metal sheets. The primary entrance is located on the east façade and consists of a top-hinged sliding metal door. A row of metal-framed windows line the south and north façades that sit underneath the overhanging eaves of the front gable roof. There are secondary entrances on the north and south façades and a corral on the south end of the building. The interior is made of metal-framed horse stalls with a concrete tile floor.

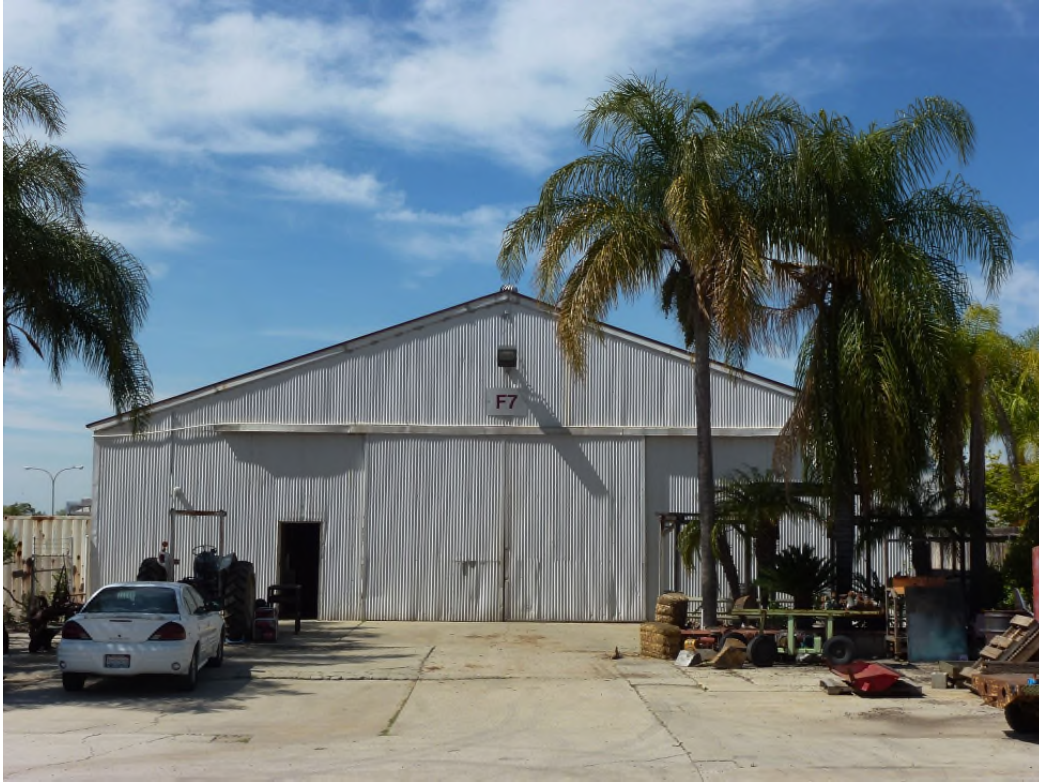
Figure 33. View of the east façade of Building F7.

The building was constructed as the Poultry Warehouse by the architectural firm Austin, Field & Fry.

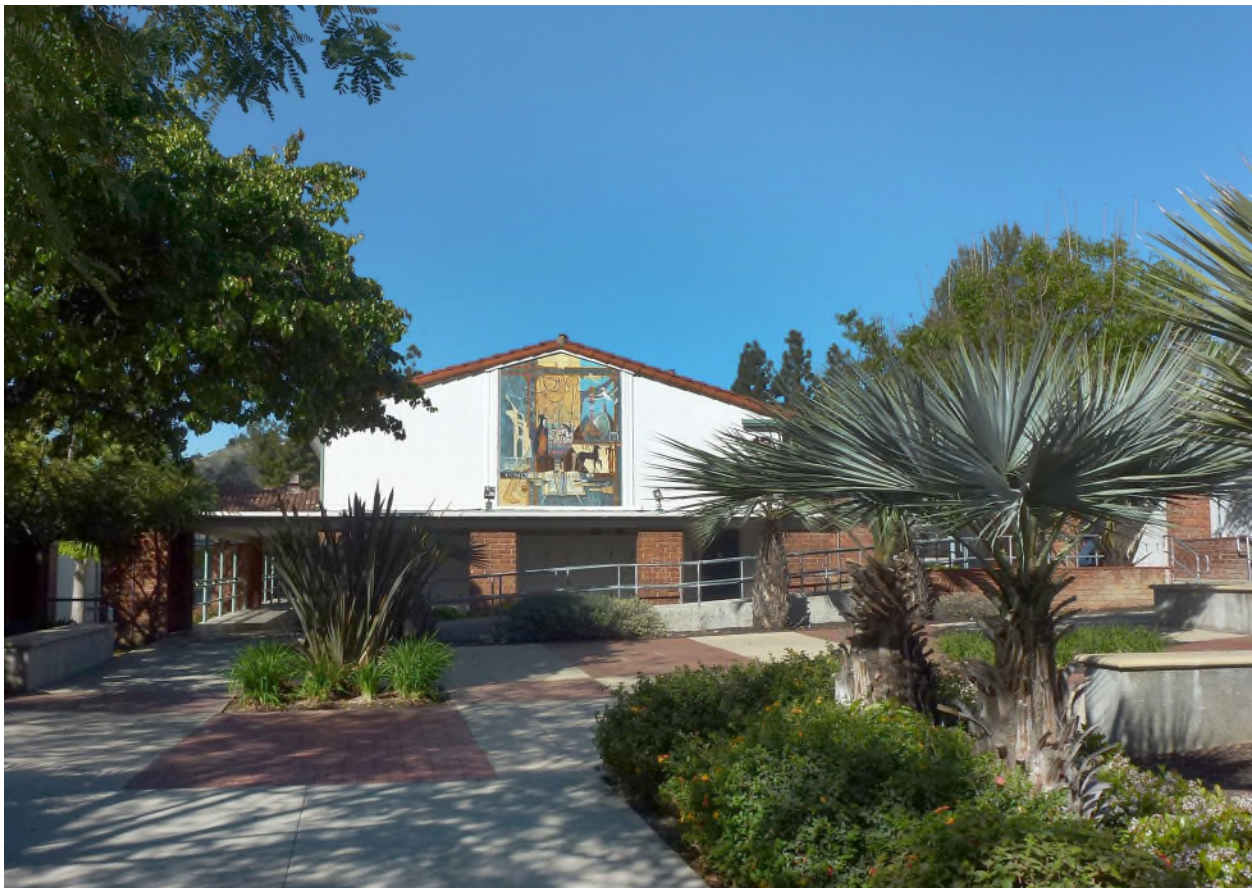
Figure 36. Detail of mosaic on east façade of Building 1B/C.
