West Parcel Solar Project

Project Final Tiered EIR

***Volume 4
Response to Public Comments on the Draft EIR
Appendices***

*MT. SAN ANTONIO COLLEGE
Facilities Planning and Management
Walnut, California*

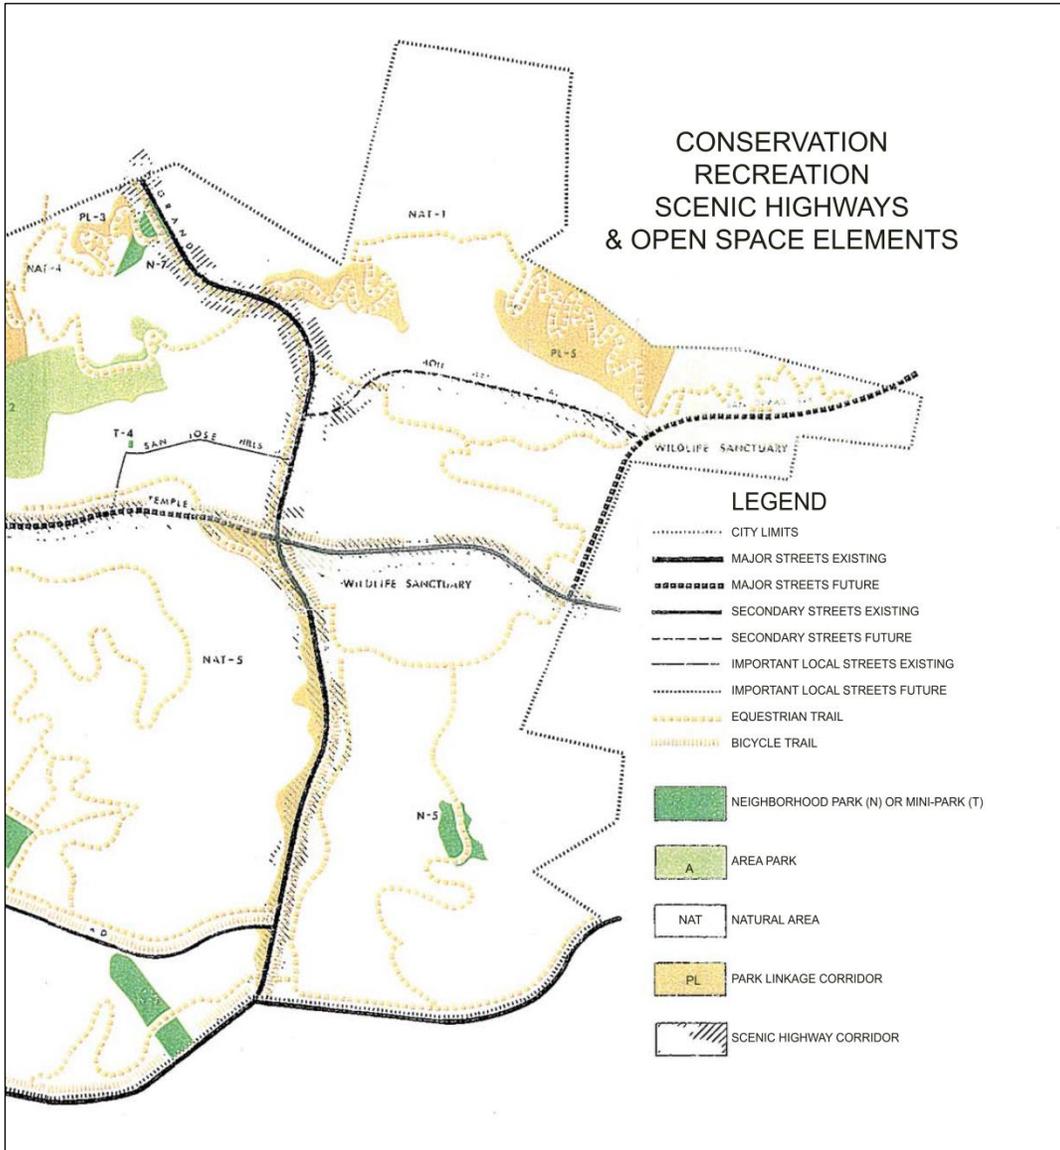
6. The General Plan Conservation, Recreation, Scenic Highways & Open Space Element, page 49, Element VI states, "Of all the existing roads within the City of Walnut, Grand Avenue possesses the most scenic value" and that "It has naturally scenic qualities south of Temple Avenue." This is precisely where Mt. SAC intends to destroy its natural hillside beauty and replace it with up to 70 feet of earthfill covered with asphalt. Further, the General Plan states, "It can be viewed as a linear open space corridor maximizing both urban and natural processes." The destruction of the natural hillsides as planned under the proposed solar project would violate the intent to the General Plan designation of Grand Avenue as a scenic highway. The Scenic Highway designation along Grand Avenue is shown on the following figure.

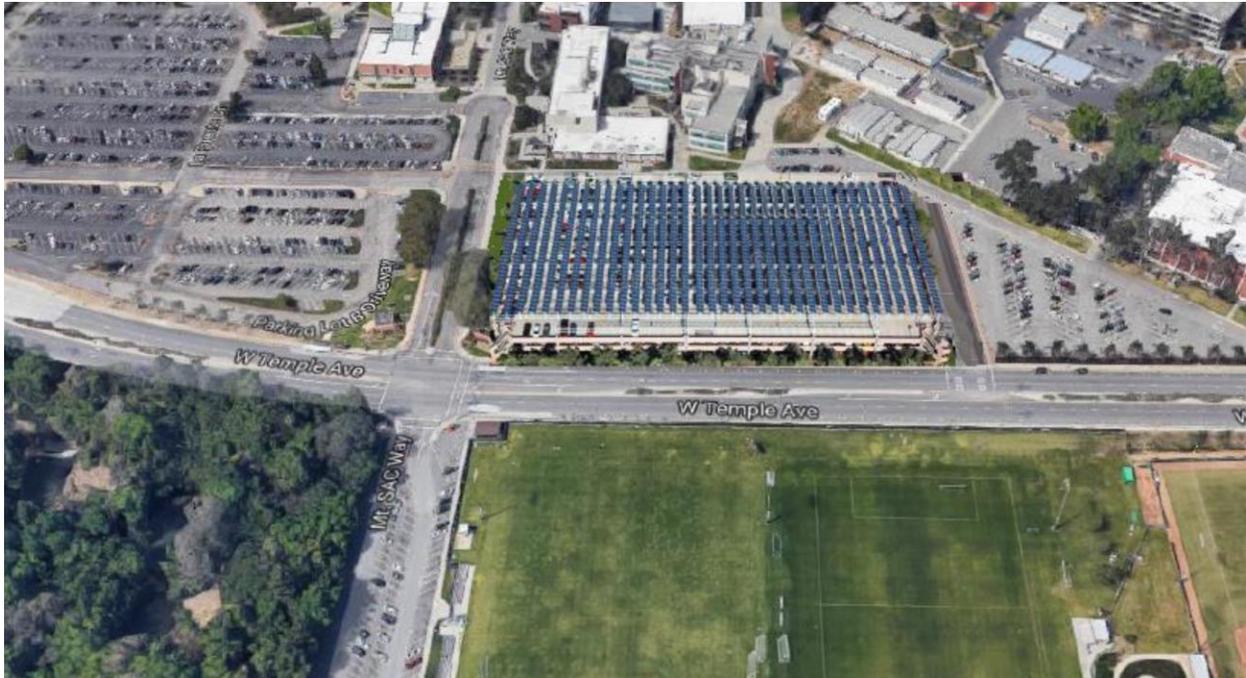
Depiction of Lot D Parking Structure with Solar Panel Canopies at Roof Level

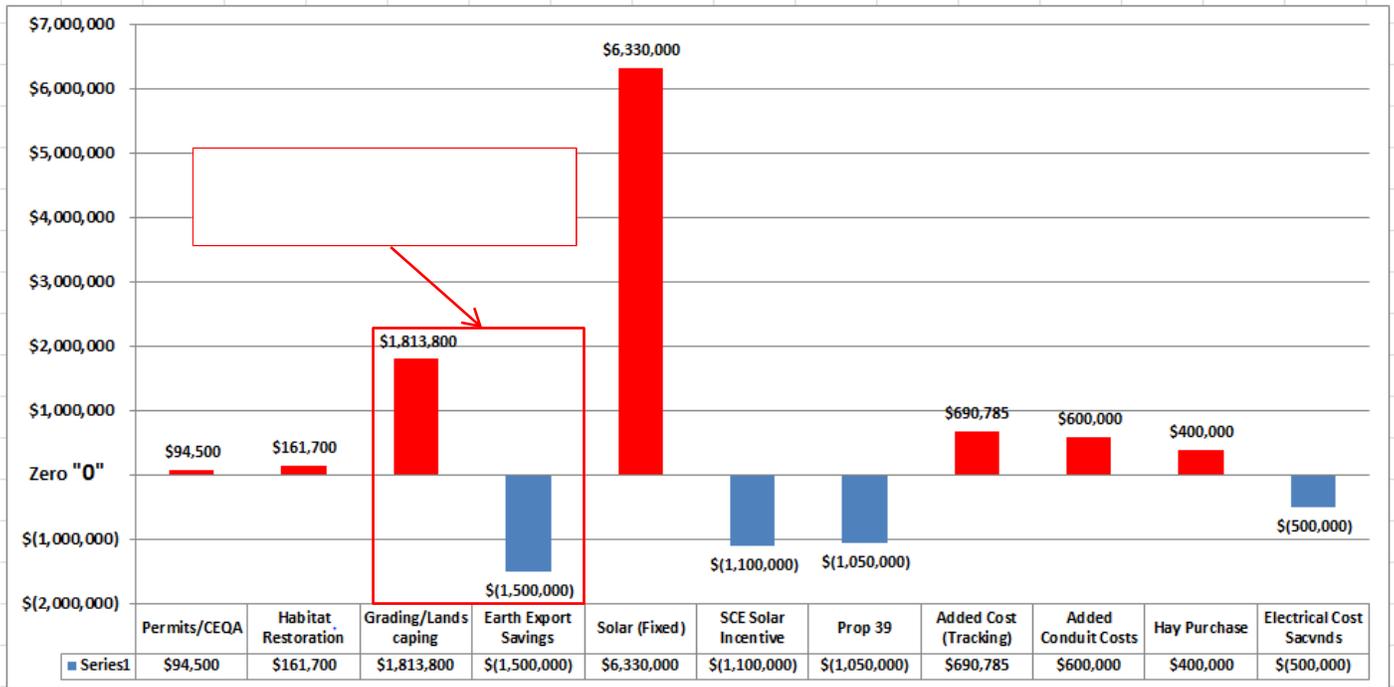
Total Project Cost – West Parcel (DEIR) Grading/Landscaping & Earth Export Savings

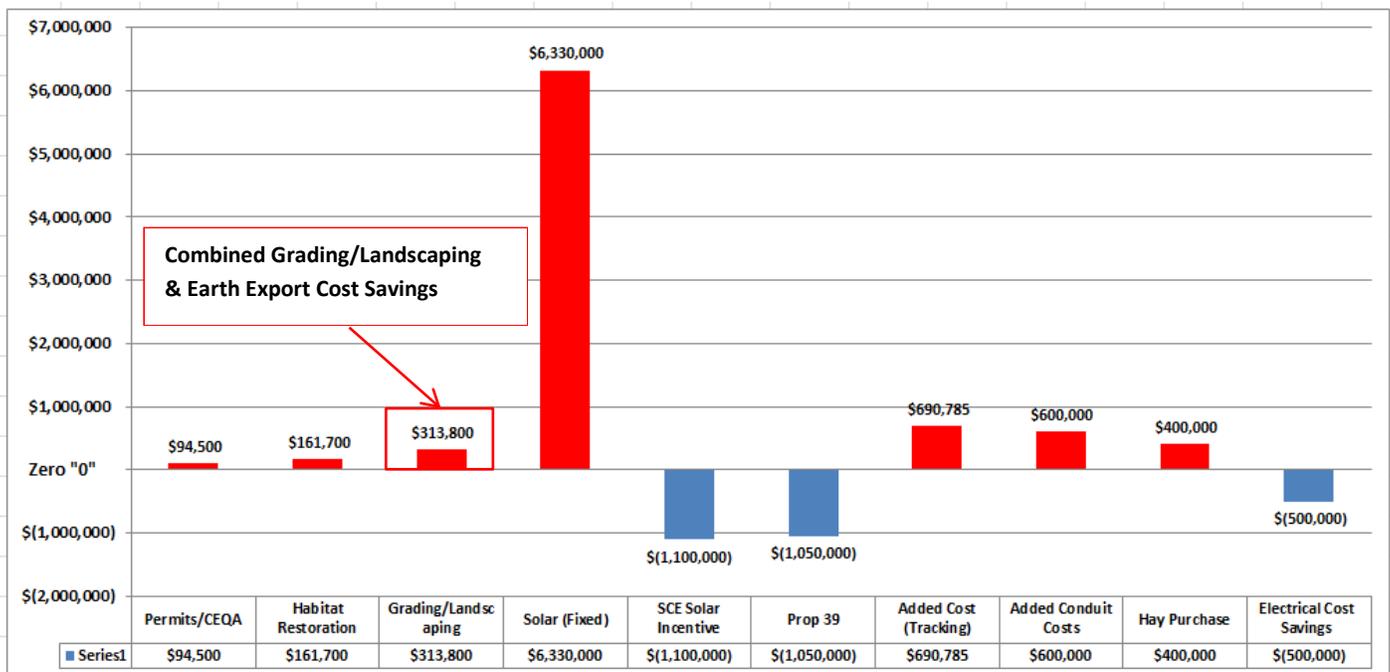
Total Project Cost – West Parcel (DEIR) Combined Grading/Landscaping & Earth Export Savings

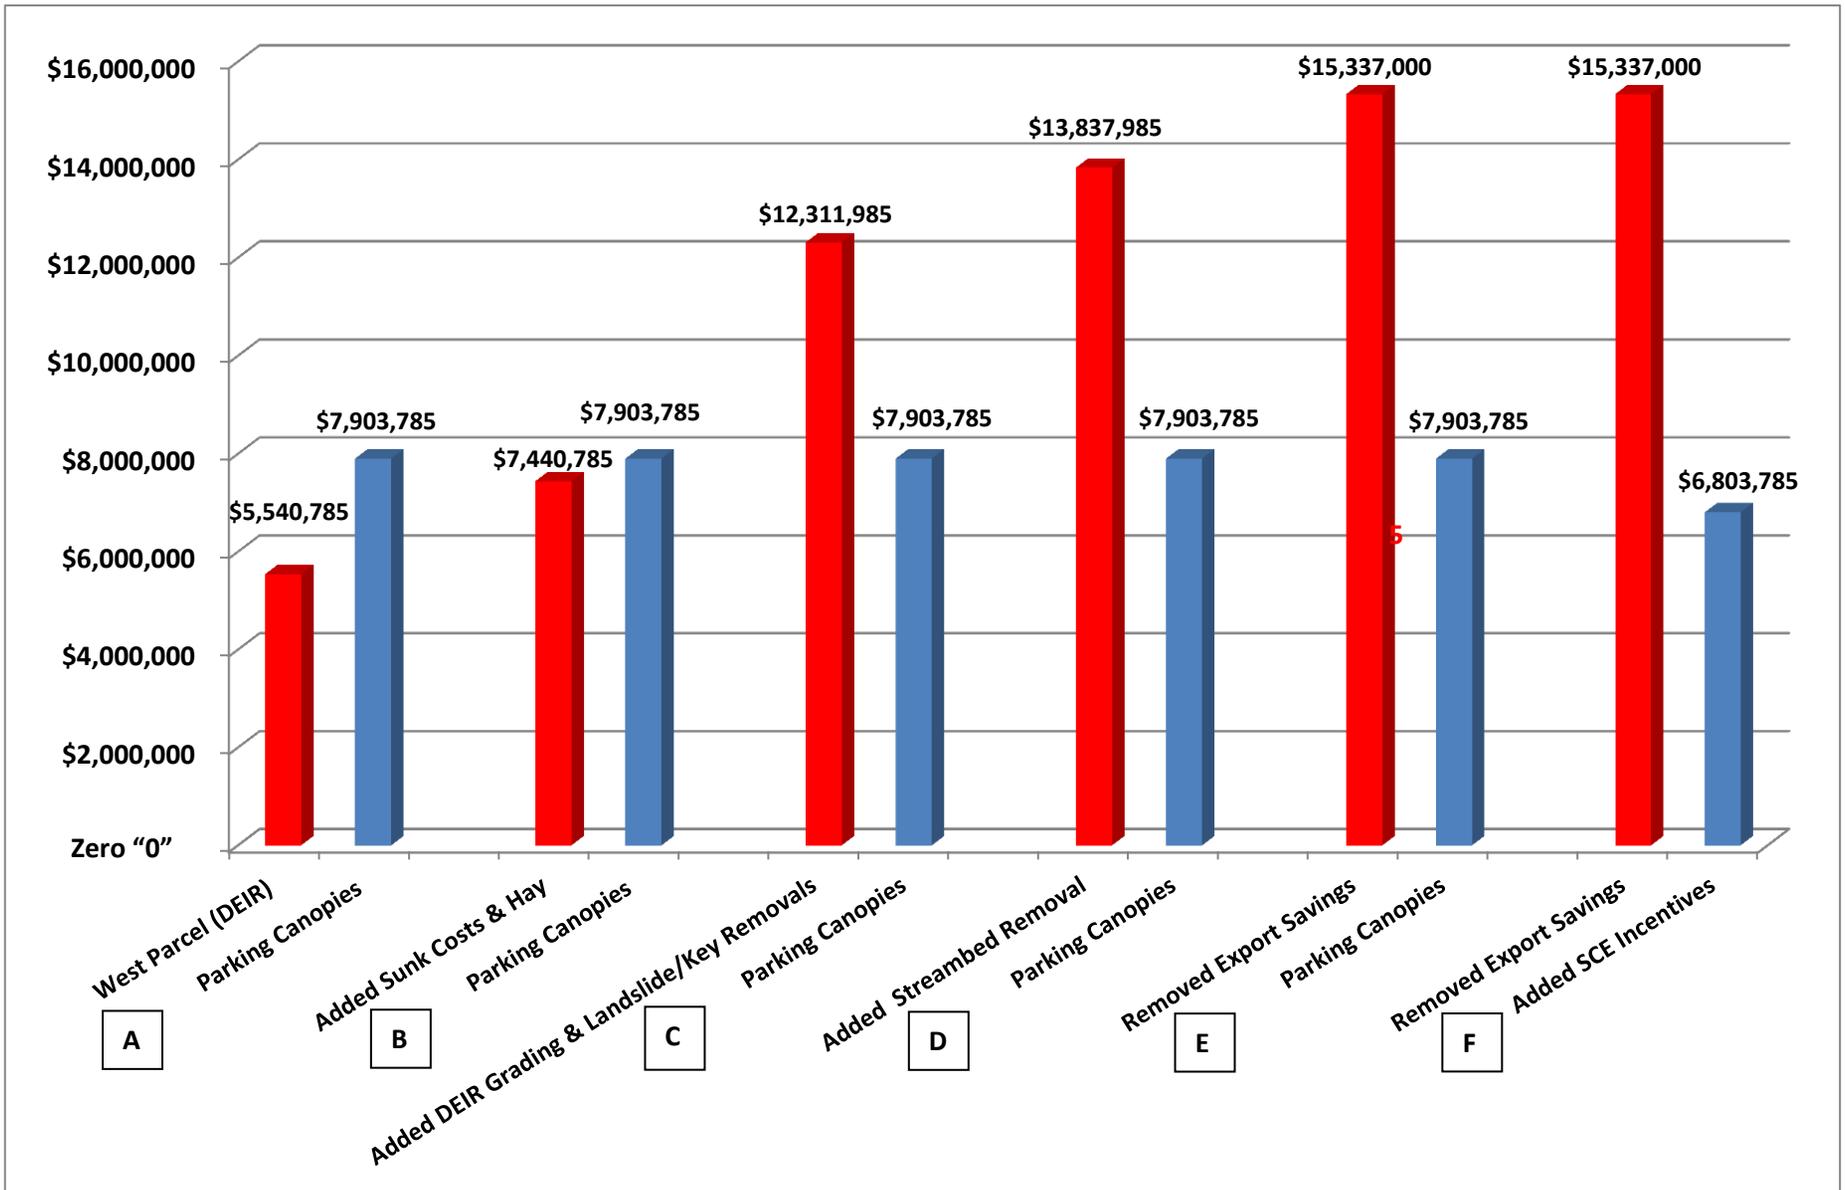
**Total Project Costs
West Parcel (DEIR) vs. Parking Canopy Mounted Solar Panels**

39. The total project costs depicted on Table 6.6.1 of the DEIR provides inadequate back-up information to evaluate the project costs. As such and as shown above, the development of costs for grading and for canopy-mounted solar arrays have been developed by UWT for comparison purposes.

- b. Vertical Bars B. Sunk cost and hay cattle feed replacement for loss of hillside grass are added to the red bar, which were left off the west parcel in Table 6.6.1.

- d. Vertical Bars D. Additional earthwork consisting of streambed materials removal and replacement, recommended by Terrestrial Solutions, Inc. (TSI) are added to the red bar.

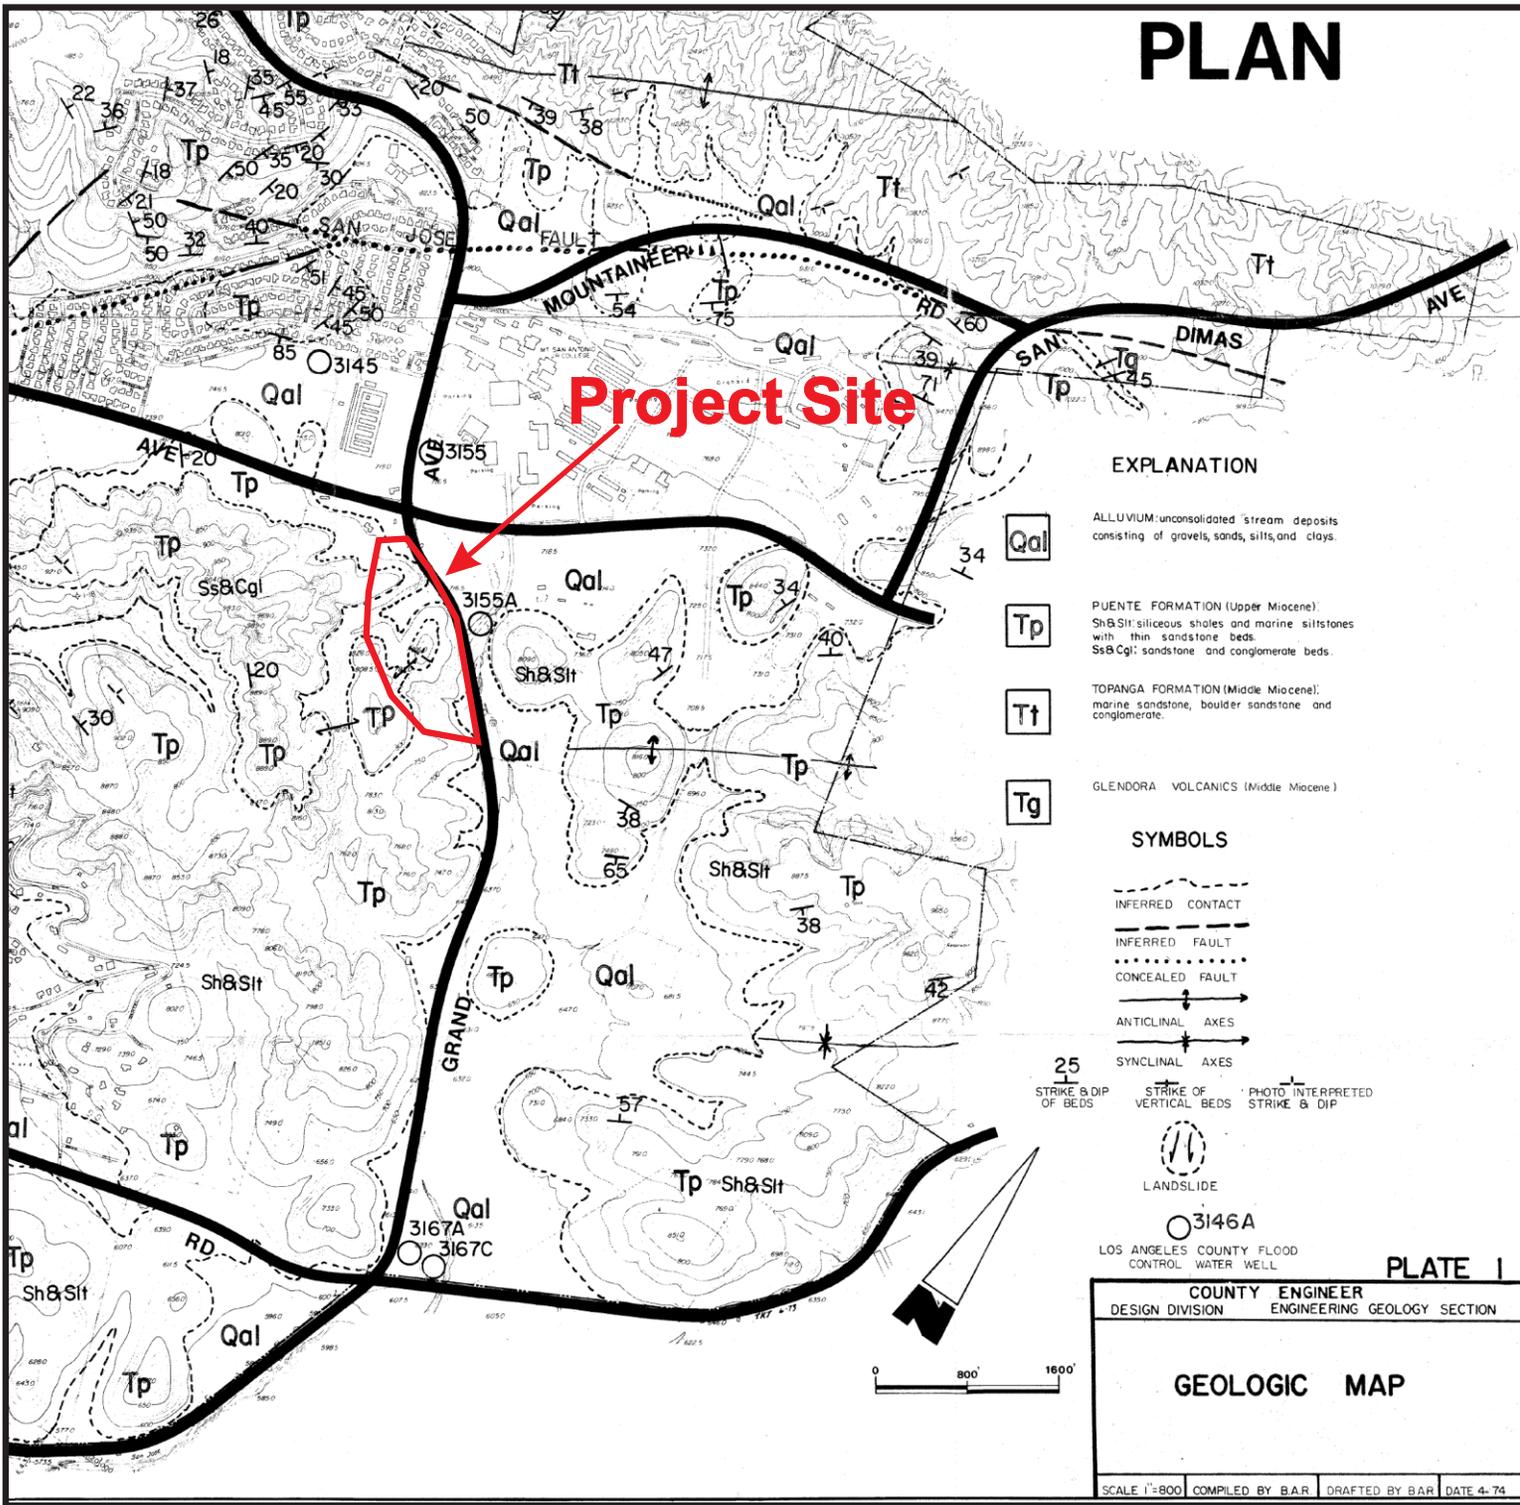
PLAN

Project Site

- Qal ALLUVIUM: unconsolidated stream deposits consisting of gravels, sands, silts, and clays.
- Tp PUENTE FORMATION (Upper Miocene):
Sh&Sst: siliceous shales and marine siltstones with thin sandstone beds.
Ss&Cgl: sandstone and conglomerate beds.
- Tt TOPANGA FORMATION (Middle Miocene):
marine sandstone, boulder sandstone and conglomerate.
- Tg GLENDORA VOLCANICS (Middle Miocene)

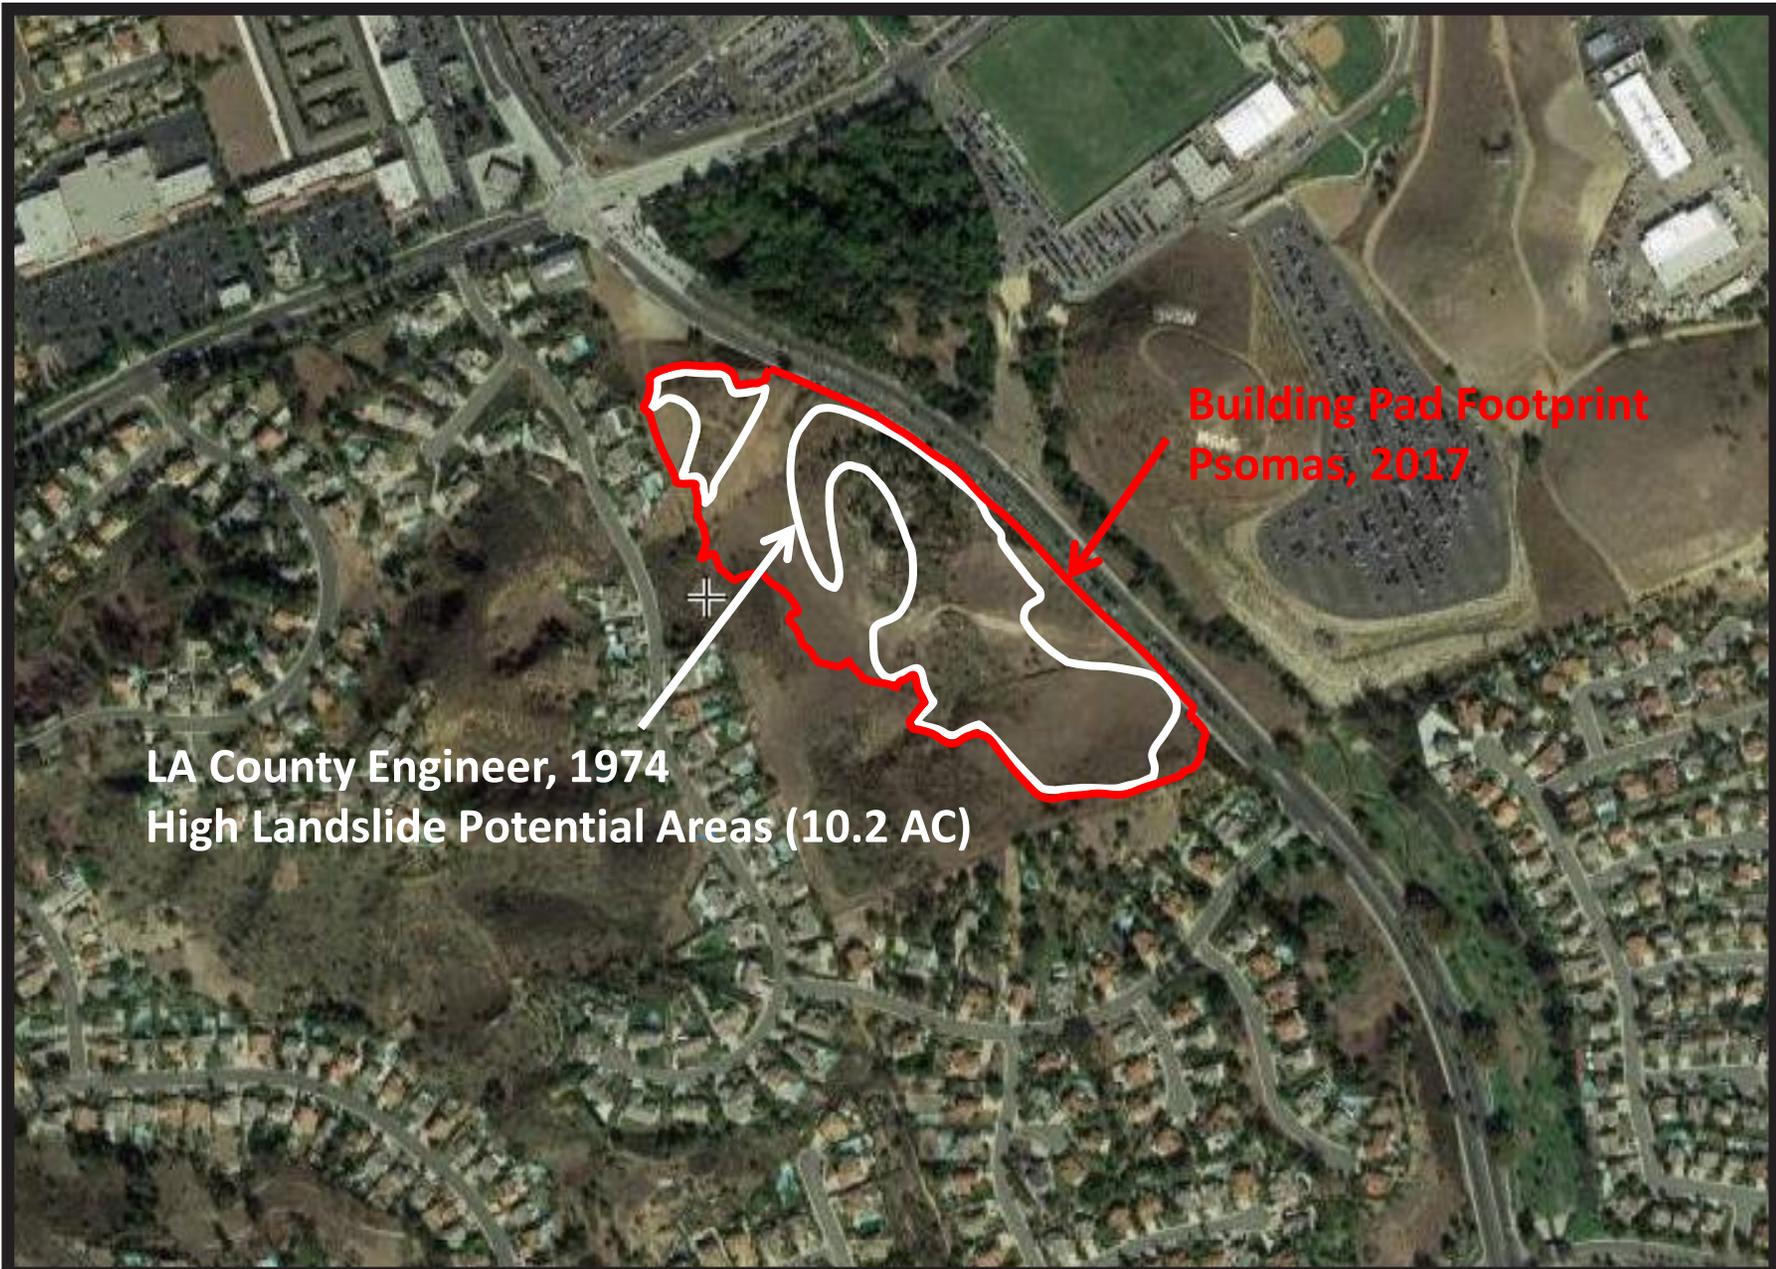
Figure 2a

LA County Engineer, 1974
High Landslide Potential Areas (10.2 AC)

Building Pad Footprint
Psomas, 2017

Converse correctly indicates that, according to official maps published by the State, the site is not located in an area that must be investigated for seismically induced landsliding. However, the Converse report does not reference the LA County Engineer Landslide Potential Map (Plate II, 1974) that indicates portions of the site have a high potential for landsliding (Figures 2a and 2b). In addition, Converse did not reference CGS Open File Report 88-21 that indicates the site is within Area 3 (Figures 3a and b). Area 3 is defined as;

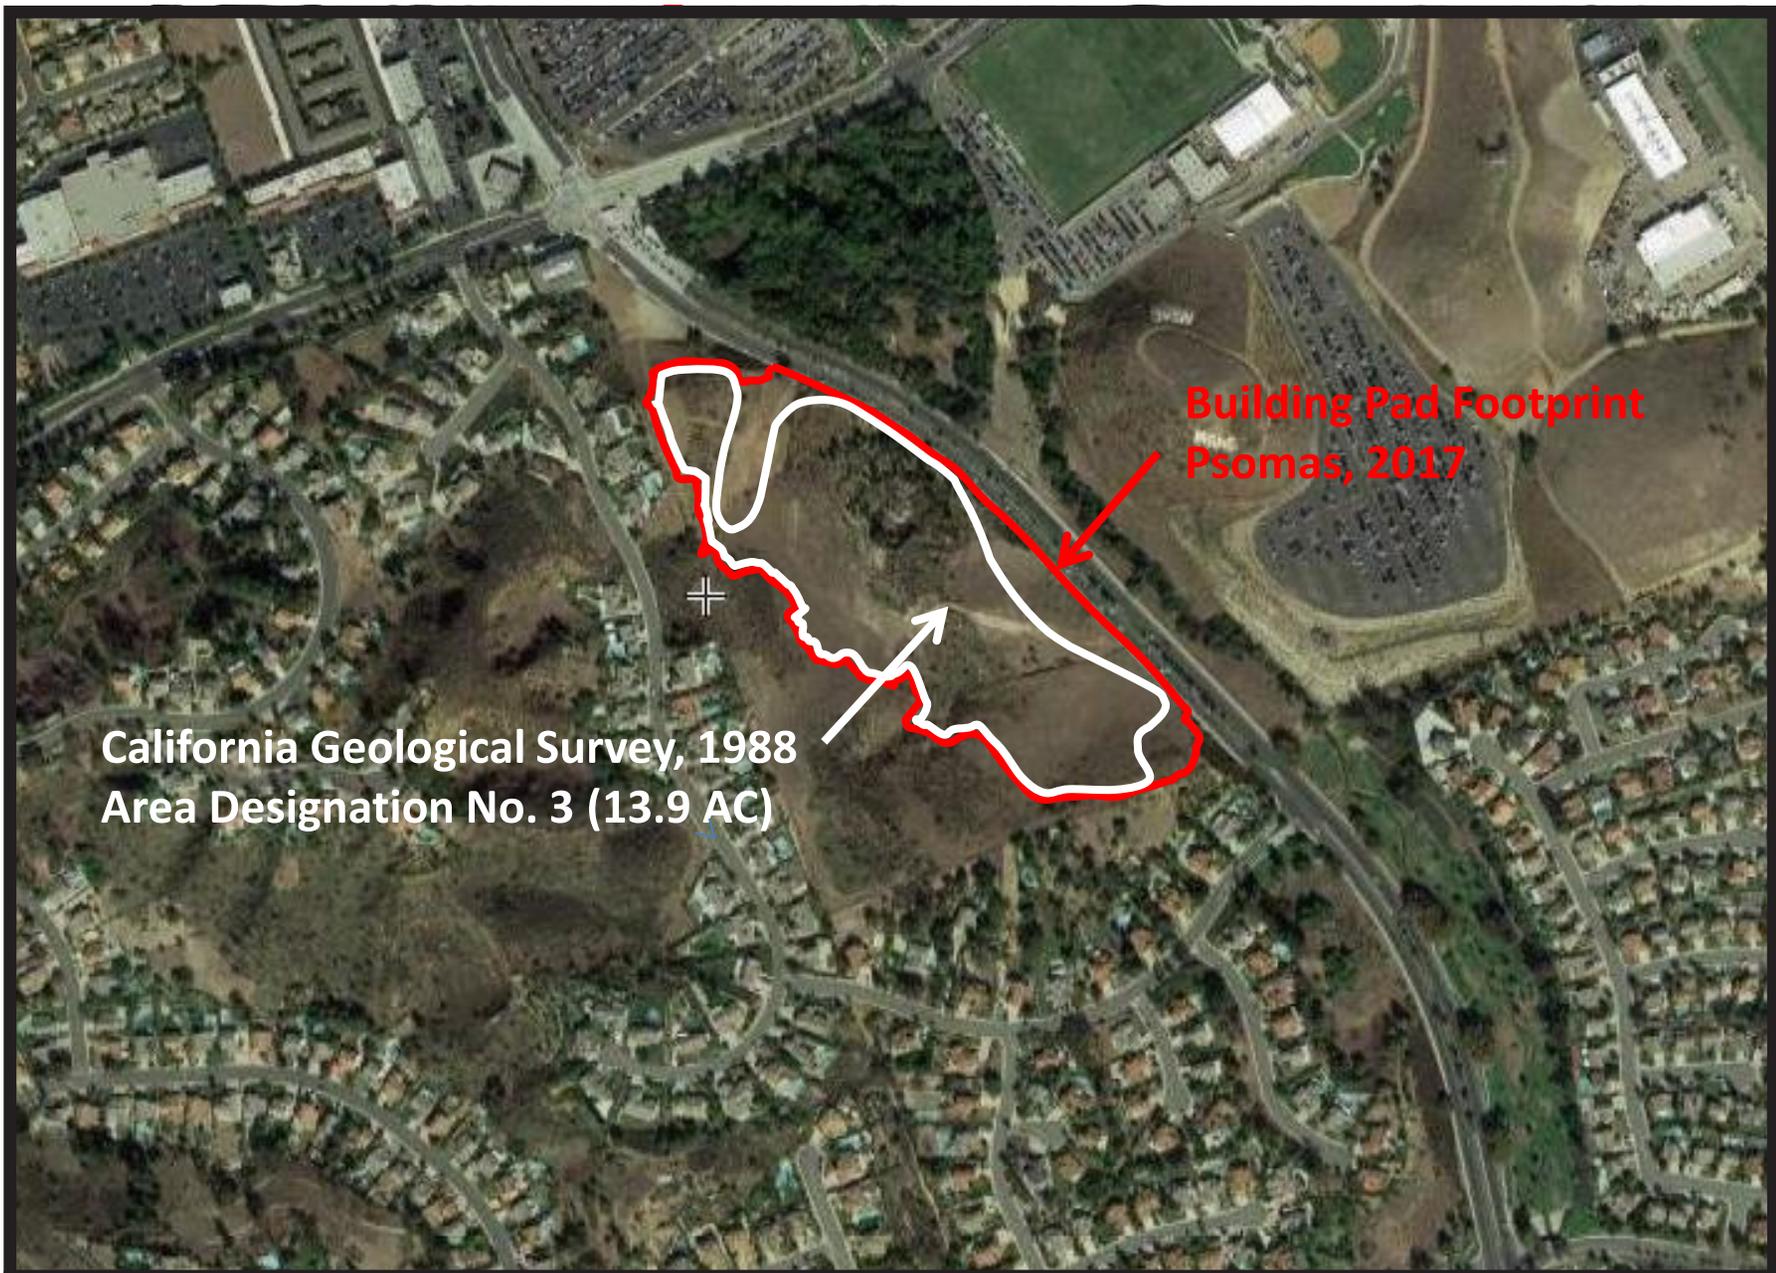
**Modified from CGS 88-21 Map No. 12.
Landslide Hazards in the Puente and San Jose Hills
1988**

California Geological Survey, 1988
Area Designation No. 3 (13.9 AC)

Building Pad Footprint
Psomas, 2017

"Relative Landslide Susceptibility Areas; Area 3 - Generally Susceptible Area. Slopes within this area are at or near the stability limits due to a combination of weaker materials and steeper slopes. Although most of the slopes within Area 3 do not currently contain landslide deposits, the materials

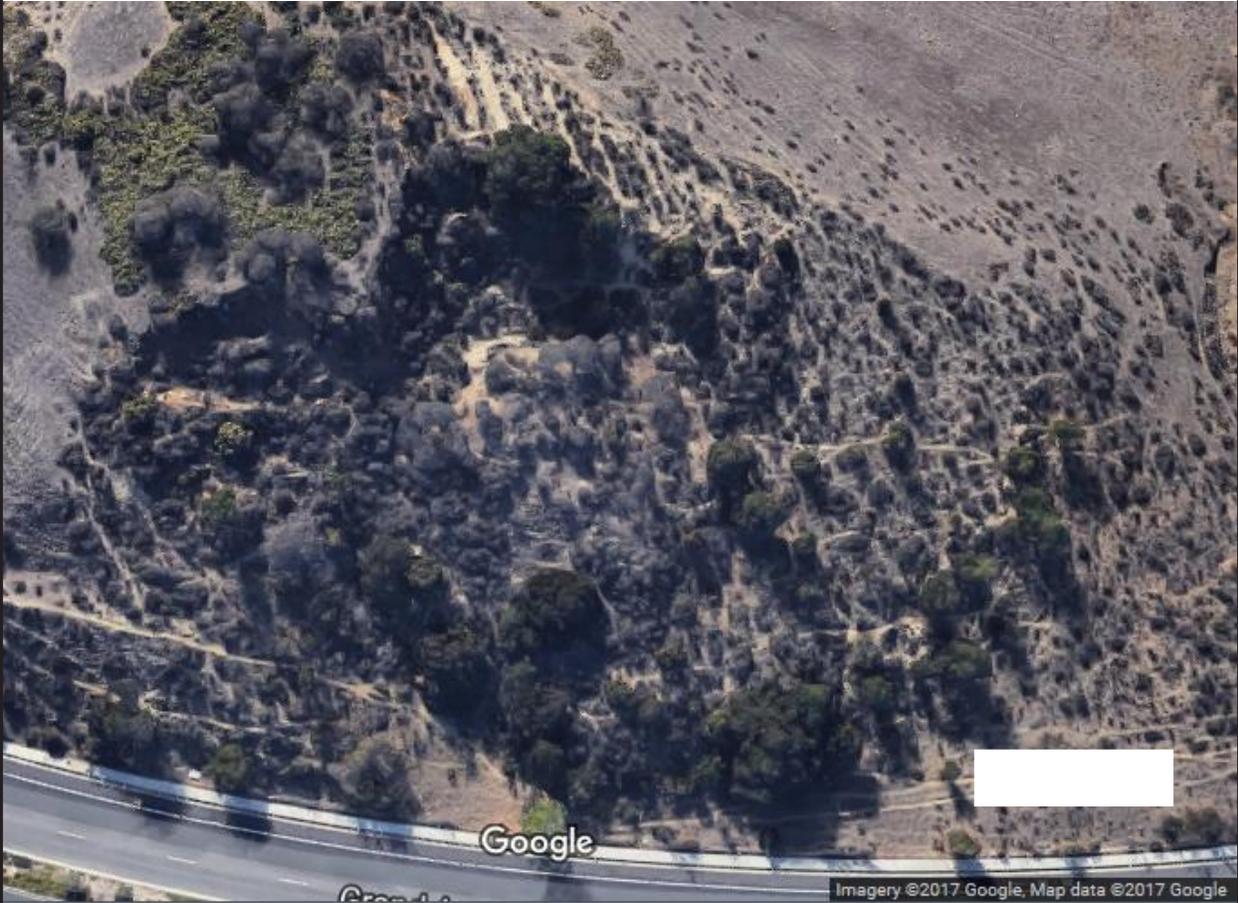
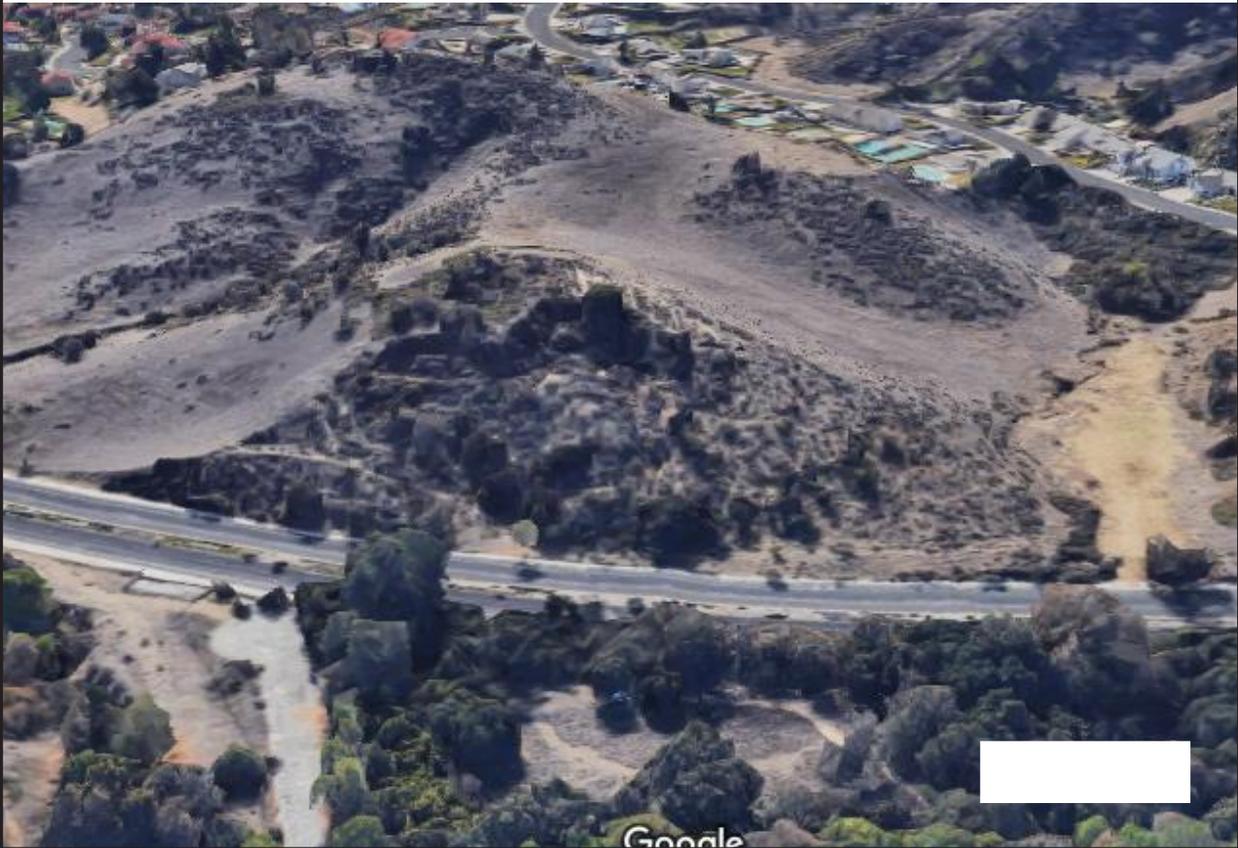
Central Hill Landslide Area (close up and broader view)

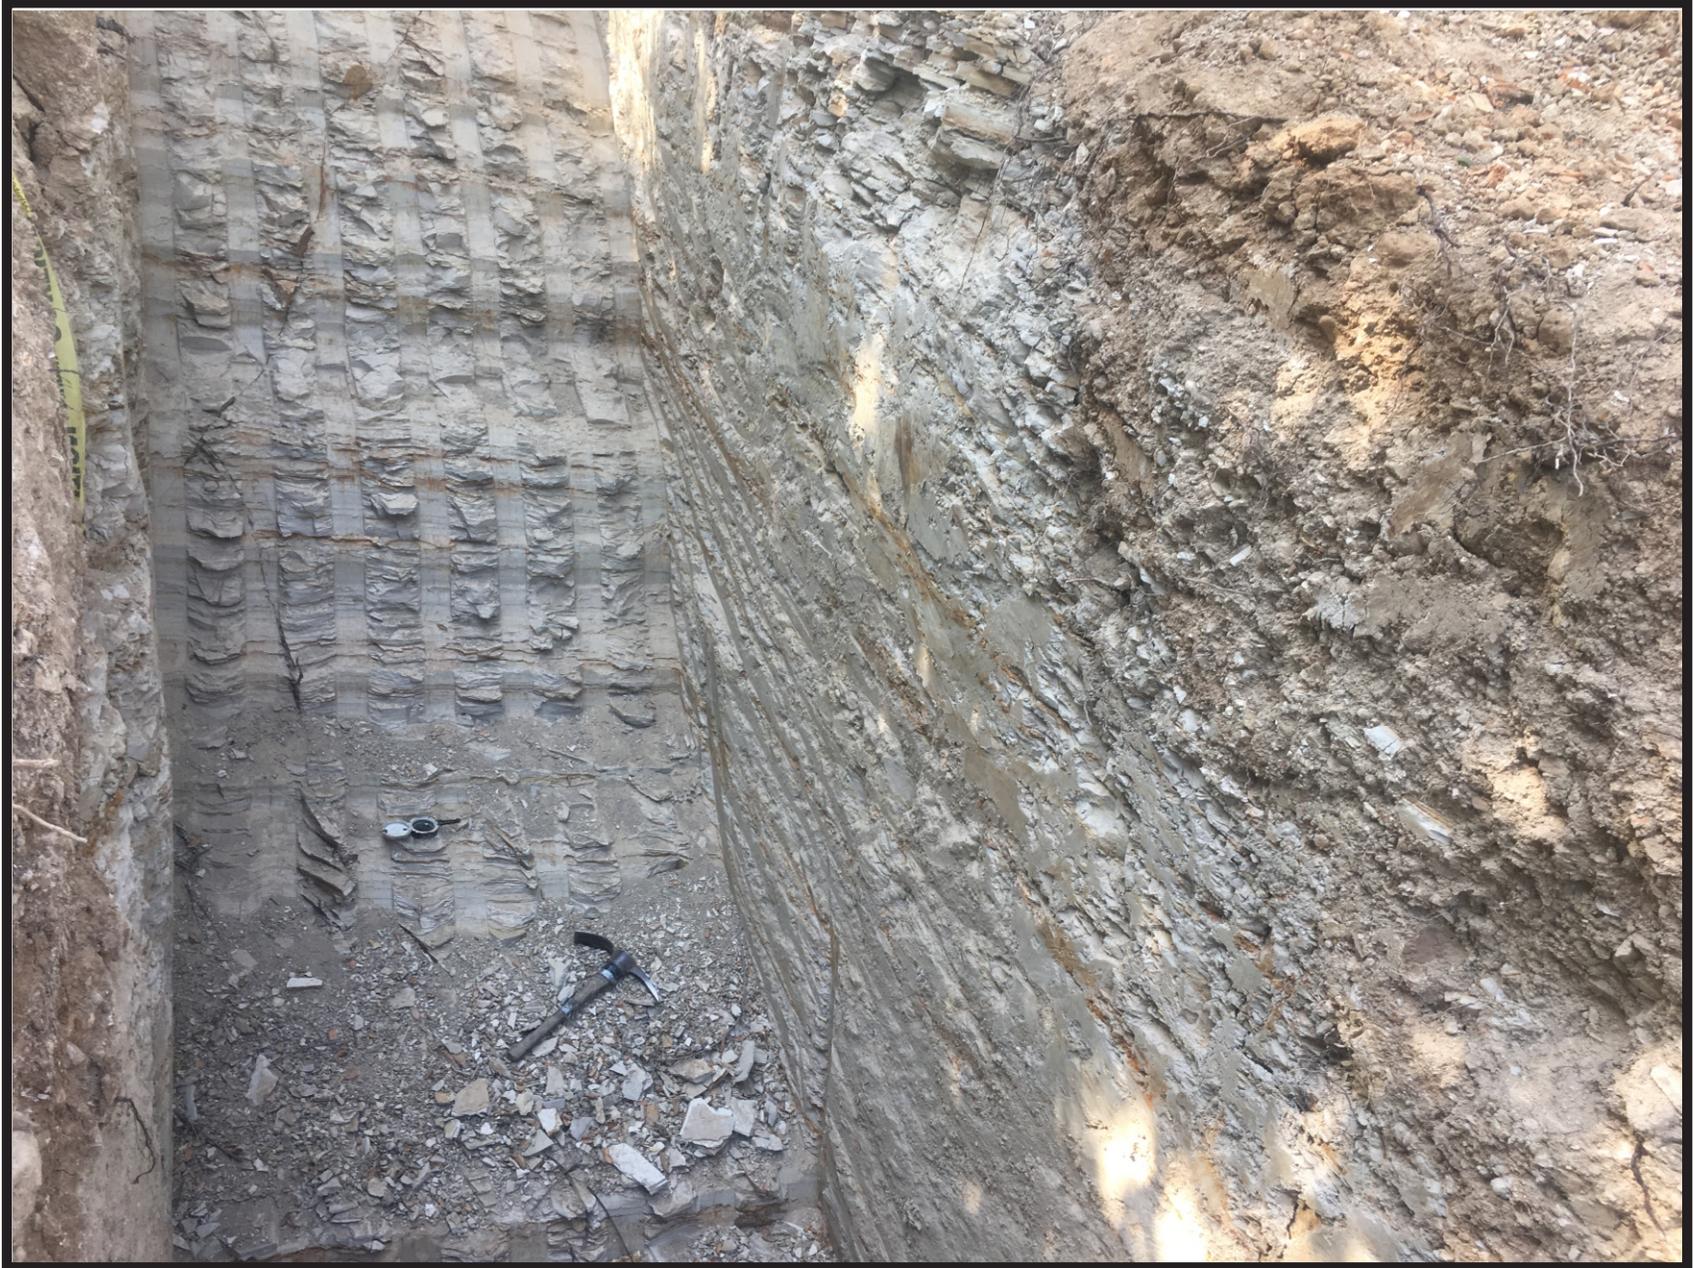
Photo 1A

Test Pit No. 4

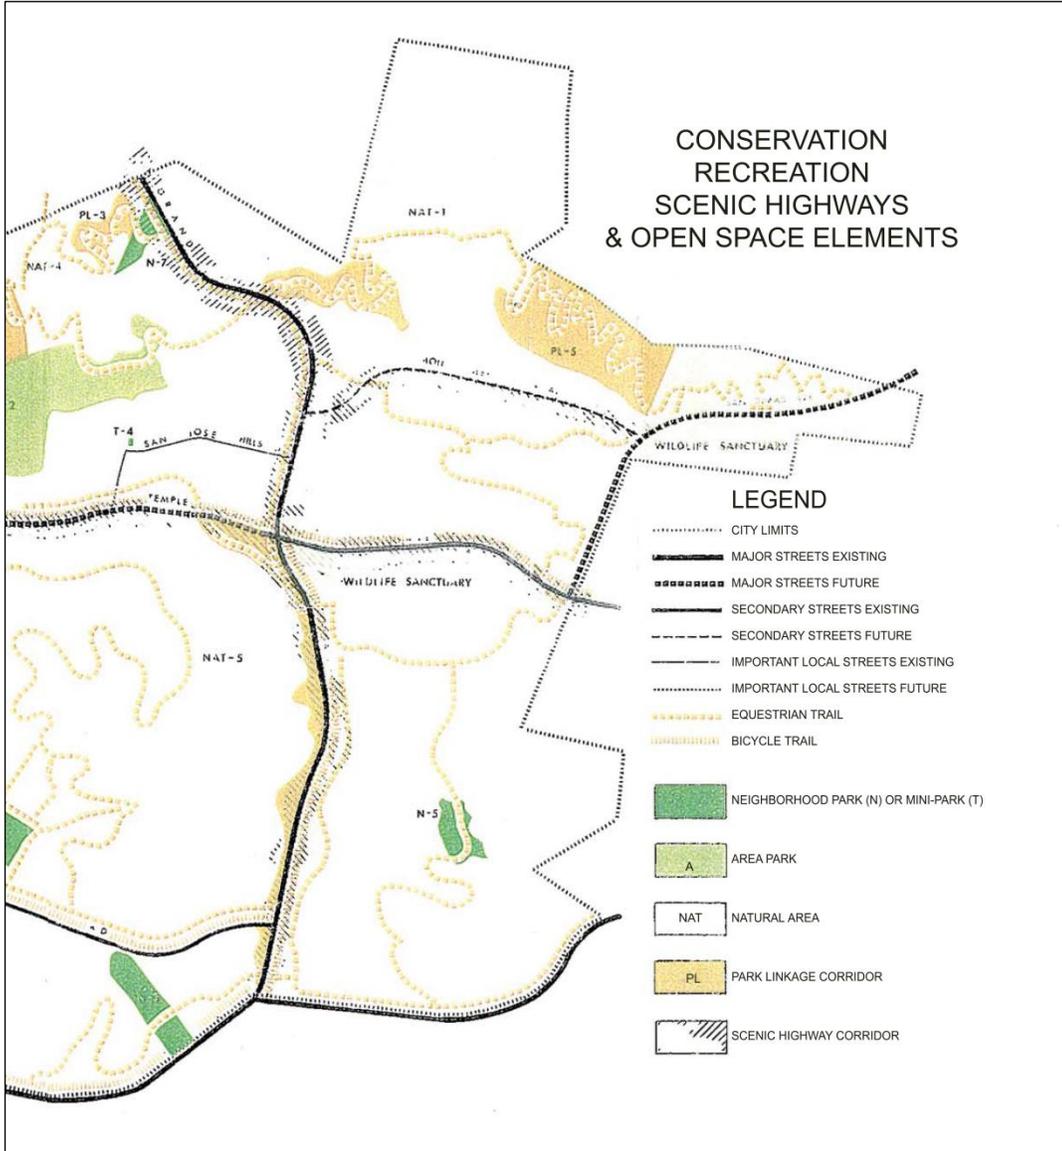
6. The General Plan Conservation, Recreation, Scenic Highways & Open Space Element, page 49, Element VI states, "Of all the existing roads within the City of Walnut, Grand Avenue possesses the most scenic value" and that "It has naturally scenic qualities south of Temple Avenue." This is precisely where Mt. SAC intends to destroy its natural hillside beauty and replace it with up to 70 feet of earthfill covered with asphalt. Further, the General Plan states, "It can be viewed as a linear open space corridor maximizing both urban and natural processes." The destruction of the natural hillsides as planned under the proposed solar project would violate the intent to the General Plan designation of Grand Avenue as a scenic highway. The Scenic Highway designation along Grand Avenue is shown on the following figure.

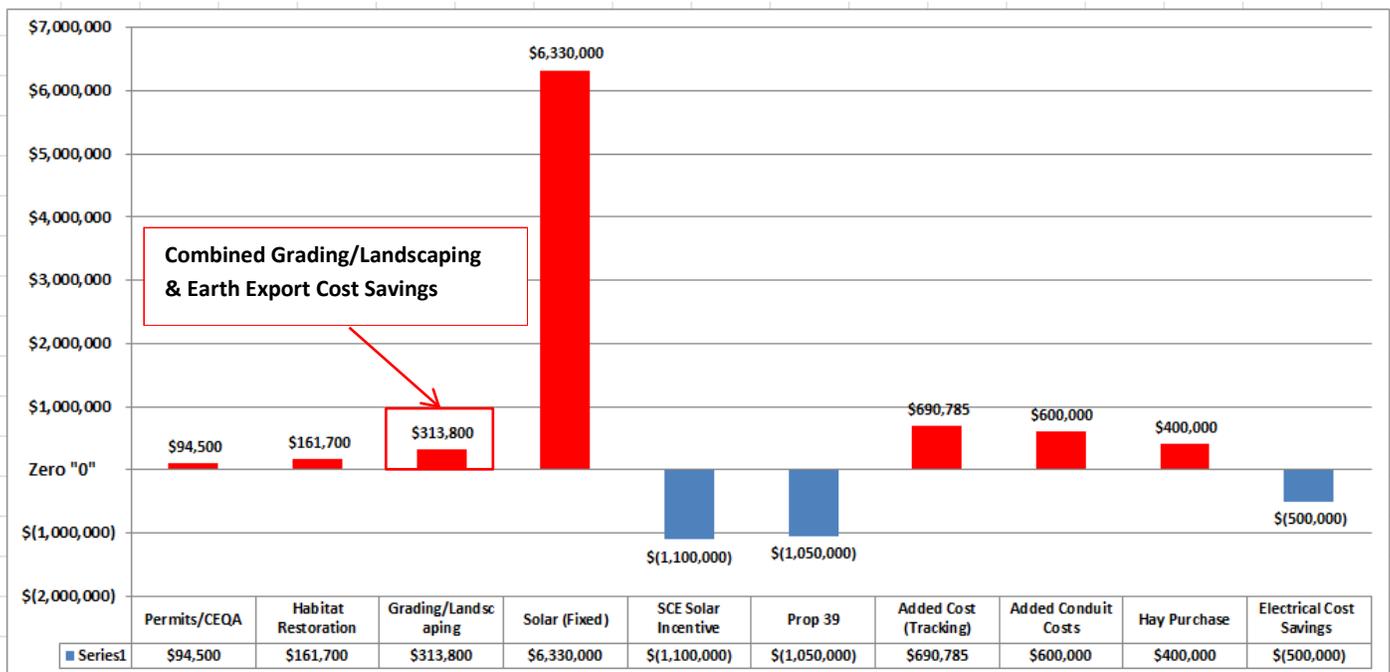
Total Project Cost – West Parcel (DEIR) Combined Grading/Landscaping & Earth Export Savings

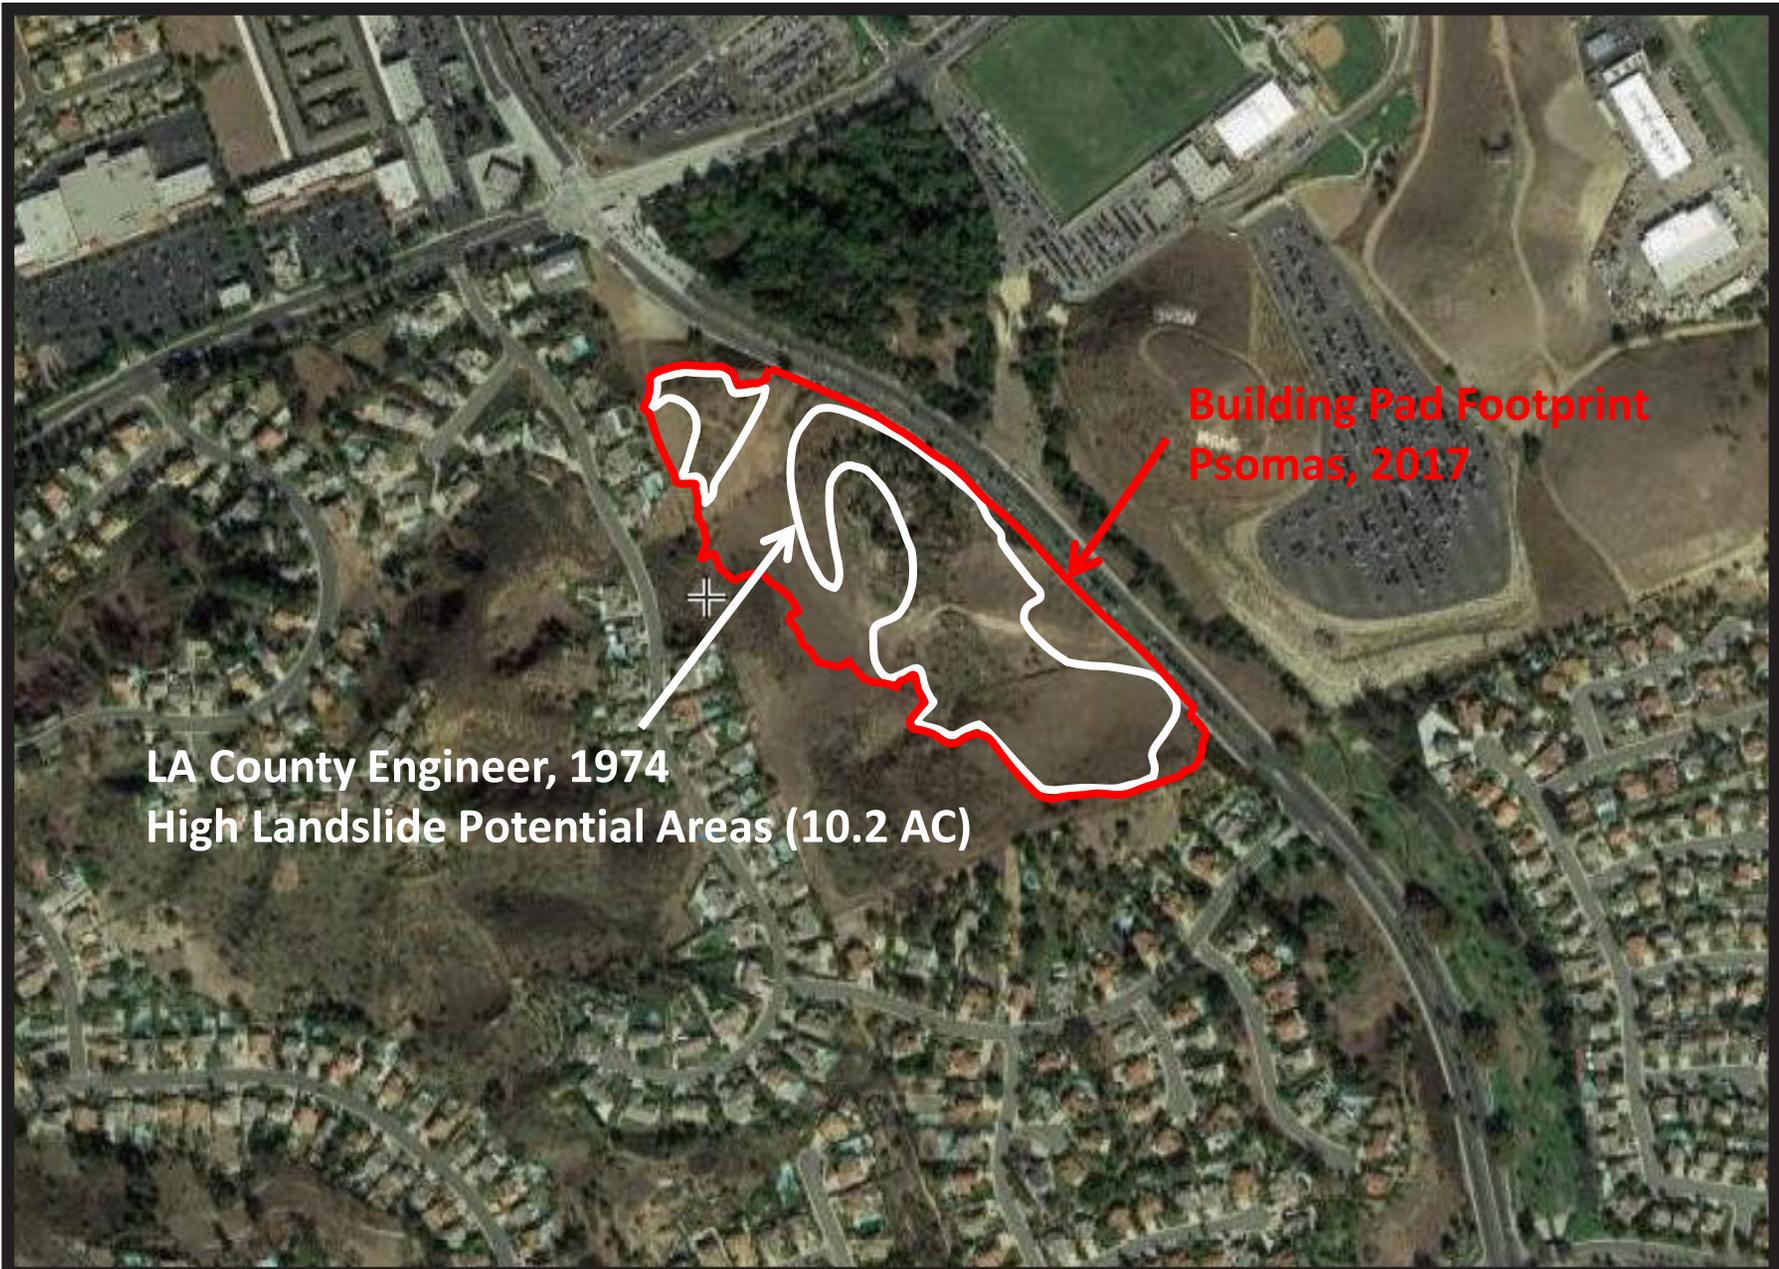
Figure 2a
Terrestrial Solutions Inc.

**Modified From
Landslide
Potential Map
City of Walnut
General Plan,
Plate II, 1974**

LA County Engineer, 1974
High Landslide Potential Areas (10.2 AC)

Building Pad Footprint
Psomas, 2017

Converse correctly indicates that, according to official maps published by the State, the site is not located in an area that must be investigated for seismically induced landsliding. However, the Converse report does not reference the LA County Engineer Landslide Potential Map (Plate II, 1974) that indicates portions of the site have a high potential for landsliding (Figures 2a and 2b). In addition, Converse did not reference CGS Open File Report 88-21 that indicates the site is within Area 3 (Figures 3a and b). Area 3 is defined as;
